## **AIRCRAFT ACCIDENT INVESTIGATION AND INQUIRY BOARD**

### **FINAL REPORT**

**RP-R5837**  
**ALLIED AG-CAT G-164A**

***DATE OF OCCURRENCE: FEBRUARY 2, 2021***

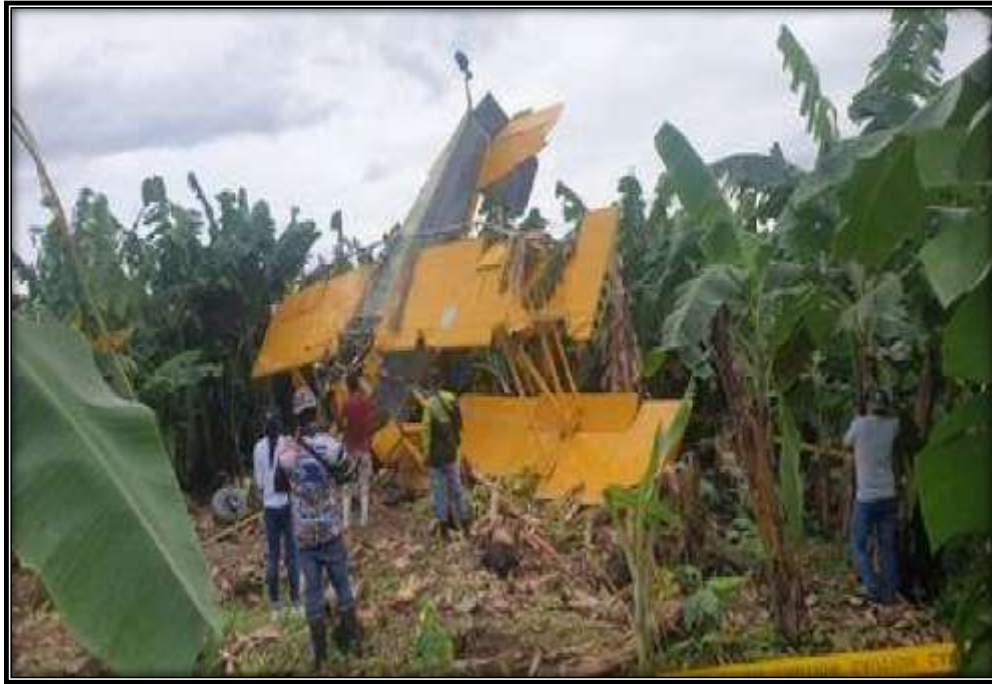
Figure 1. RP-R5837 aircraft final resting point.

Upon touched down, it continued to move forward for another fifty (50) feet, colliding with cable wires, guy wires and thirty (30) banana plants before the main landing gears fell into a canal almost three (3) feet deep and five (5) feet wide. The aircraft flipped over and came to a full stop with a heading of 230 degrees and coordinates of 07°23.22" N, 125°36.52" E.

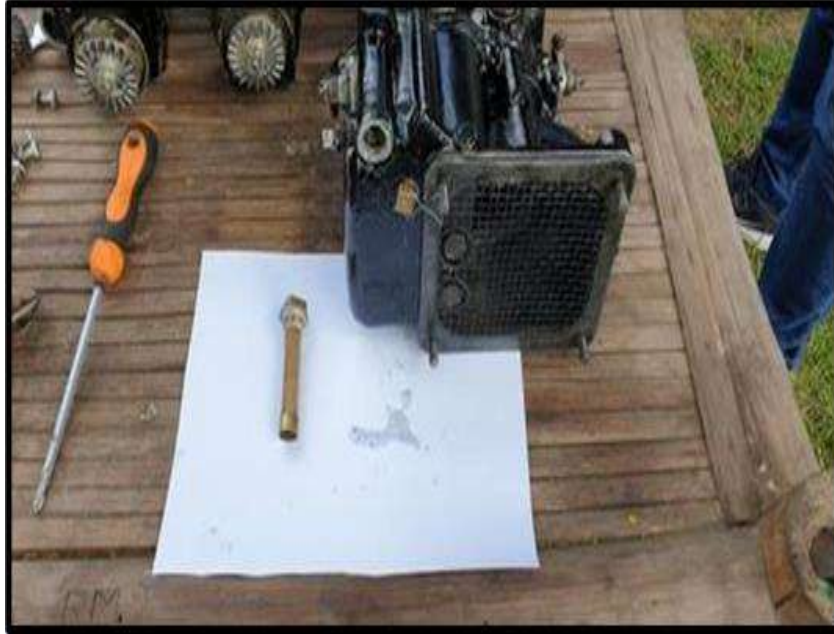
An engine teardown inspection was performed by the operator's Approved Maintenance Organization (AMO) together with the accident investigator. The inspection revealed no signs of crack in all its cylinders, there were sparks during the magneto check, however the carburetor fuel filter was found to be contaminated with water and the fuel screen contains

particulates (Figure 2 & 3). It also shows that three (3) of the nine (9) retrieved spark plugs has traces of fuel water contamination (Figure 4).

Figure 2. Carburetor Fuel Assembly contaminated with water.

- f. The carburetor fuel filter was contaminated with water and the fuel screen has some particulates.
- g. Three (3) of the nine (9) retrieved spark plugs has traces of fuel water contamination.

- a. Carburetor fuel filter contaminated with water and particulates leading to engine low power.

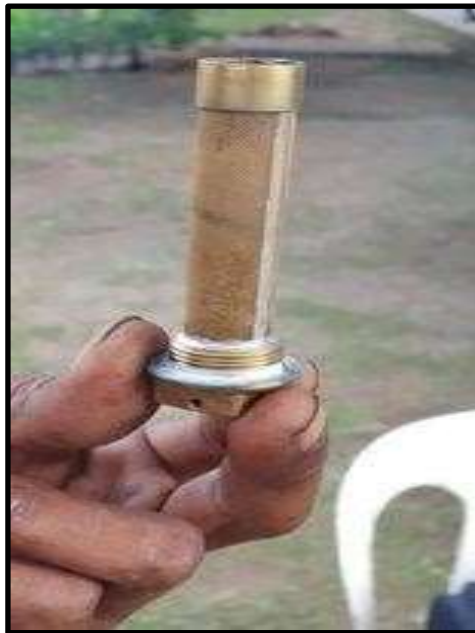
Figure 3. Carburetor fuel filter with particulates.

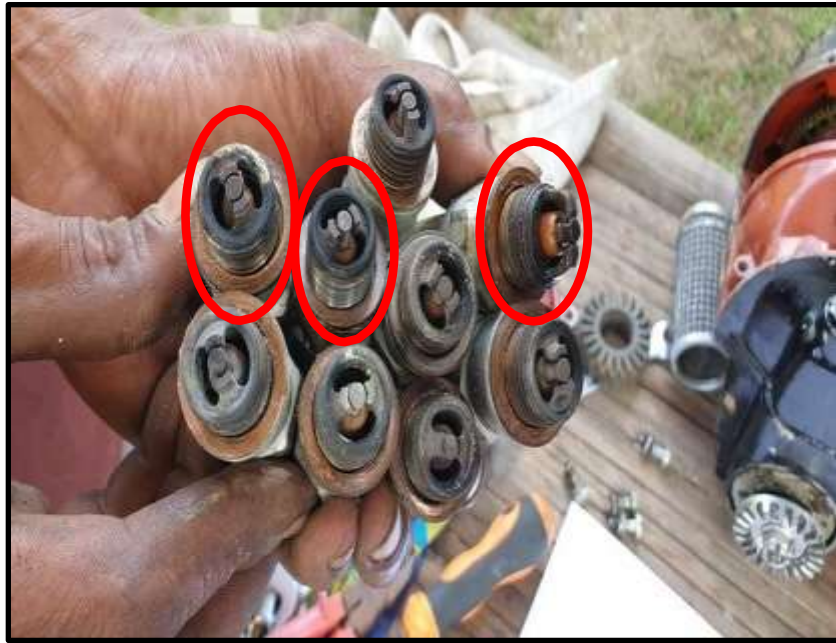
Figure 4. Three (3) of the nine (9) retrieved spark plugs has traces of fuel water contamination.

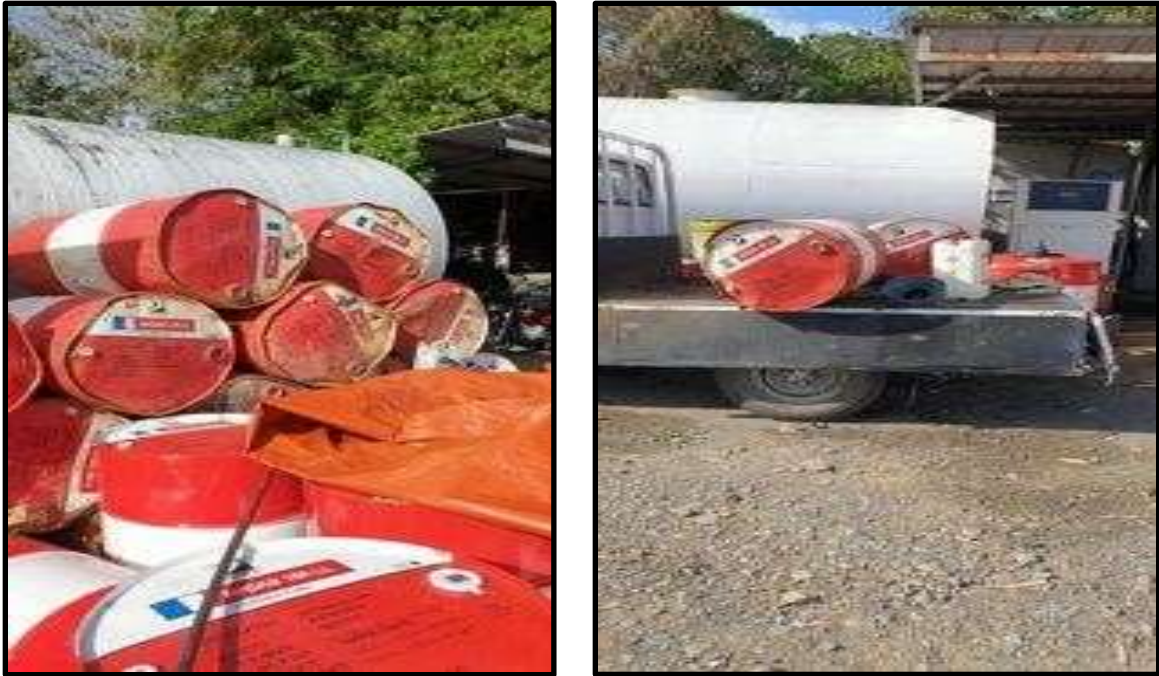
Interview was also conducted with the maintenance personnel to determine conditions, acts or safety deficiencies that might have caused or contributed to this occurrence. It further revealed that the operator performs multi transfer fueling cycle in performing agricultural aerial spray. This multi transfer fueling cycle is consist of initially transferring of fuel from the operator's under-ground fuel storage tank to recycled drums then to plastic containers and finally to the aircraft. This multi transfer fueling cycle to service aircraft in remote locations exposes the fuel and equipment for contamination to occur. Likewise, the use of plastic containers not designed for fuel and recycled drums particularly the cap gasket may pose as a hazard. Apart from falling out of the cap and preventing proper sealing, the gasket will become brittle and degrade wherein the fragments can then be tipped into the aircraft fuel tank along with the fuel. This fragment over time can either clog fuel system filters.

Figure 5. Recycled drums and plastic containers used during multi transfer fueling

- a. Include in the Company Operations Manual the detailed company fueling procedures, including inspection and maintenance of under-ground fuel tanks.

- b.** Conduct training to Pilots and Maintenance personnel on the established company fueling procedures.
- c.** Include discussion on hazards associated with improper refueling procedures during regular safety meetings so that everyone involved in the operation will be fully aware of the potential risks.
