## AIRCRAFT ACCIDENT INVESTIGATION AND INQUIRY BOARD

### **FINAL REPORT**

**RP-R8278**  
**AT - 504**

**TITLE:** An accident involving an Air Tractor Inc., AT-504 type of aircraft, with Registry Number RP-R8278 owned and operated by Davao Agritech Incorporated, that impacted with terrain at Panabo City, Davao del Norte, Philippines on November 08, 2021/0825H.

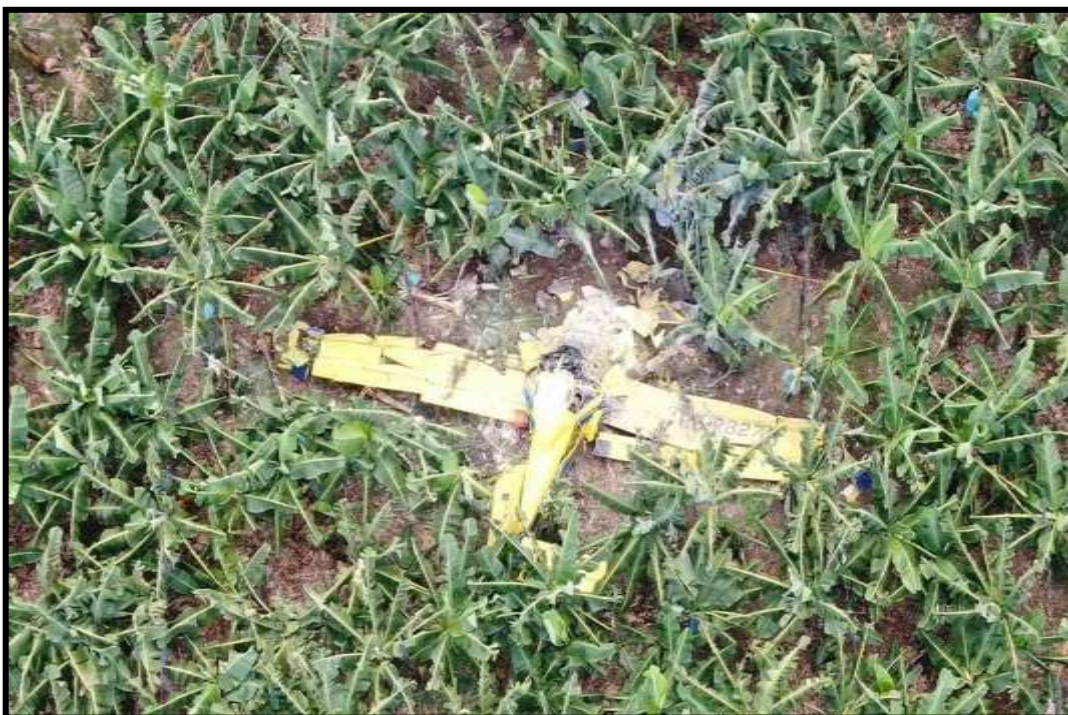
The pilot was on his first line of aerial swath after transferring to a new location of the ninth load, when witnesses saw the aircraft moving upwards and dive towards the ground. The aircraft came to stop after ground impact with the nose in a downward position. There were no ground scars leading towards the wreckage. The aircraft's last heading was 233 degrees with coordinates of 07.405751N, 125.573195E (Figure 1). Both occupants were still restrained by their seat belts when the company rescue team arrived in the area. They were brought to the nearest hospital but was declared dead on arrival (DOA). There was no post-crash fire noted and visual meteorological condition (VMC) prevailed at the time of the accident.

Figure 1- RP-R2878 final resting point

The aircraft was substantially damaged after it impacted the ground during an aerial swath operation. There were no ground scars leading towards the wreckage. It came to a full stop with the nose in a downward position with a heading of 233 degrees and coordinates of 07.405751N,125.573195E.

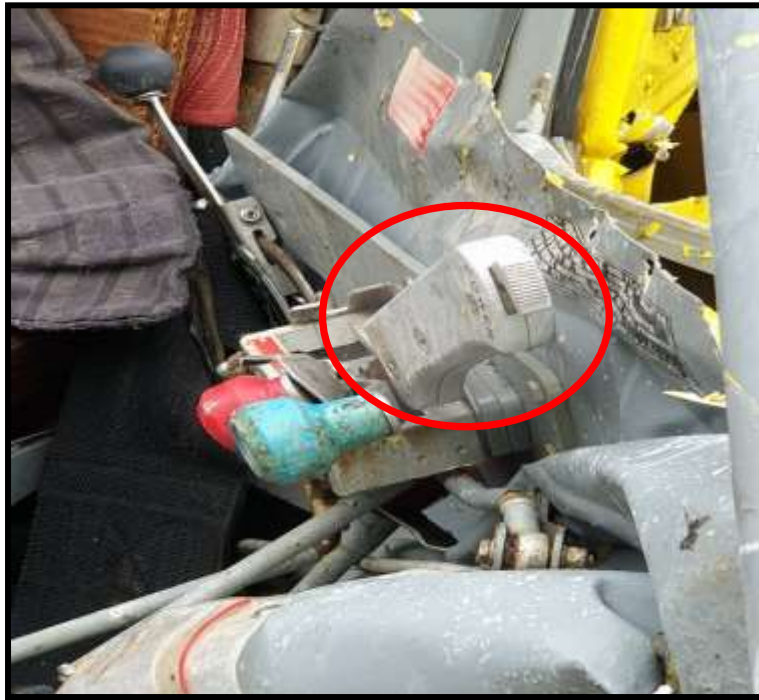
The aircraft entered into a stall as a result of an excessive right bank. To recover from such situation, the stall must first be eliminated by releasing the back-elevator pressure as necessary or by moving the elevator control forward. This lowers the nose and returns the wing to an effective AOA. The amount of elevator control pressure or movement applied depends on the severity of the stall, and the proximity of the ground. A moderate movement of the elevator control slightly forward of neutral may be required. An excessive negative load on the wings caused by excessive forward movement of the elevator may impede, rather than hasten, the stall recovery. A maximum allowable power should also be applied to increase the airspeed and assist in reducing the wing's AOA. The throttle should be promptly, but smoothly, advanced to the maximum allowable power.

Inspection of the cockpit of the aircraft during the site investigation, CAAP investigator reveals that the power lever was in full power setting (Figure 2). This could probably indicate that the pilot tried to recover the aircraft. However, the aircraft having been in close proximity to the ground, the pilot's opportunity to recover the aircraft was reduced. With such lower margin for recovery, subsequent impact with the terrain is imminent.

Figure 2. Throttle position in full power

- a.** Does not allow Passenger to be onboard during actual spraying activity.
- b.** Only allow newly hired pilot as observer during actual spraying activity after the particular aircraft type rating is already attained.
- c.** Strictly adhere to the Operating Limitations and Performance particularly on bank angle limitations while operating an AT-504 type of aircraft.
