# AIRCRAFT ACCIDENT INVESTIGATION AND INQUIRY BOARD

## FINAL REPORT

RP-C1030  
CESSNA 152

**TITLE:** Incident involving a Textron Aviation Inc., Cessna 152 type of aircraft with Registry Number RP-C1030 operated by WCC Aviation Company that had forced landing due to engine mechanical failure at Barangay Pilar, Sta. Cruz, Ilocos Sur, Philippines, on February 12, 2020 at about 0900H/0100 UTC.

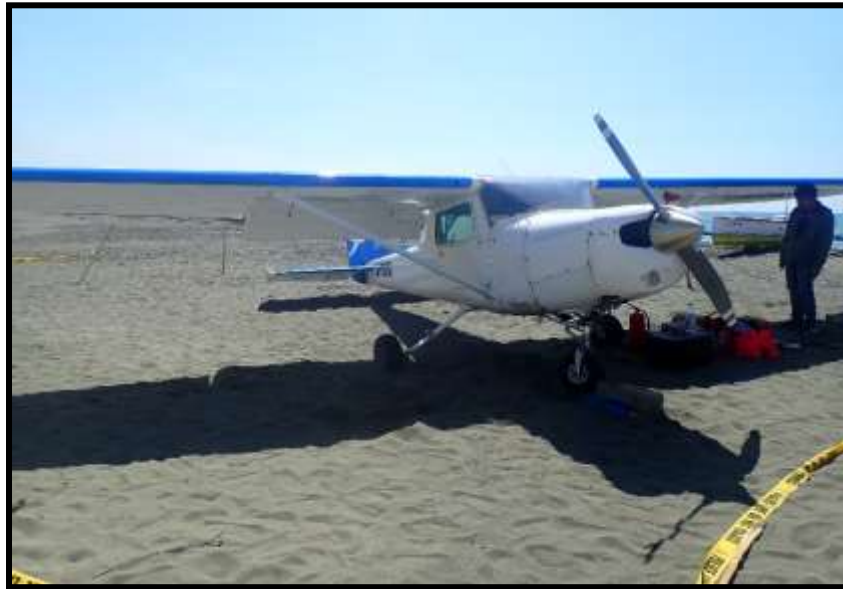
Figure 1. RP-C1030 at its final resting point.

The FI took control of the aircraft and discovered a forced landing area on the shoreline of Sta. Cruz, Ilocos Sur. During the landing roll, about one hundred (100) meters from the touchdown point, the aircraft nose landing gear (NLG) hit a drift wood and subsequently fractured the NLG arm assembly and steering bolt. The aircraft continued to roll for another thirty (30) meters, scrapping the beach with its propeller. The lower engine mounted to the firewall bolts were bent due to the NLG impact. The aircraft came to a complete stop, with the final resting point located at coordinates 17°4'31.86"N, 120°26'17.00"E and heading approximately north. The occupants then immediately performed engine shutdown procedures and alighted the aircraft with no injuries. No fire ensued. The barangay duty personnel and some fishermen on site immediately arrived to assist in securing the aircraft.

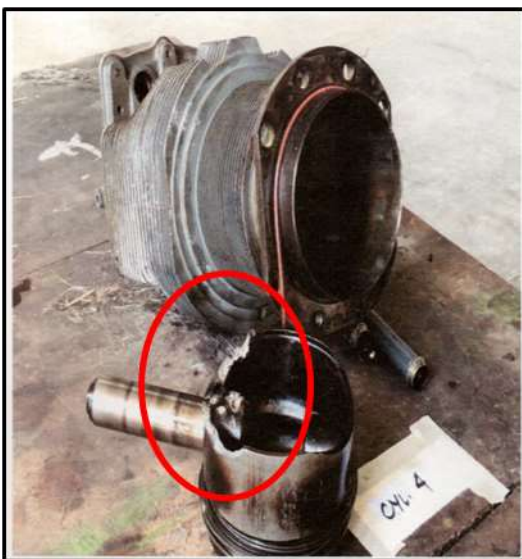
The engine teardown highlights the damage to cylinder #4's piston (Figure 2). The cylinder #3 was also damaged and its connecting rod big end cap bolt was broken (Figure 3). Additionally, the crankshaft was broken too (Figure 4). The connecting rod of cylinder #3 impacted the crankcase resulting to a hole above the oil sump. The misalignment between the cylinder and its rod resulted to the connecting rod becoming stuck in place (Figure 5). Assorted debris of engine materials were collected on the oil sump (Figure 6). The hole was measured roughly about seven point seventy-eight (7.78) centimeters (Figure 7). Hence result of the engine teardown on which the crankshaft was broken substantiated that the engine could not perform normal operation.

Figure 2. Cylinder #4.

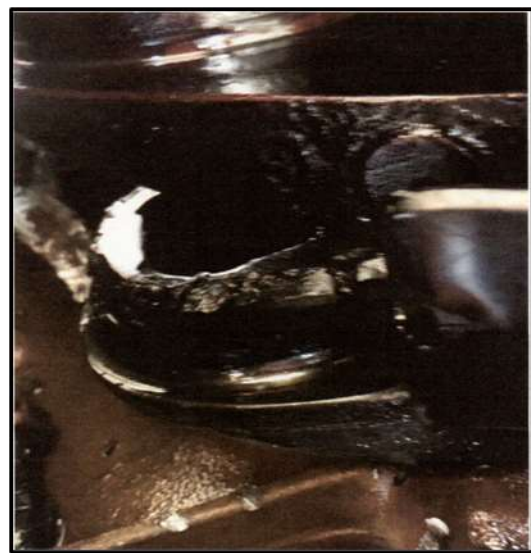
Figure 3. Cylinder #3.

- a. The failure of the cylinder #3 connecting rod big end cap bolt resulted to a sudden stoppage of the engine. (Material Factor).

- a. To ensure that the operator, WCC Aviation Company, include in the company policy and procedures manual the procedures for Cessna 152 pilots when breaking in a new propeller model, such as the Sensenich 72CK56-0-54.
- b. To ensure that the operator, WCC Aviation Company, install an operating placard in the cockpit to provide essential safety information and warnings to the pilot regarding the operation and limitations of the aircraft.

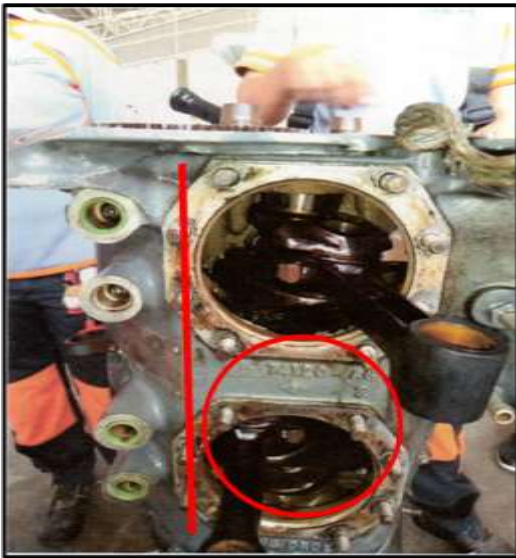
Figure 4. Broken crankshaft.

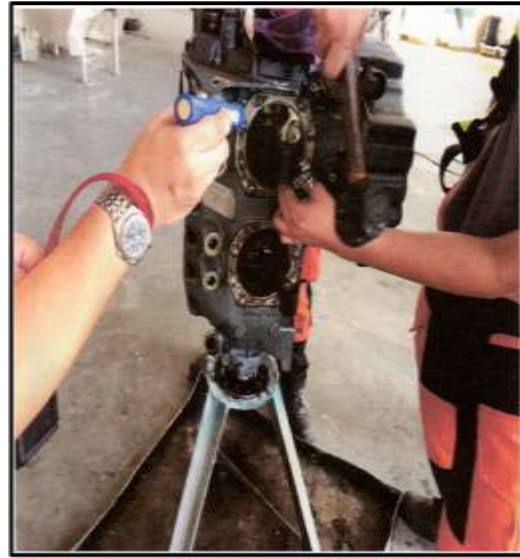
Figure 5. Broken connecting rod Cylinder #3.

Connecting rod failure is responsible for a significant number of catastrophic engine failures. When a rod fails in flight, it often punches a hole in the crankcase (“thrown rod”) and causes loss of engine oil and subsequent oil starvation. Rod failure has also been known to cause camshaft breakage. The result is invariably rapid and often leads to a total loss of engine power. However, connecting rods usually have a long useful life and are not normally replaced at overhaul. (Rod bearings, like all bearings, are always replaced at overhaul.) Many rod failures are infant-mortality failures caused by improper tightening of the rod cap bolts during engine assembly. It can also be caused by the

failure of the rod bearings, often due to oil starvation and unusual vibrations. Such rod failures are usually random failures unrelated to time since overhaul.

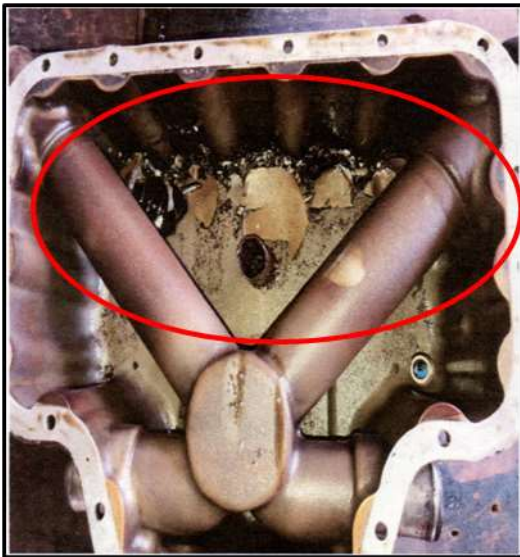
Figure 6. Assorted Metals collected.

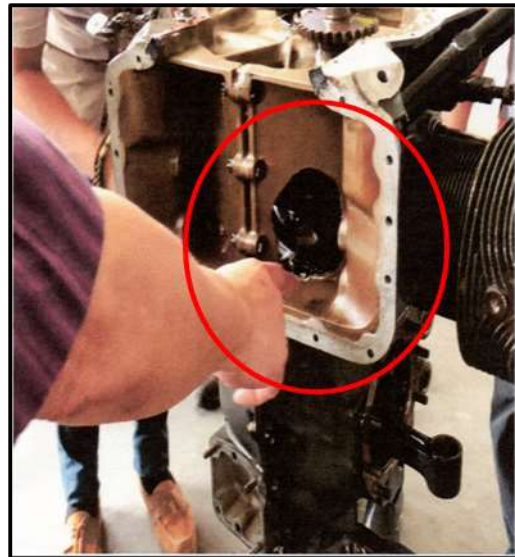
Figure 7. The hole in the crankcase.
