## AIRCRAFT ACCIDENT INVESTIGATION AND INQUIRY BOARD

### **FINAL REPORT**

**RP-C3521**  
**CESSNA 172S**

**TITLE:** Incident involving a Textron Aviation Inc., Cessna, C-172S type of aircraft with Registry Number RP-C3521 owned and operated by AAG International Center for Aviation Training, that veered off the side of the runway at Iba Community Airport, Iba, Zambales, Philippines, on August 14, 2020/1500H.

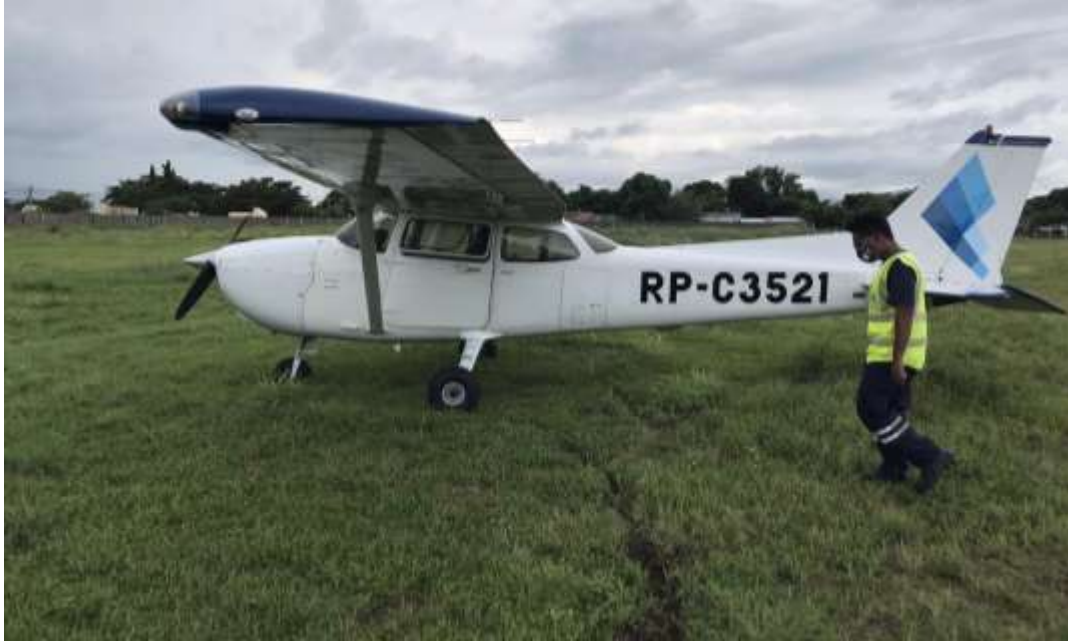
The aircraft while turning to the left prior executing a 180 degree turn for take-off on RWY 32, continued to roll towards the left side of the runway. The wheels departed the pavement and continued to roll for another 36 meters before it came to a full stop in a soft ground about 10 meters from the runway edge (main wheels) with last heading of 040 degrees and coordinates of 15 32.14 N, 119 97.11E. Review of the documents shows that the aircraft and pilot's documentation are in proper order. There were no significant remarks listed on the aircraft logbook before the incident.

Figure 1. Aircraft's final resting point

Failure of the SP to control the aircraft while initiating a 180 degrees right turn resulting to taxi excursion. (Human Factor)

- a. Establish appropriate SOP and operational guidelines to manage and execute appropriate aircraft speed while taxiing.
- b. Conducts safety meeting which covers the following:
  - 1. Review of safety protocols on aircraft ground operation.
  - 2. Review of Crew Resource Management.
  - 3. Safety briefing reminder.
