AIRCRAFT ACCIDENT INVESTIGATION AND INQUIRY BOARD

FINAL REPORT

RP-C511
KODIAK 100

TITLE: Incident involving a Kodiak 100 type of aircraft with Registry Number RP-C511 operated by WAIACO that had a bounced landing at Divilacan Airstrip, Divilacan, Isabela, Philippines, on December 5, 2020/1200H

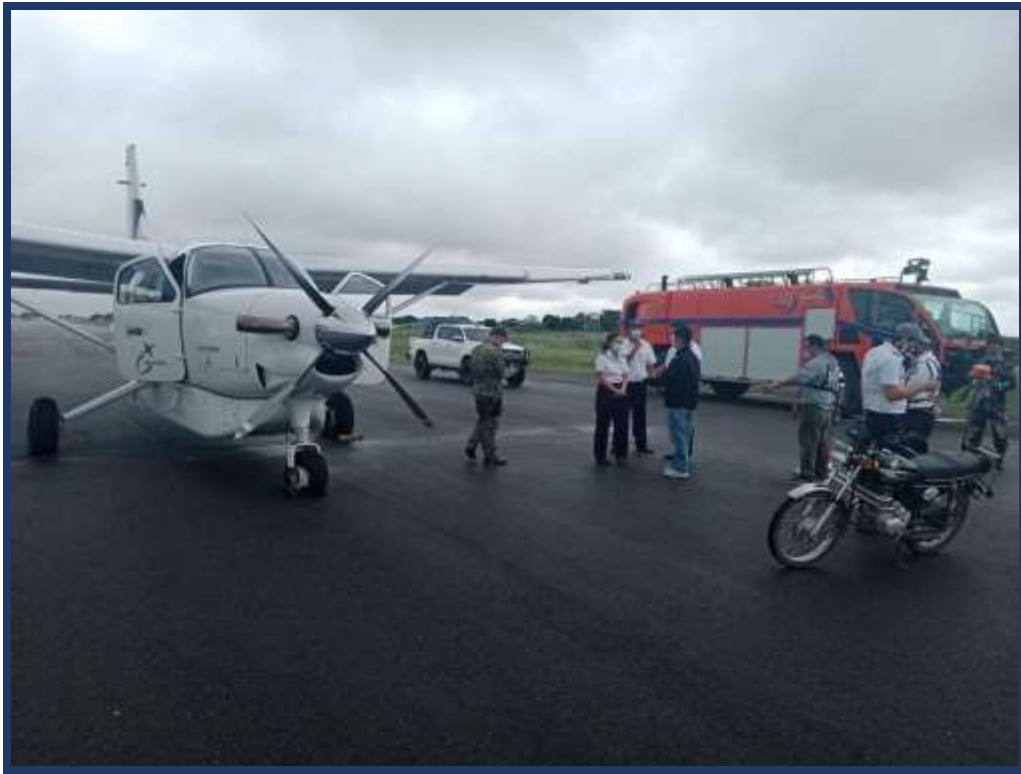
On December 5, 2020, at about 1200H, a Quest Aircraft Kodiak 100 with registration no. RP-C511 sustained damage on its nose landing gear following a bounced landing at Divilacan Airstrip, Divilacan, Cagayan. After the bounce landing the Pilot initiated a go-around and proceeded to Cauayan Airport. The aircraft landed safely using RWY 20 and came to complete stop between distance-to-go markers 2 and 3. The aircraft is being operated by World Aviation International Services Corporation (WAISCO) holder of Air Operator Certificate (AOC) authorized to perform commercial air operations. The pilot and the nine (9) passengers did not sustain any injury. The passengers disembarked in the middle of the runway. Visual Meteorological Conditions (VMC) prevailed at the time of the incident.

Figure 1: RP-C511 final resting point

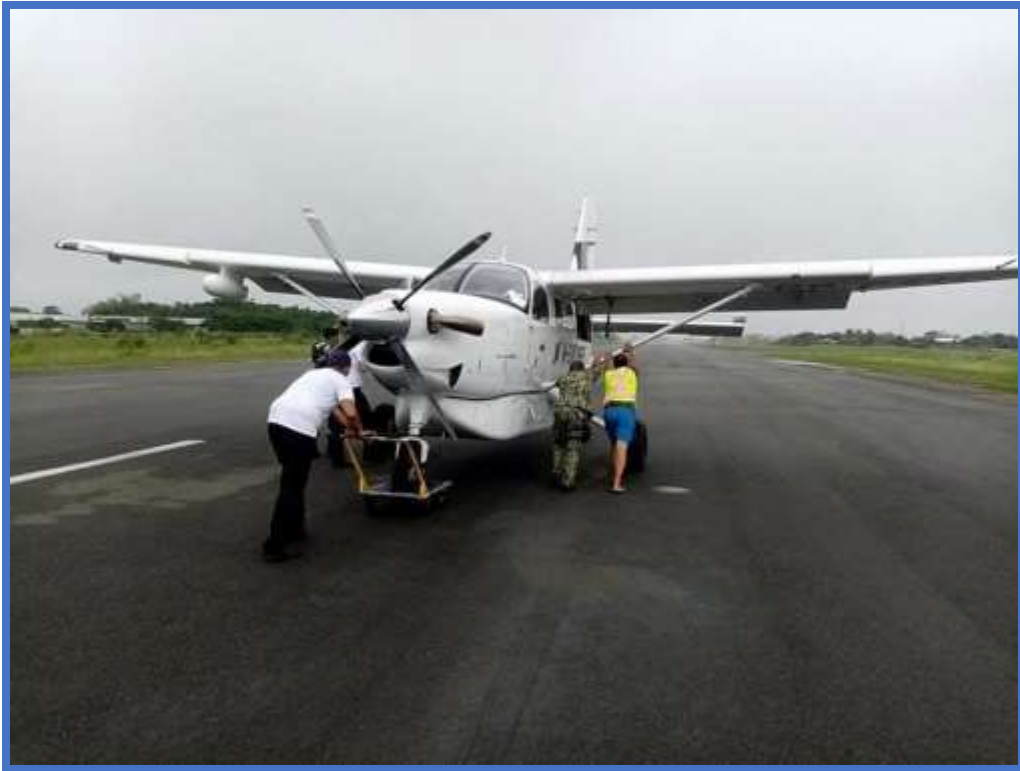
The aircraft touched down in the first 100 meters of the Divilacan airstrip. The aircraft bounced in the initial touchdown, after the second bounce, the pilot initiated a go around and proceeded to Cauayan Airport as its alternate airport. The aircraft landed in RWY 12 uneventfully and came to a stop between distance to go markers 2 and 3. With a flat nose wheel and damaged nose landing gear the Pilot decided to shut down the engine and requested assistance from the Airport personnel to tow the aircraft to the ramp (Figure 2).

Figure 2: the aircraft being towed to the ramp

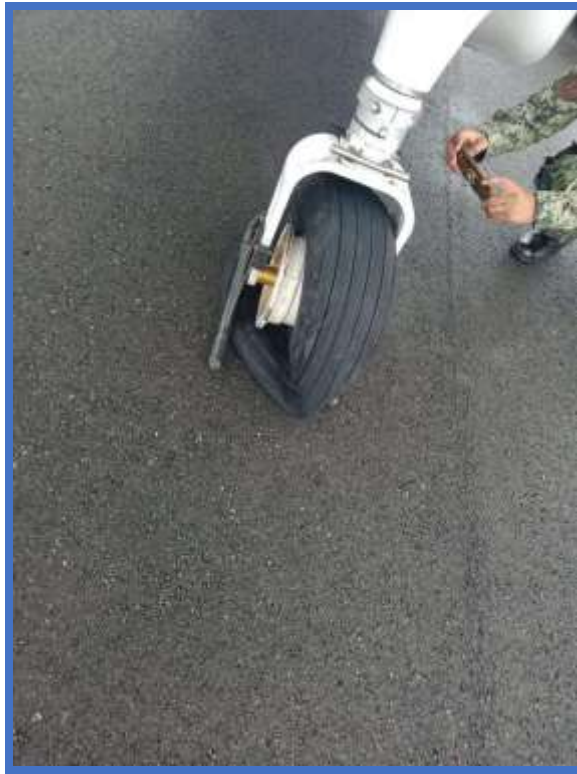
The aircraft sustained damage on its nose landing gear.

On final approach, the wind was observed from the aircraft Garmin 1000 navdata to be 8-10 kts right crosswind. Accordingly, the aircraft was fully configured for landing. Before touch down, the Pilot claimed the the aircraft was hit by strong gust of wind that resulted to a bounced landing on initial touchdown. Following a bounced landing, the aircraft landed again with its nose landing gear. The Pilot initiated a go-around and proceeded to Cauayan Airport Isabela as its alternate airport. Before landing, the aircraft flew over the Airport and the Pilot requested Cauayan FSS to check its nose landing gear for any damage. Cauayan FSS responded “looked OK for landing”. The aircraft landed utilizing runway 32 and came to stop in the middle of the runway between distance-to-go markers 2 and 3. The passengers disembarked at the runway and the aircraft was towed towards the ramp area. Visual inspection on the nose landing gear revealed deflated nose gear strut and tire (Figure 3).

Figure 3: Deflated nose gear strut and tire

- a.** Failure of the Pilot to maintain control of the aircraft following a bounced landing.

- a. Immediately suspended all its flights to all airport/airstrip not certified by CAAP through a Memorandum issued dated December 6, 2020.
- b. The Pilot involved was subjected to ground refresher training with emphasis on analyzing weather maps, data and information, approaching and landing procedures on cross wind or in sudden change of wind direction and speed including go-around procedures on January 4, 2021.
- c. The involved Pilot was subjected to flight refresher training on February 6, 2021 by the Head of Training.
- d. The Pilot involved underwent line check last February 26, 2021 before he was released for line flying.

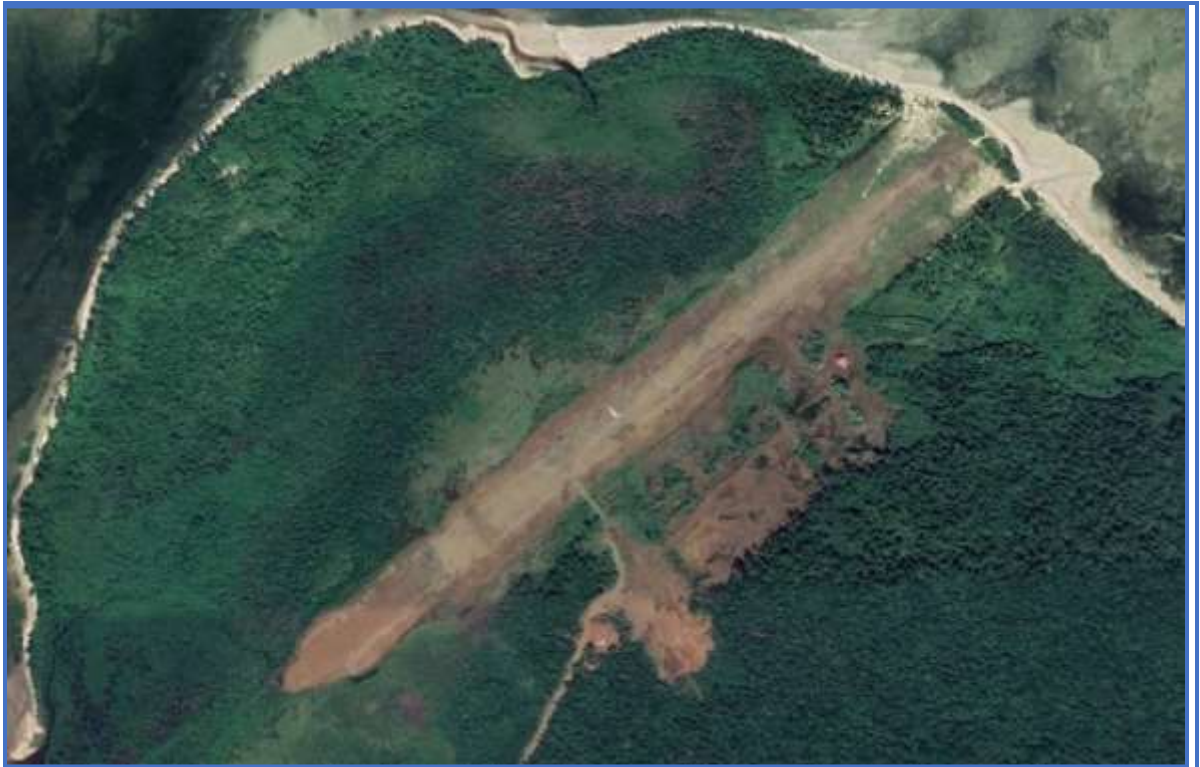
Divilacan Airstrip is located in the town of Divilacan, Isabela. According to Roundscad Corporation, the company that developed the airstrip, the runway has a total length of 1,500 meters and width of 46 meters with surface tapped up to base course and compacted.

Investigation disclosed that the airstrip has no ground to air communication facility including basic guide to wind direction and speed like windsock to aid Pilots during landing. Verification with AANSOO revealed that Divilacan Airstrip has not undergone certification process from CAAP nor permit to Operate (PTO) was issued.

Figure 4: Divilacan Airstrip taken from google earth with imagery date of 12/24/2020

- b. Non-availability of wind direction indicator to serve as reference to the pilot for actual wind speed and direction.
