AIRCRAFT ACCIDENT INVESTIGATION AND INQUIRY BOARD

FINAL REPORT

RP-C8230 **TECHNAM P2010**

TITLE: Incident involving a Tecnam P2010 type of aircraft with Registry Number RP-C8230 operated by First Aviation Academy that had a nose wheel separation following a bounced landing at RWY 07, Subic Bay International Airport, SBFZ, Subic, Zambales Philippines on January 5, 2020/0917H

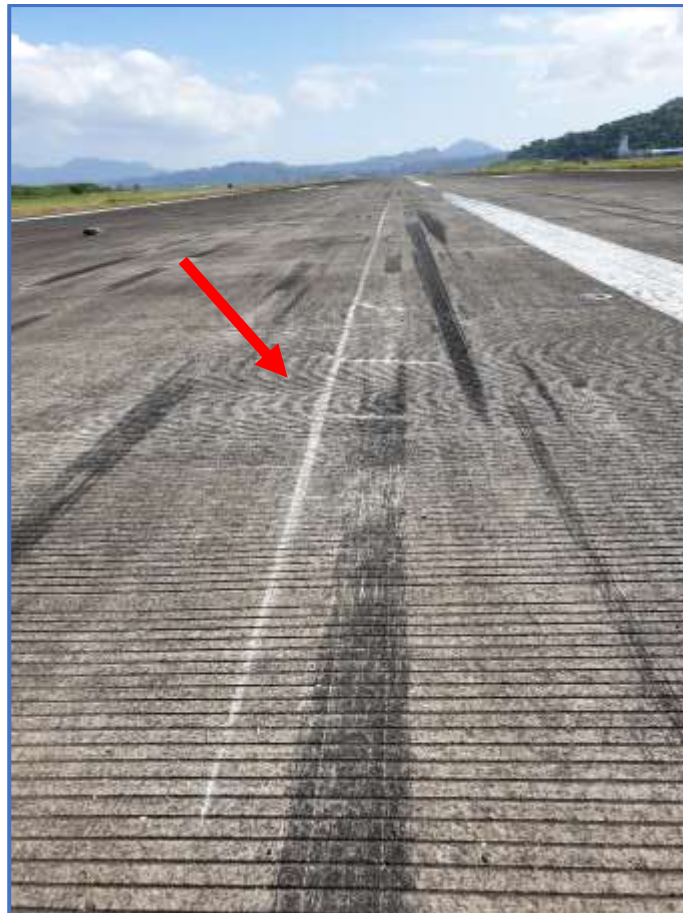
The runway sustained propeller strike marks and scrape caused by the broken nose landing gear strut.

Figure 1: Shows the propeller strike and runway scrape marks.
