# AIRCRAFT ACCIDENT INVESTIGATION AND INQUIRY BOARD

## FINAL REPORT

### RP-C8262 PIPER AIRCRAFT CORPORATION/PA-31

***PLACE OF OCCURRENCE: PALANAN COMMUNITY AIRPORT,  
PALANAN, ISABELA, PHILIPPINES***

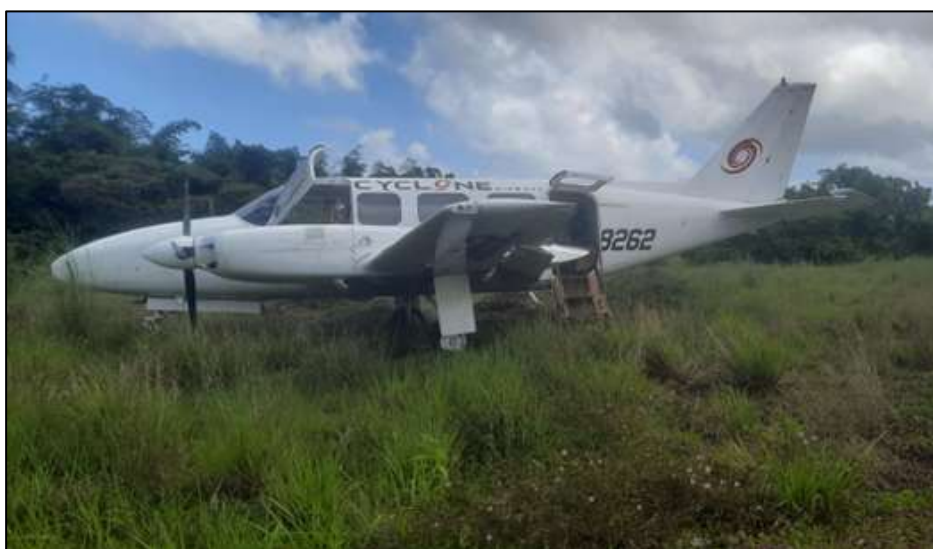
The pilot reported that after the aircraft touched down, he applied brakes. After repeated braking applications, the pilot noticed that the right-side brakes were not working properly.

Figure 1 – The aircraft at its final resting point.

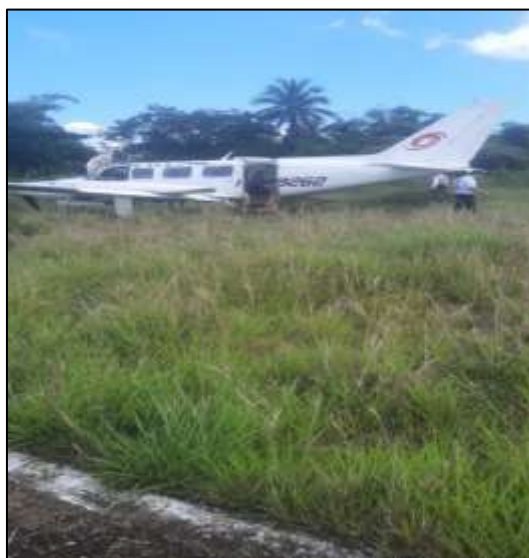
During the landing roll, the aircraft suddenly veered towards the right side of the runway 02 centerline, about fifty (50) meters before the threshold. The main wheels of the aircraft exited the paved section of the runway and continued rolling for another ten (10) meters to the grassy area. The pilot maneuvered the aircraft to the left, narrowly avoiding a pile of aggregate rocks due to a work-in-Progress (WIP) on the runway edge (Figure 3), which caused its threshold to shift. However, the aircraft sustained no external damage.

Figure 4 – The aircraft at about 10 meters from the edge RWY 02.

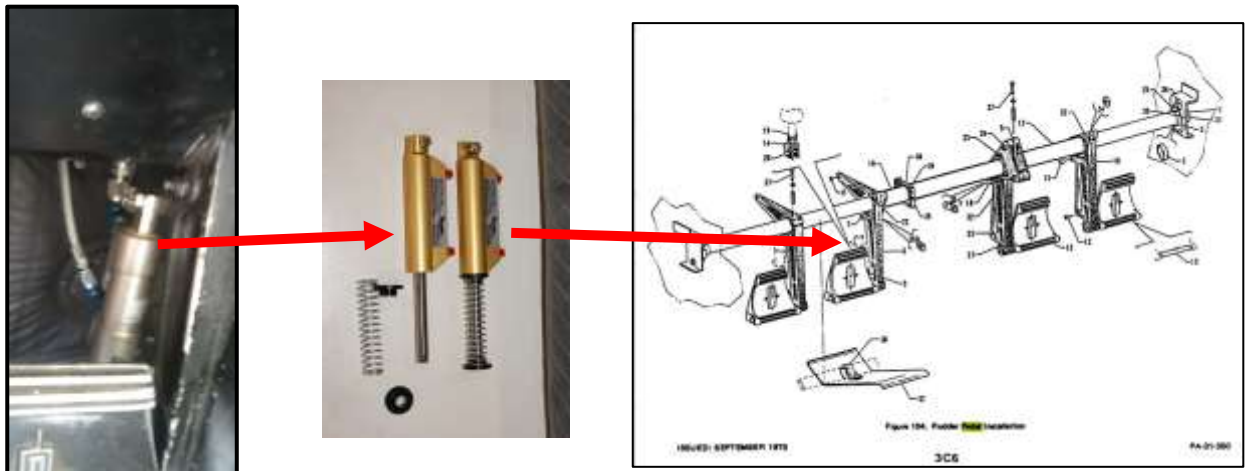
The investigation revealed that there was no external damage to the aircraft. Unfortunately, the aircraft's right rudder/brake pedal forward hydraulic piston (brake master) had a leak from its gasket/seal. This resulted in a leak of hydraulic fluid on the right-side wheel brake system, causing the right main landing gear brake to malfunction (Figure 5). As part of its maintenance program, the company should conduct a thorough inspection of the aircraft's right rudder/brake pedal forward hydraulic master piston. Since this is the first time this kind of event has manifested itself, the pilot and maintenance crew may have overlooked the signs that the pedal component is deteriorating.

Figure 5- Right rudder/brake pedal forward hydraulic master piston.

- a. The failure of the right-hand brake system resulted in an aircraft overrunning the runway.

The company sent two (2) mechanics to Palanan Community Airport to address the event's brake component issue. What the mechanics did was clean the aircraft's right hand brake pedal forward hydraulic piston. One of the mechanics placed a rag under the pedal to check for leaks after testing the component several times and finding it operable (Figure 6). The AMO included the affected part in the 50- and 100-hour inspection package, as specified in the manufacturer's aircraft service manual, during

- 5.1 Following the occurrence, Cyclone Airways Inc., initiated the following safety corrective actions:
  - a. The operator has repaired the right rudder/brake pedal forward hydraulic master piston as per ASM (App 1-2) and the aircraft was released back to service.
  - b. The operator also conducted an initial and re-currency training of their mechanics covering the subject aircraft and issued a memorandum regarding the enhanced maintenance of the aircraft hydraulics and brake system components (App 3-4).
