AIRCRAFT ACCIDENT INVESTIGATION AND INQUIRY BOARD

FINAL REPORT

RP-R4861
AGCAT G-164B

TITLE: Incident involving an Allied AGCAT G-164B Turbo type of aircraft with registry number RP-R4861 owned and operated by Airtrac Agricultural Corporation experienced propeller ground strike after landing at Dacudao Aerodrome, Calinan, Davao City, Philippines, on February 10, 2020/0820H.

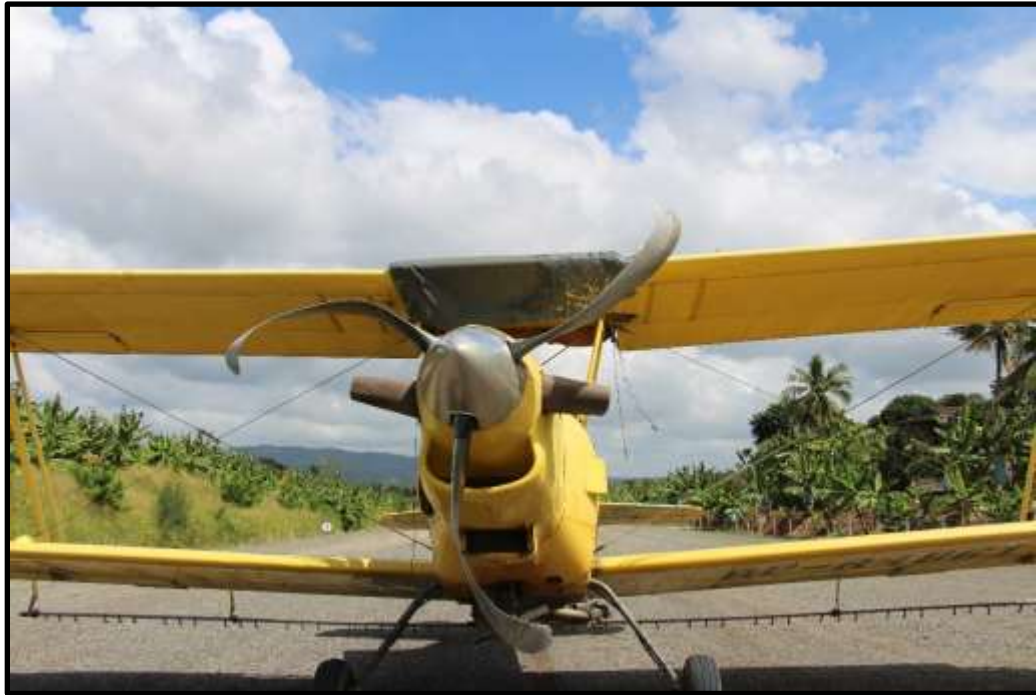
Figure 2: Propeller blades bent at mid span

The aircraft came to a complete stop with a heading of 180 degrees and coordinates of 07°13.49" N, 125°27.43" E. All of the three (3) propeller blades were bent at midspan.

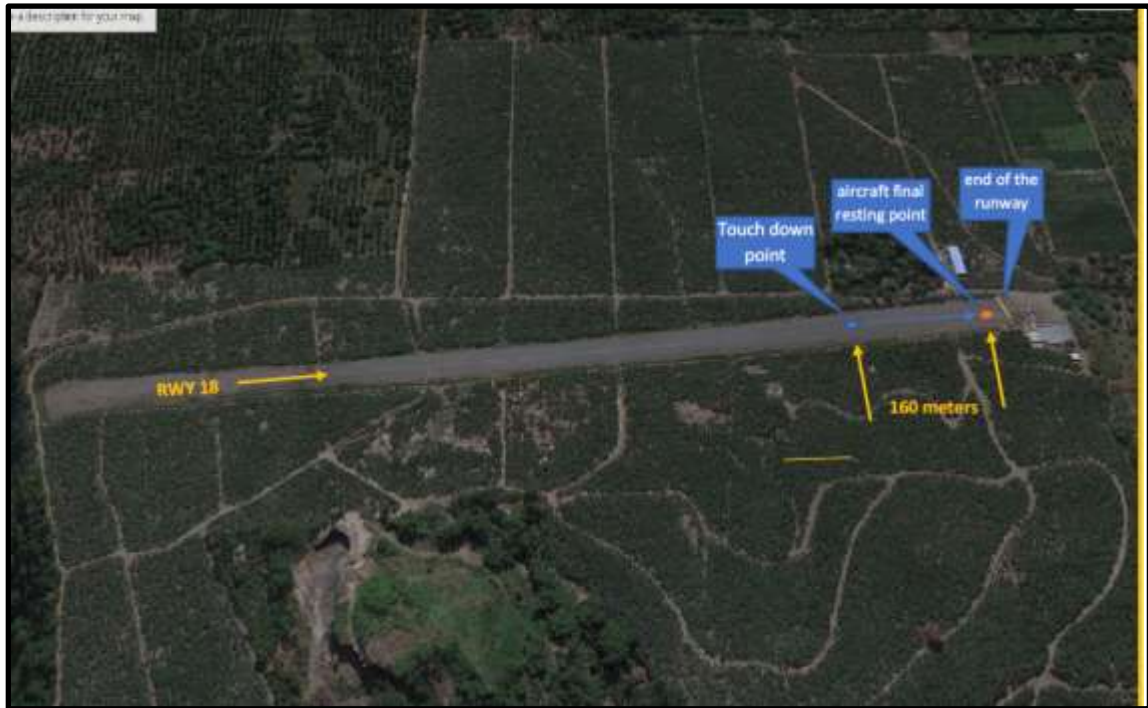
Figure 3: Approximate aircraft track

A pilot landing in a tailwheel aircraft is challenging in any wind condition. When there is a tailwind, landing safely is even more difficult. In this event, RP-R 4861 was making a landing with approximately 12 to 15 knots tailwind. It touched down hard almost at 1/4th of the remaining runway. It bounced twice, followed by the propeller ground strike after a nose over due to hard braking. As with any landing, maintaining aircraft control is the first priority, but in this case, the tailwind increases the aircraft's ground speed, and there is the problem of stopping the aircraft safely. A go-around should have been initiated during un-stabilized approach.

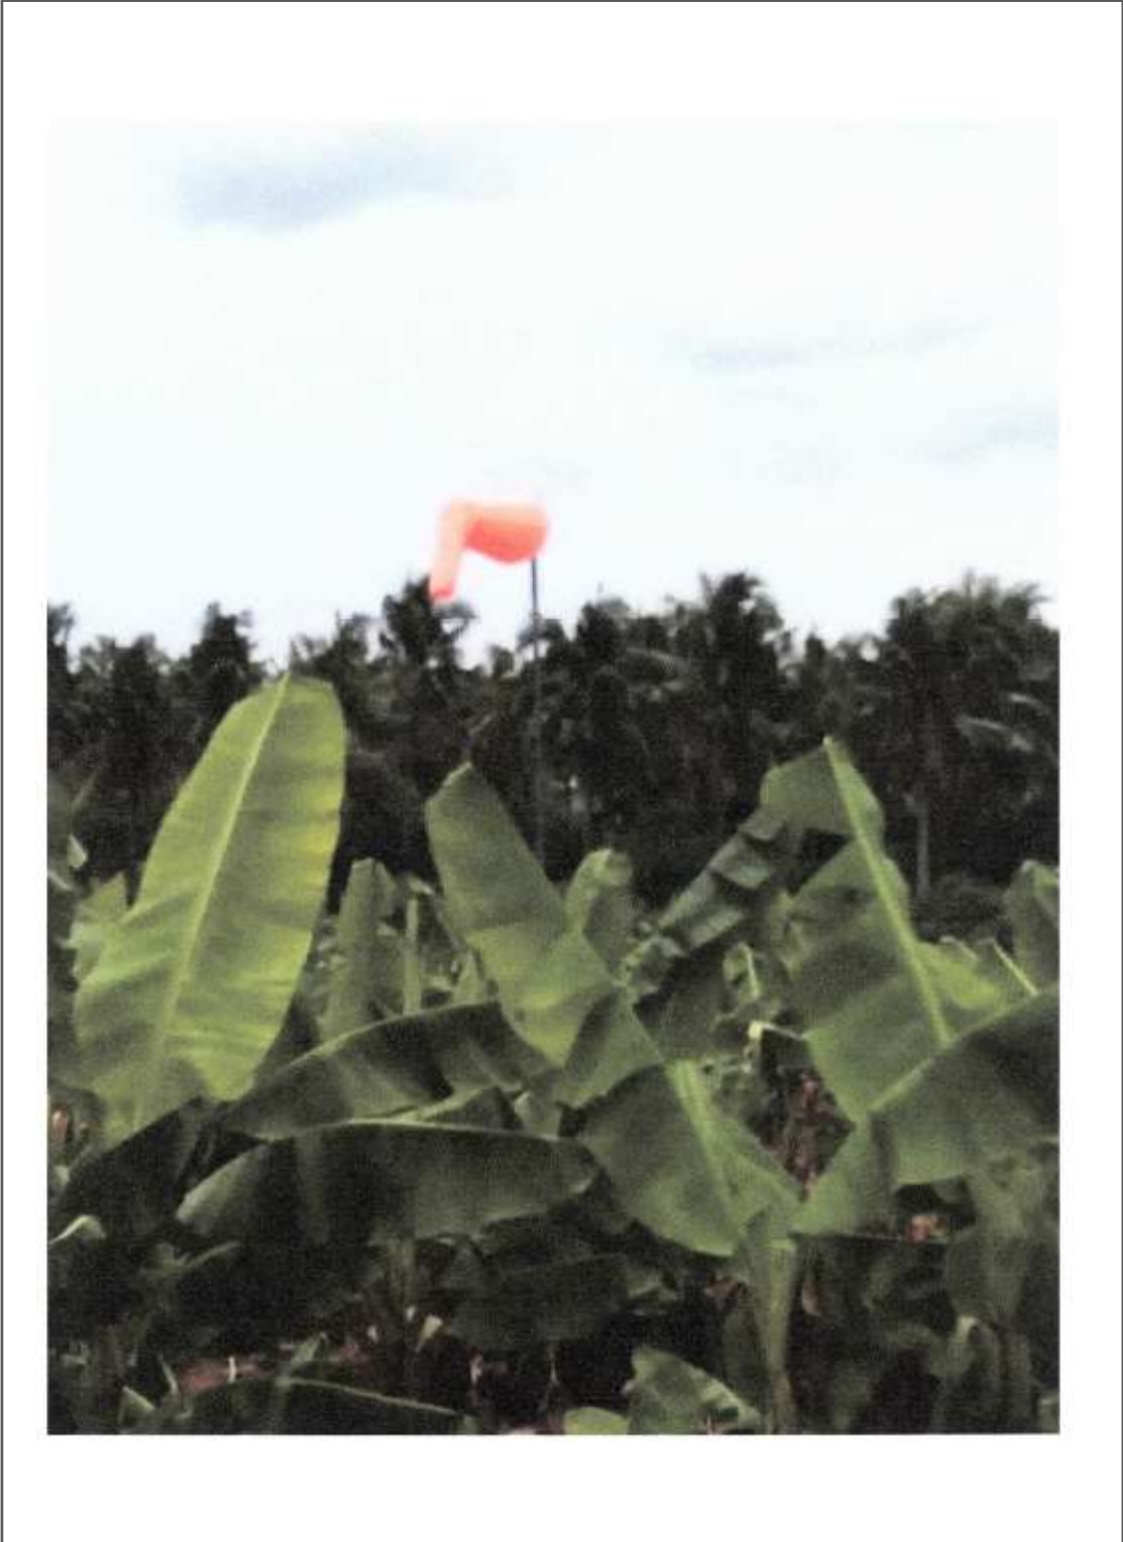
Attach is a 3 picture of the runway and the wind cone.

In compliance with your recommendation to install a wind cone in Dacudao Aerodrome after the incident of RP-R 4861 on February 10, 2020, Airtrac constructed a Wind Directional Indicator (Wind Cone) at runway 18 which abeam in the threshold of the runway 18 in order to monitor the wind condition in short finals and it was done on Aug 24, 2020.
