Republic of the Philippines
CIVIL AVIATION AUTHORITY OF THE PHILIPPINES

AIRCRAFT ACCIDENT INVESTIGATION AND INQUIRY BOARD

FINAL REPORT

RP-C5905 DE HAVILLAND AIRCRAFT OF CANADA LIMITED DHC-8-402

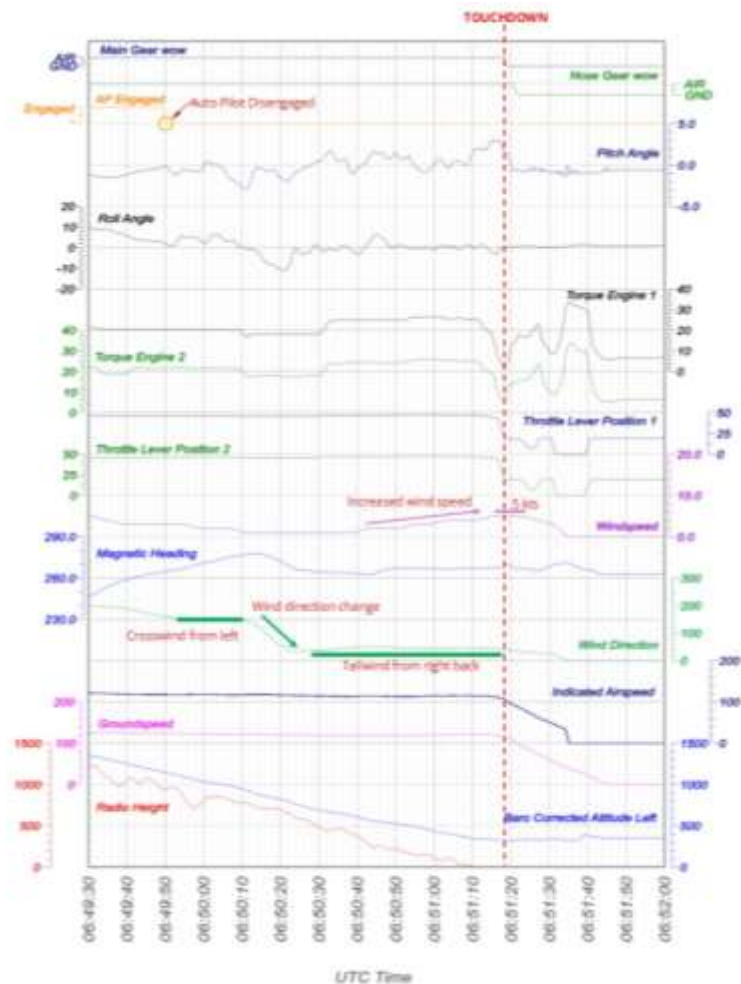
Figure 3 – FDR data during the approach.

At 06:49:50, the autopilot was disengaged when the aircraft was at 941 feet above ground level (AGL). The aircraft's magnetic heading was 264.5°, and the indicated airspeed (computed airspeed) was 118 knots. The recorded wind direction and speed at this point were 161° and 3 knots, respectively.

During the descent to 800 feet AGL with the autopilot disengaged, the wind was blowing from the left side of the aircraft (approximately 150° at 2–3 knots). Between 800 and 600 feet, the wind direction shifted from the left to the right-rear quadrant. From 600 feet down to touchdown, the wind direction was approximately 45°, indicating a tailwind from the right rear, and the wind speed increased to 5 knots as the aircraft descended.

From the time the autopilot was disengaged until the main gear touched down, the pitch angle varied from -2.9° to +3.1°, while the roll angle ranged from 11.1° left bank to 6.5° right bank. At 100 feet AGL, the indicated airspeed was 116 knots and the groundspeed was 121 knots. When passing over the threshold of runway 26, the radio altimeter indicated 23 feet AGL, with an indicated airspeed of 116 knots and a groundspeed of 122 knots.

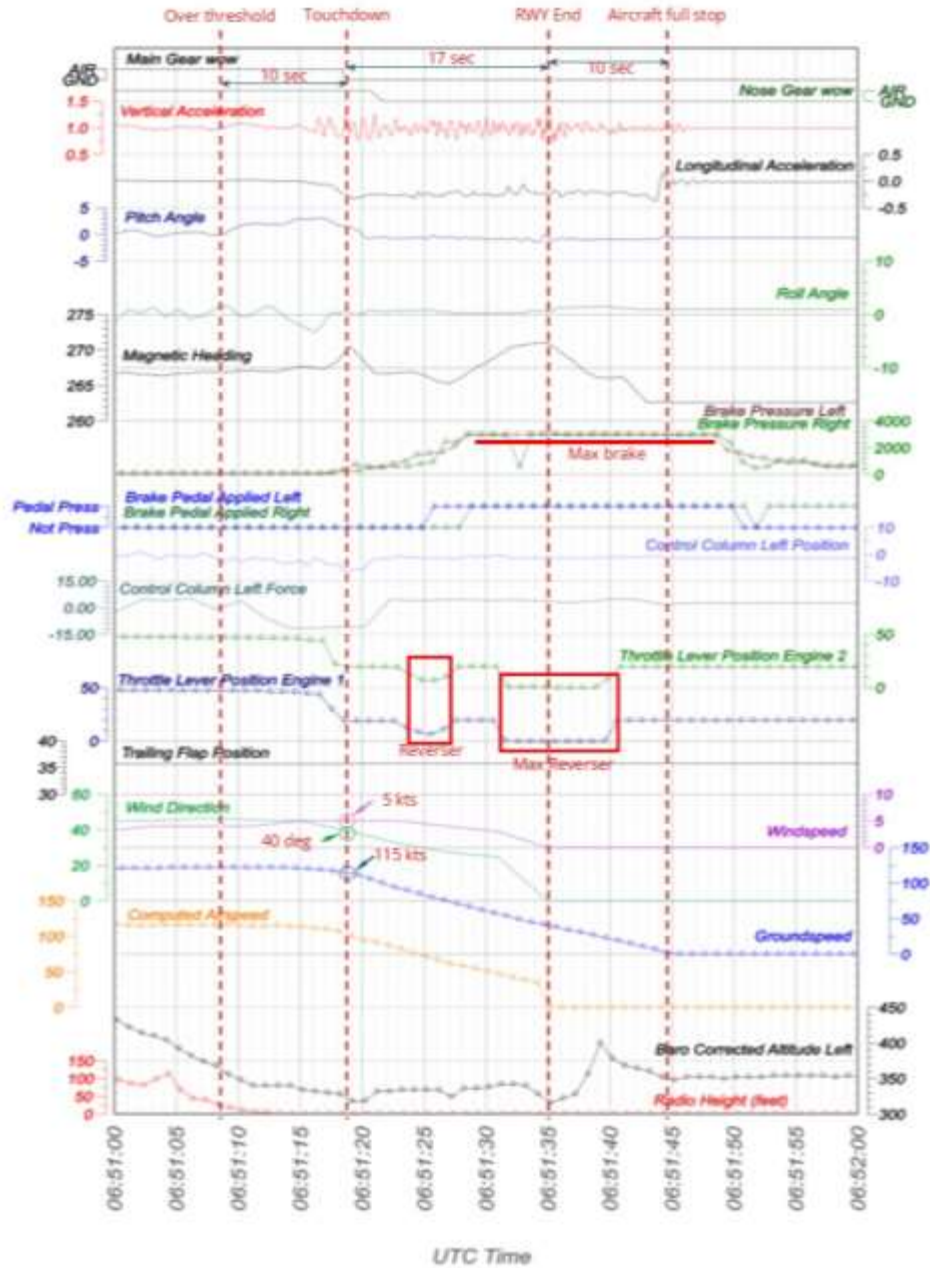
Figure 4 - FDR data during the landing.

At 06:51:19, the main gear weight-on-wheels (WOW) "ground" signal was recorded. At that time, the aircraft had a pitch angle of 1.5°, an indicated airspeed of 104 knots, a ground speed of 115 knots, wind speed of 5 knots, and wind direction of 040°. Two seconds later, the nose gear WOW "ground" signal was recorded.

One (1) second before the main gear WOW "ground" signal was recorded, the power lever was set to the "IDLE/DISC" position, briefly moved to the reverse

position, and then immediately returned to the "DISC" position. Four (4) seconds later, the power lever was set to the max reverse position and held there for eight (8) seconds. During this time, the torque value was recorded to have increased.

At about the same time the main gear WOW "ground" signal was recorded, the brake pressure began to increase and reached approximately 3,000 psi after about nine (9) seconds. The brake pressure was maintained until the aircraft came to a complete stop. During this period, the magnetic heading shifted to the right, away from the runway heading, and the right brake pressure momentarily decreased. Additionally, the FDR did not record any anti-skid parameter.

At 06:51:36, the aircraft was calculated to have passed the end of runway 26 at a ground speed of 34 knots.

At 06:51:45, the aircraft was calculated to have come to a complete stop approximately 105 meters beyond the end of runway 26.

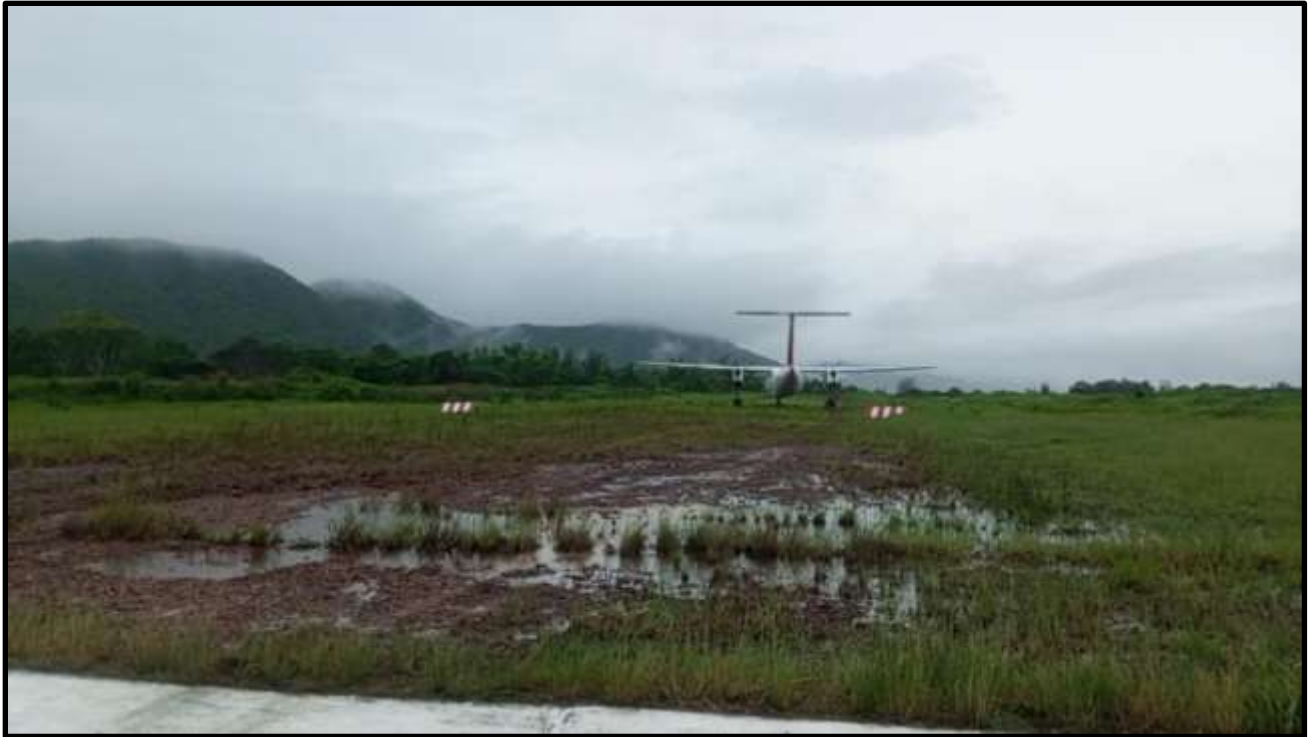
The aircraft overshot the paved portion of the runway and came to rest on soft ground, with no reported damage. A post-incident runway inspection revealed tire marks indicating that the aircraft touched down at coordinates 12°07'19"N, 120°06'03"E, which is approximately 600 meters from the threshold of runway 26. The touchdown point was noted to be within the center of the runway. The aircraft's final resting position was recorded at coordinates 12°07'16.8"N, 120°05'39"E, approximately 105 meters beyond the end of runway 26 and 729 meters from its touchdown point.

Figure 5 – The aircraft at its final stopping point.

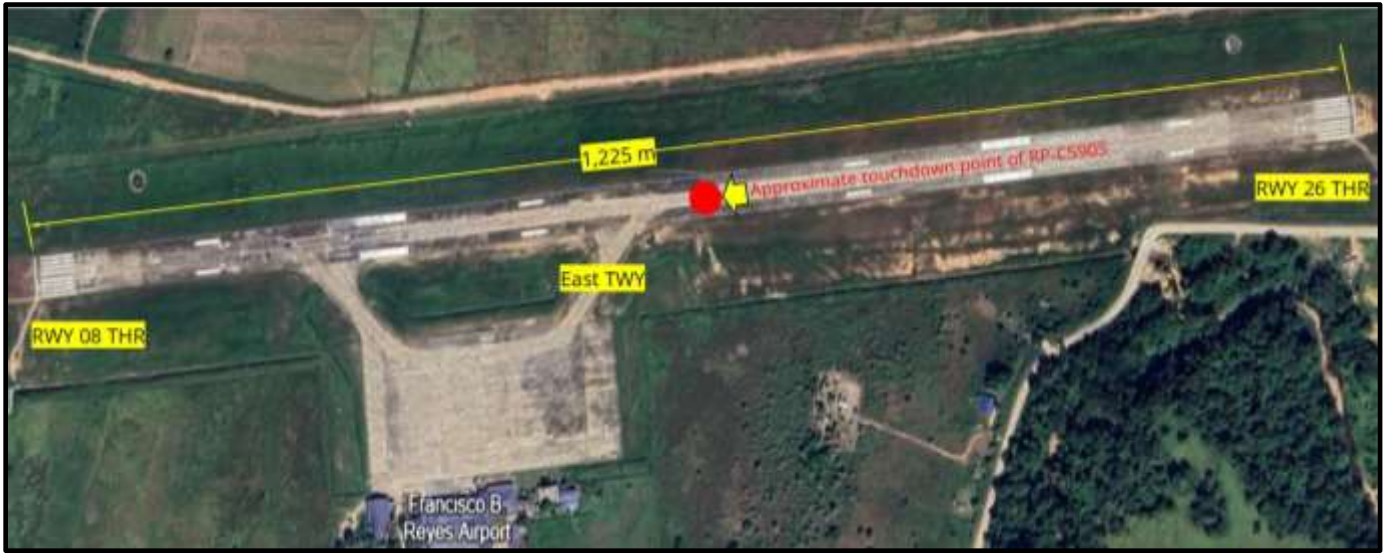
To further validate what transpired during the flight, additional perspective into the landing performance was drawn from publicly available cabin video footage, which suggests that approximately ten (10) seconds elapsed between the aircraft passing the runway 26 threshold and main gear touchdown. Using ground speed and magnetic heading data recorded in the DFDR, the touchdown point was calculated to be approximately 600 meters from the runway threshold. This indicates a relatively long float prior to touchdown, significantly reducing the available distance for deceleration. The data suggests that the aircraft landed beyond the designated touchdown zone, leaving only about half of the runway's total length available for stopping. This was further corroborated by airport terminal CCTV footage, which shows the aircraft touching down just before the east taxiway, located approximately 650 meters from the threshold of runway 26 (Figure 7).

In summary, the extended landing roll and subsequent runway excursion were the result of multiple contributing factors including a late touchdown, delayed application of full reverse thrust, an undetected tailwind component, a soft landing, and decreased surface friction due to precipitation. While the approach was stabilized, the cumulative effect of these factors rendered the remaining runway length insufficient for a complete stop on the paved surface. The event underscores the operational importance of timely deceleration actions, accurate and updated weather reporting, and formalized SOPs for performance-critical scenarios, particularly when operating in marginal conditions on short runways.

Figure 7 – Approximate touchdown point of RP-C5905 on July 14, 2024.
