Republic of the Philippines
CIVIL AVIATION AUTHORITY OF THE PHILIPPINES

FINAL REPORT

HL7525 AIRBUS A330-322

DATE OF OCCURRENCE: OCTOBER 23, 2022

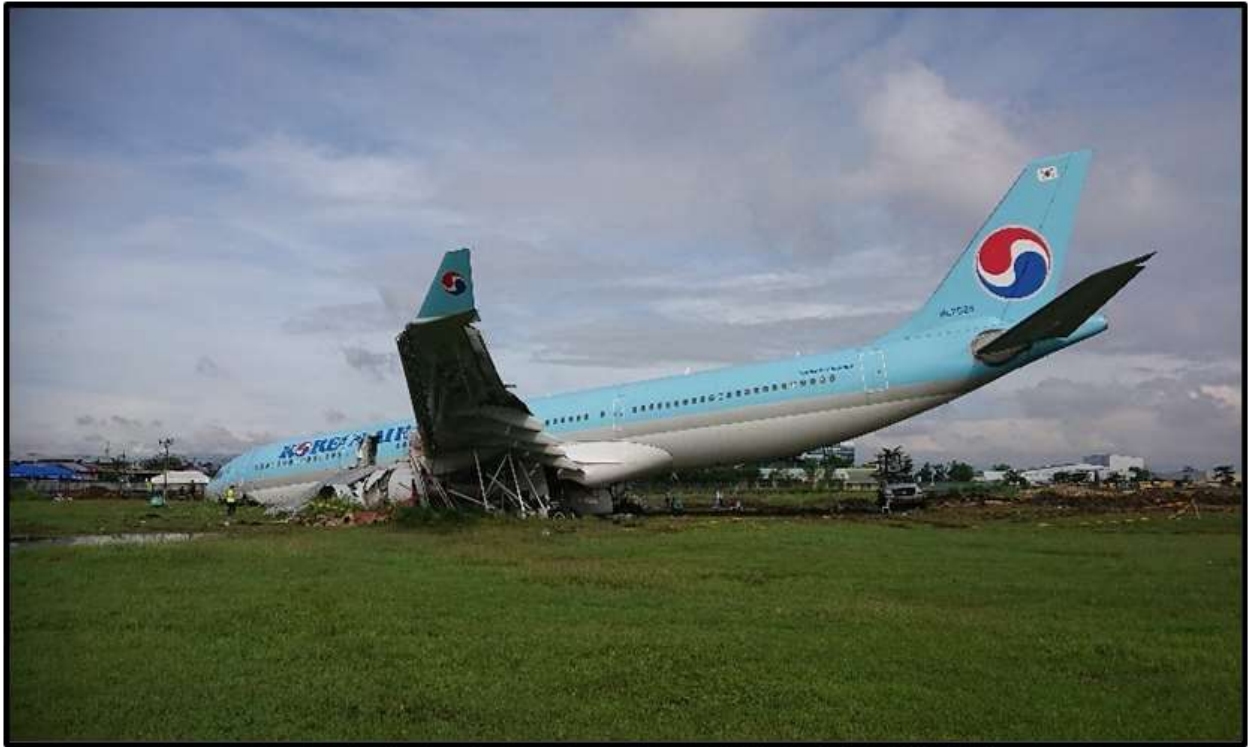
Figure 1 - The aircraft at its final resting point.

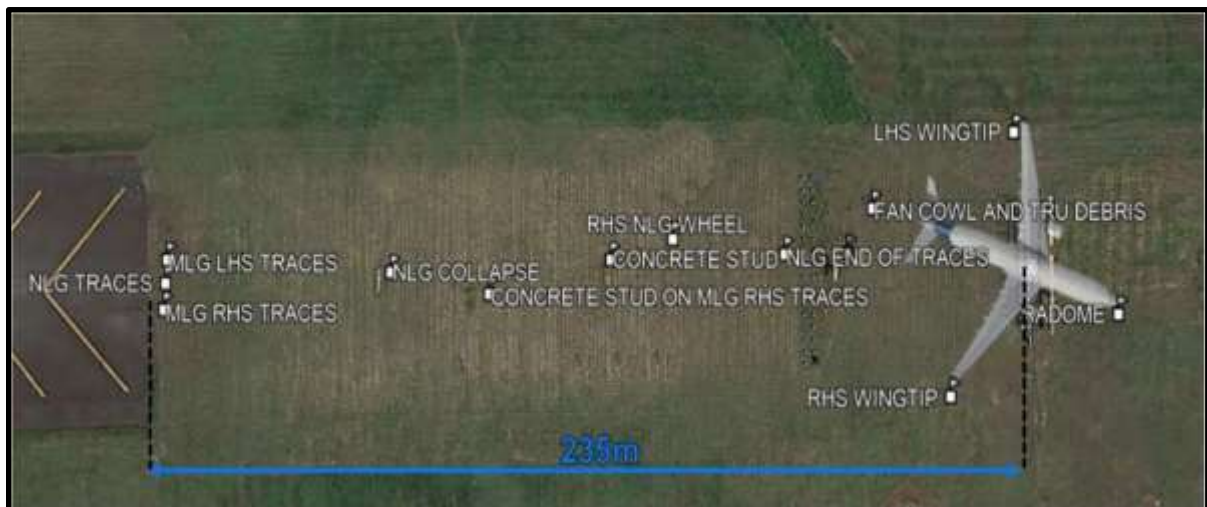
The aircraft failed to stop and overran the end of the runway. The aircraft exited RWY 22 with traces of all the landing gears. The NLG collapsed after hitting the concrete base slab of the approach light, after which its RH NLG wheel was detached upon hitting another concrete stud. The aircraft collided with the ILS localizer antenna and another runway approach lighting system before the aircraft came to a complete stop at the grassy portion about 235 meters from the end of RWY 22 at coordinates 10°17'41.8" N 123°57'59.9" E with a final heading of 245° (Figure 5).

Figure 5 - The aircraft path exiting RWY 22.

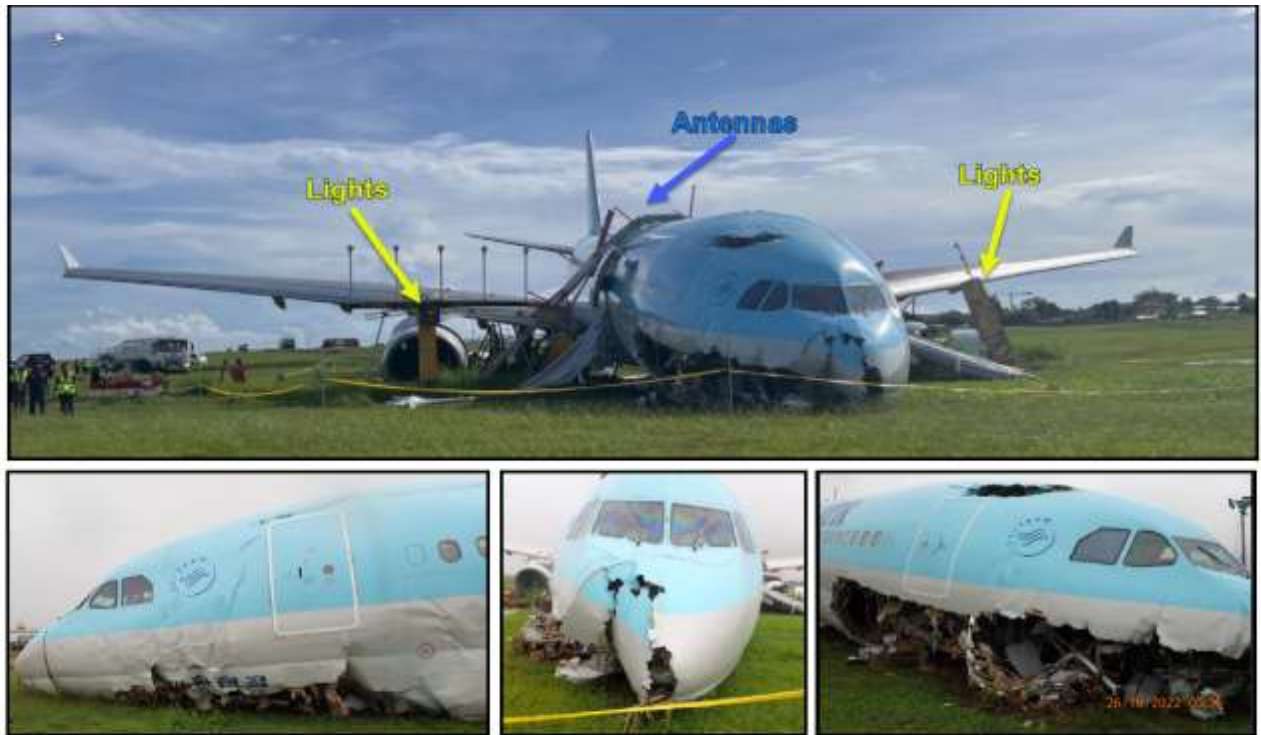
As mentioned above, the aircraft Nose Landing Gear collapsed and the lower part of the forward fuselage was heavily damaged (Figure 6).

Figure 6 - The aircraft rested on its nose the lower part of the forward fuselage heavily damaged

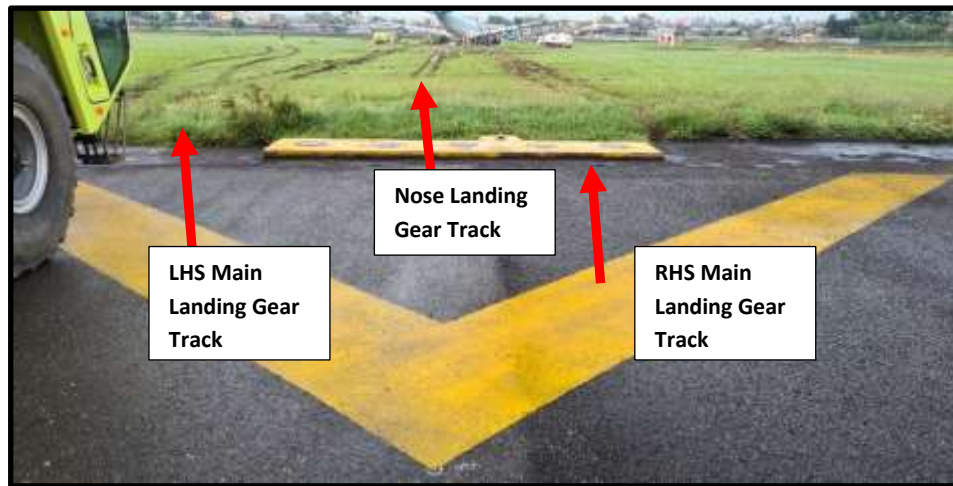
The area where the aircraft exited RWY 22 have visible tire marks on the ground leading to the aircraft. (Figure 7).

Figure 7 - The aircraft tire marks exiting RWY 22.

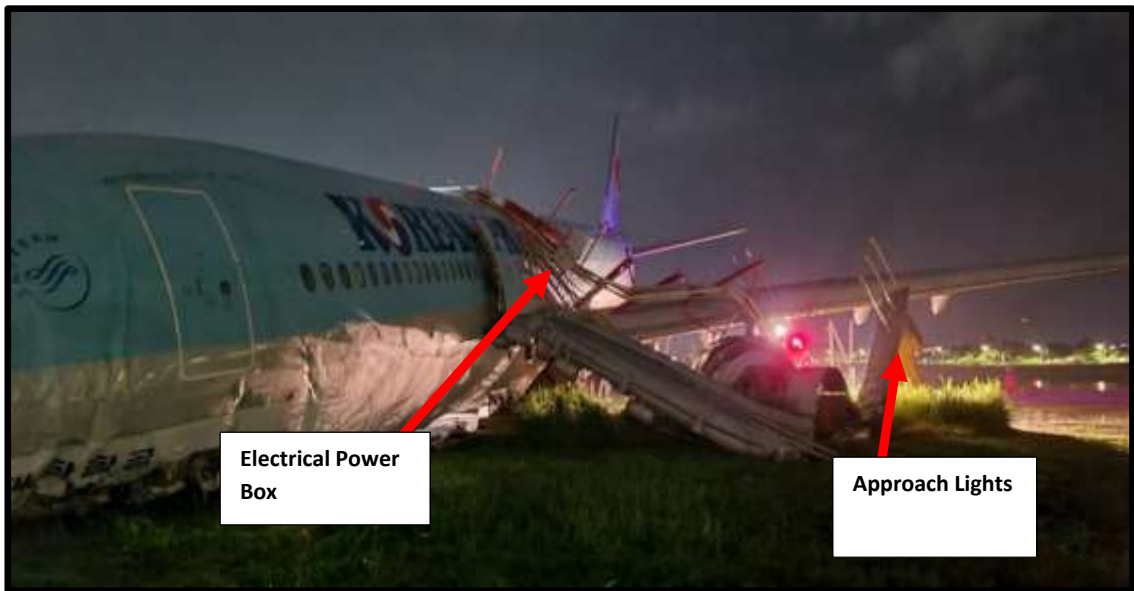
The ILS localizer antenna coiled to the aircraft wings and fuselage. The electrical power box was also damaged. The approach lights with concrete stands were also affected by the collision (Figure 8). Presence of the detached NLG wheel was observed within the path of the aircraft (Figure 9).

Figure 8 - The aircraft left wing colliding with the Electrical Power box and Approach lights.

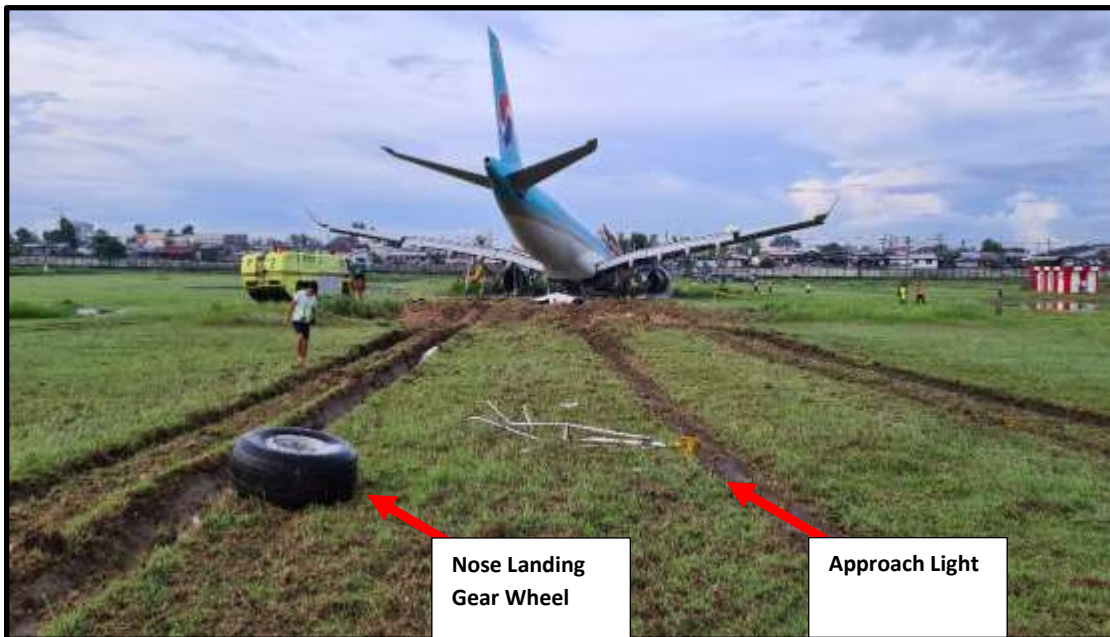
Figure 9 - Presence of the detached NLG wheel was observed within the path of the aircraft.

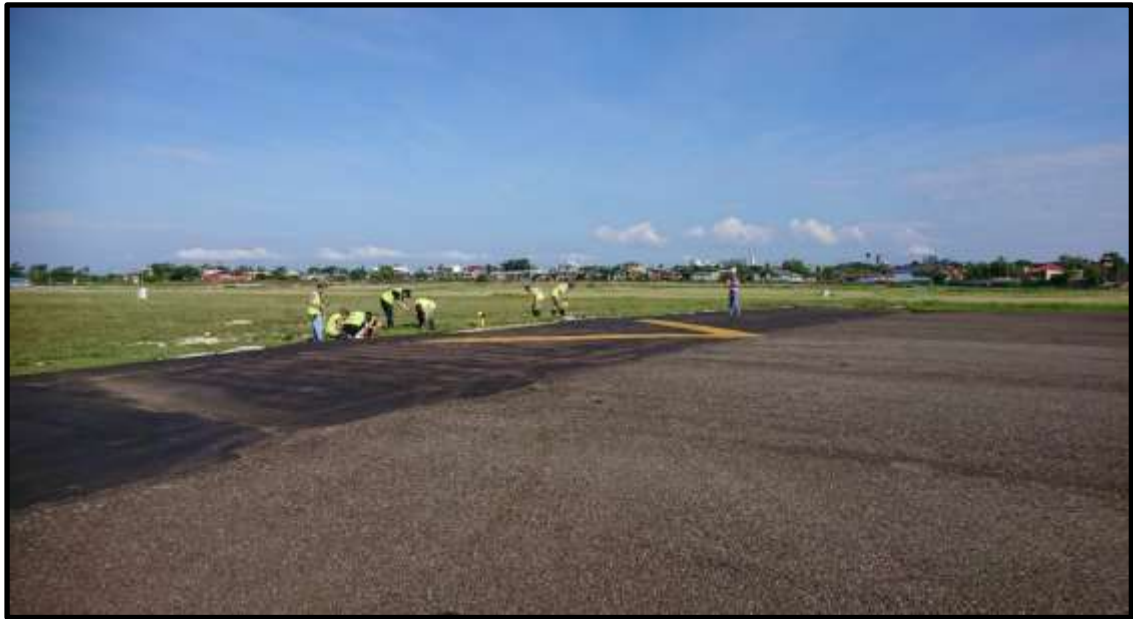
Figure 10 - The edge of the paved portion before the threshold of RWY 22.

The last inspection of the accident site, in particular at the threshold of RWY 22, was done on October 30, 2022. During the inspection, wheel marks were seen on the unpaved portion before RWY 22. The distance measurement of the wheel marks shows similarity to the design characteristics of the A330 aircraft. Main landing gear (MLG) components were also found in this location. It further revealed that the right-hand (RH) MLG then hit a 15 cm step at the edge of the paved portion before the threshold of RWY 22.

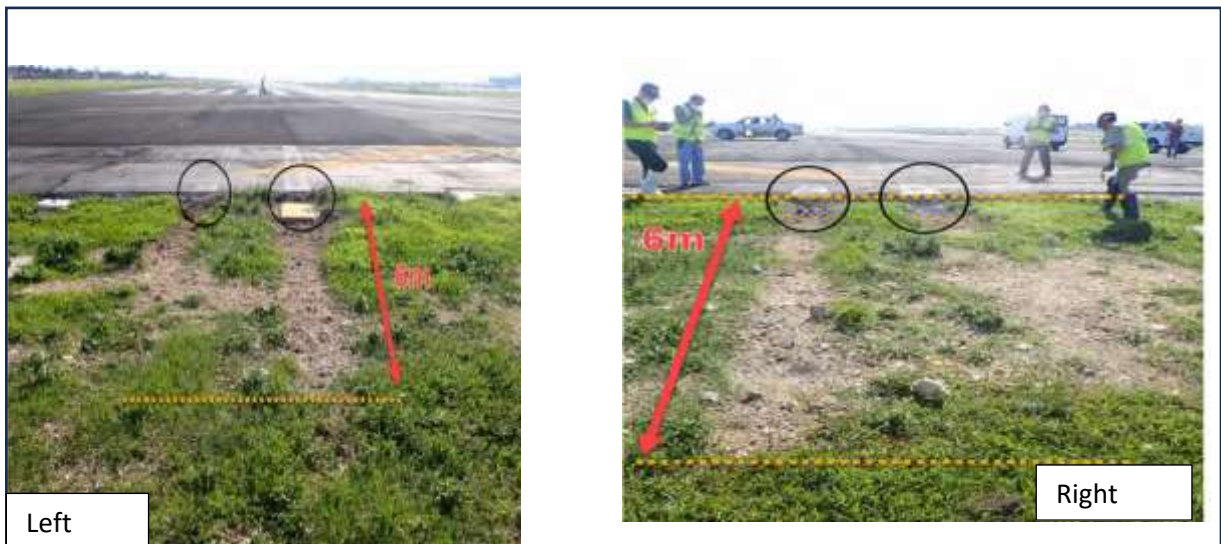
edge portion of RWY 22 (Figure 11-left). The RH MLG also hit the other edge portion (Figure 12-right).

Figure 11 and 12 - The aircraft main landing gear tire marks before the paved portion of RWY 22.

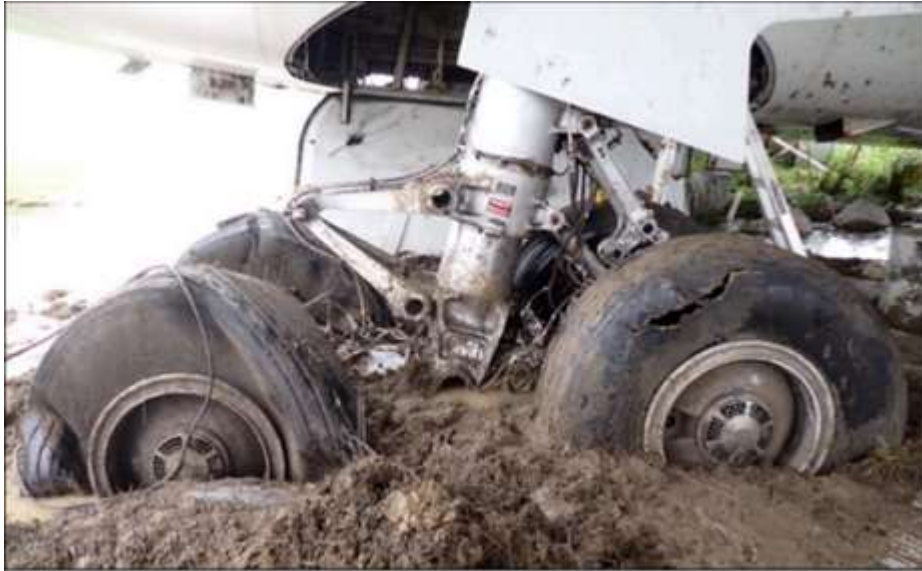
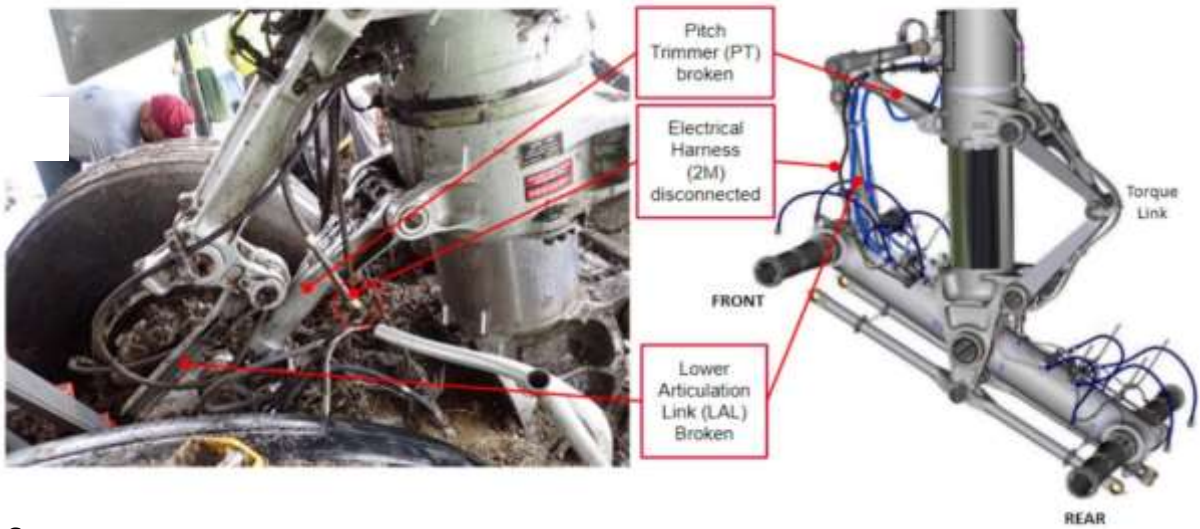
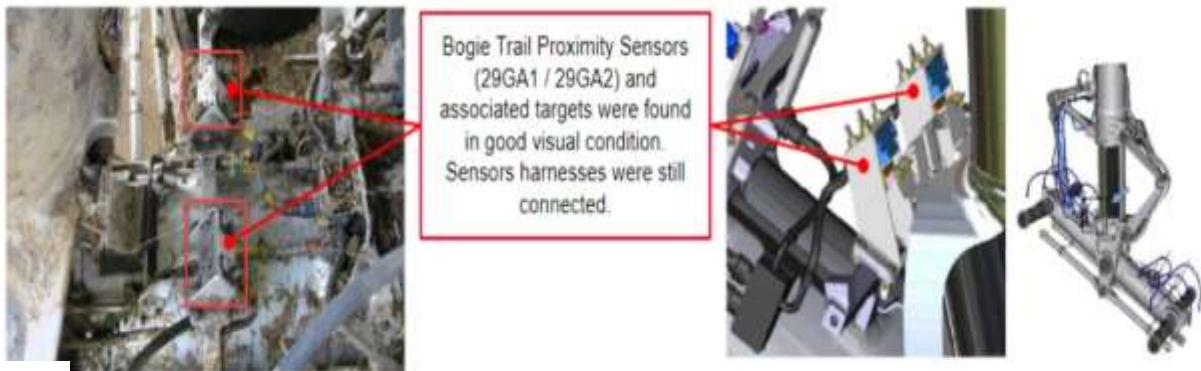
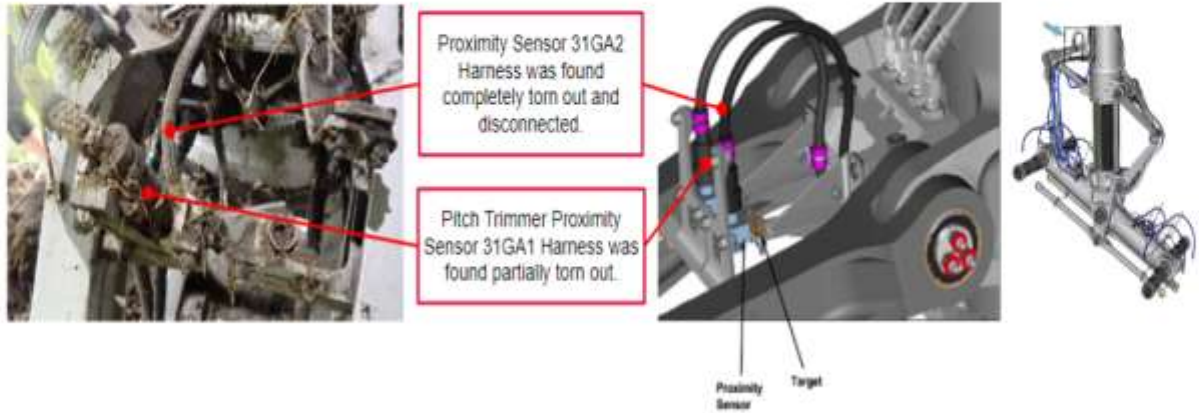
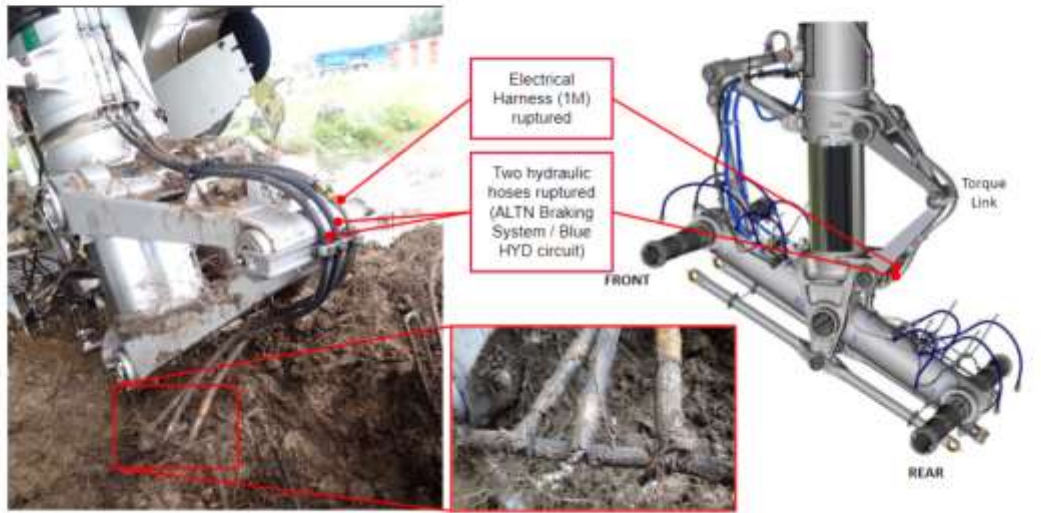
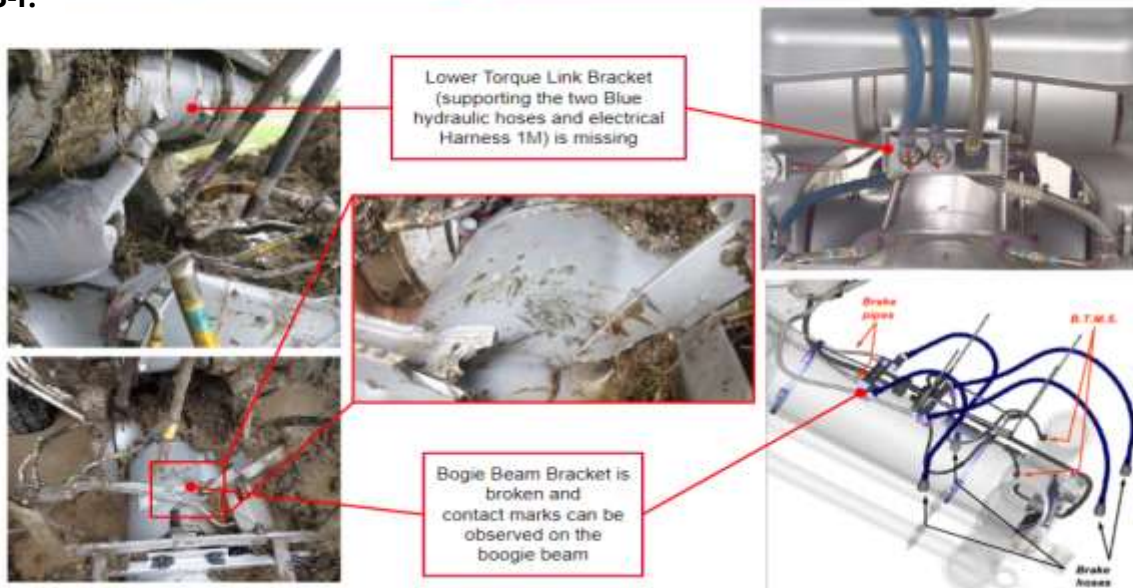
Note: The pictures below illustrate the RH MLG damage, it was at down locked position and all its tires deflated (Figure 13 a, b, c, d, e, f).

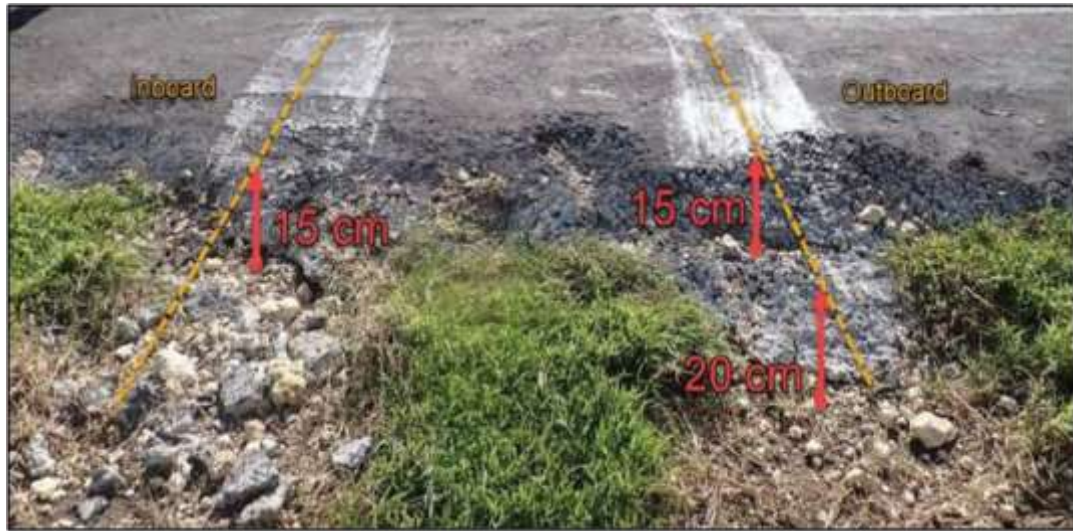
During the on-site examination, tire marks indicated that the aircraft made ground contact before reaching the paved portion of RWY 22. It was also observed that the right-hand main landing gear (RH MLG) struck the uneven concrete edge adjacent to the unpaved area of RWY 22, with a step approximately 15 cm in height (Figure 18). This uneven surface is located in the transition zone between the paved portion of the runway strip and the graded part of the undeclared RESA.

Such existing surface was not in accordance with the published AANSO-CAAP Manual of Standards, 2nd Edition, dated February 2017, chapter 6.4.1.13, ICAO Annex 14 Volume 1, chapter 3.5.8, and ICAO Doc 9157 Aerodrome Design Manual Part 1, which states that “a RESA must be prepared or constructed so as to reduce the risk of damage to an aeroplane undershooting or overrunning the runway. The aerodrome operator has to consider improving the conditions of the threshold end of Runway 04/22 to meet the CAAP and ICAO requirements.

Figure 18 - The 15 centimeters step at of the cemented edge of RWY 22.

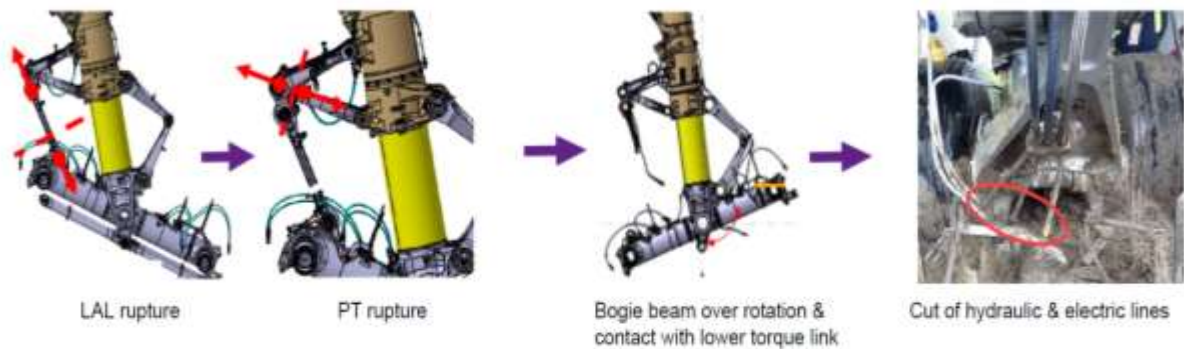
After the rear wheels of the RH MLG hit the step, the bogie beam had a sharp derotation that resulted in the LAL being ruptured. This subsequently allowed the bogie beam to continue its derotation freely and made contact with the lower torque link (front wheels not being stopped by the ground due to the aircraft trajectory). The sequence of events was shown in figure 19.

Figure 19 - The Derotation.

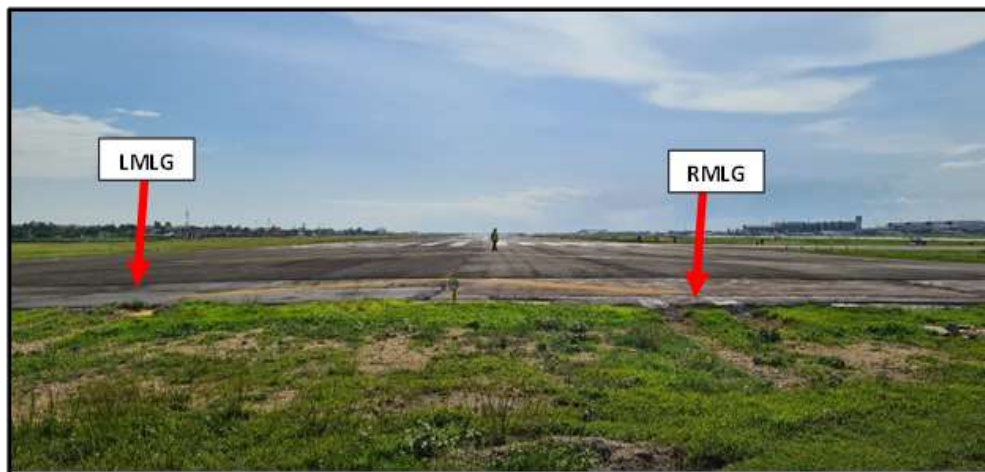
A late go-around may result in ground contact (Figure 24). The flight crew must consider to perform a go-around if adequate visual references are not obtained at minima or lost below minima, there is a loss and/or a doubt about situation awareness.

Figure 24 - The MLG visible tracks were seen before the pavement of RWY 22.

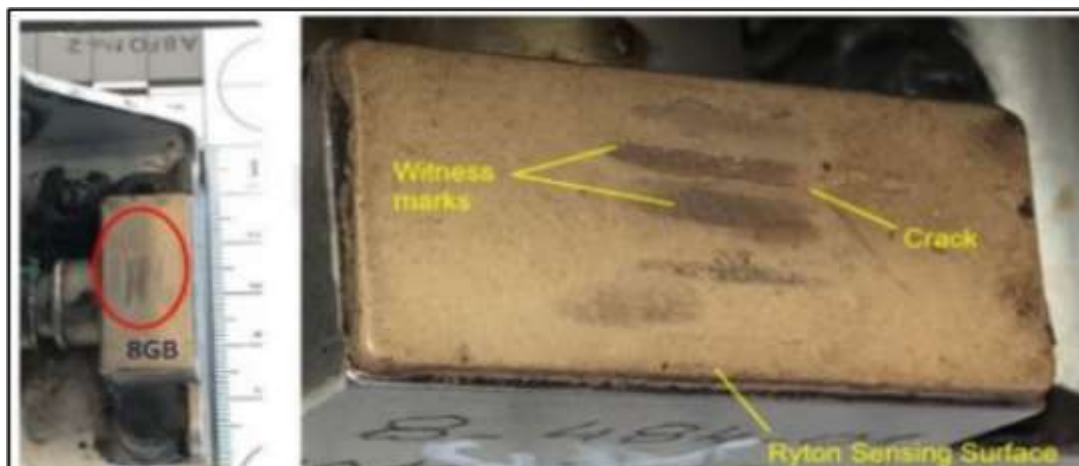
The returned proximity sensor was determined to have physical damage to its sensing face, as a noncontact sensor, this is considered an unusual finding. The physical damage to the Ryton face appears to be new damage; this is in line with it occurring during the event. An energy-dispersive x-ray spectroscopy (EDS) was conducted on the sensing surface, and metallic material surface (i.e., traces of Cr, Fe, Ni, and Zn) was found in the two witness marks (Figure 28)

Figure 28 - The witness marks found in the RH MLG (8GB) sensor.

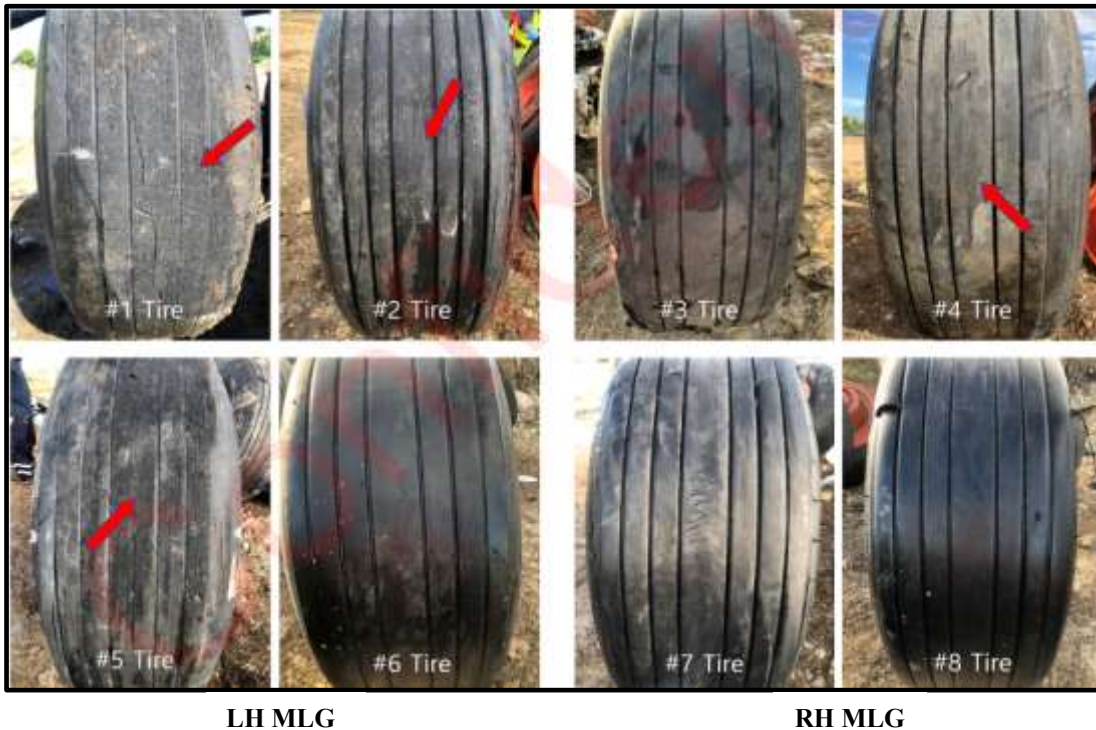
even though the crew used the right brake pedal more than the left (Figure 31). This was explained by the rupture of hydraulic hoses at the RH MLG brake level.

Figure 31 - Tire condition after the accident as per Airbus wheel numbering convention.

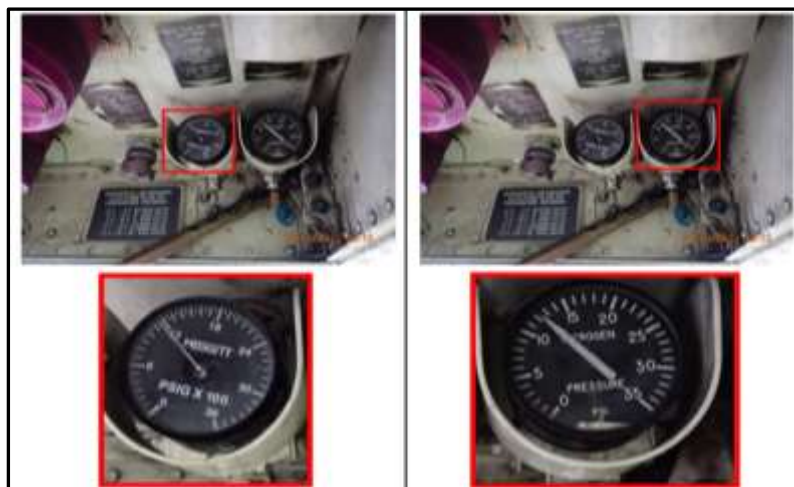
1. Parking Brake Accumulator Pressure-Gauge (5432GG) – The pressure was about 1,200 PSI.
2. Yellow Power Accumulator Pressure-Gauge (5433GG) – The Pressure was around 1,200 PSI.

Figure 32 - The aircraft brake pressure accumulator gauges during inspection.

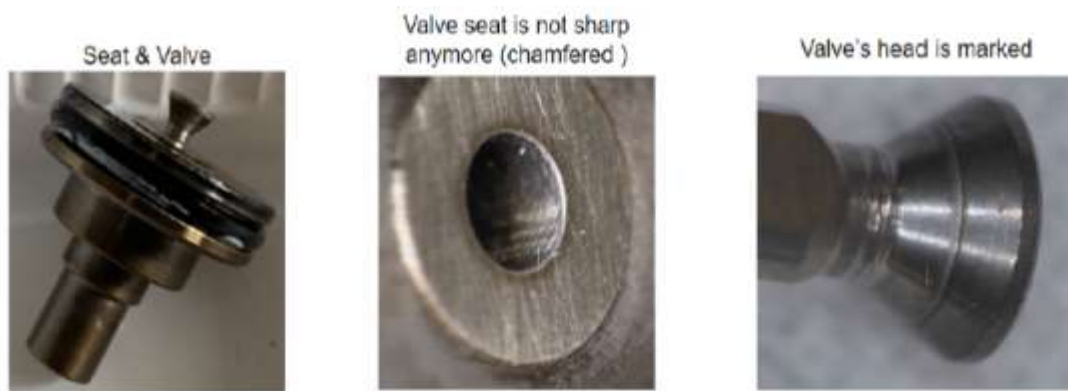
All these components were tested as per CMM and all were found No Fault Found (NFF) except the Park Hydraulic Manifold, where an internal leakage was found on the Pressure Release Valve (PRV) as shown in figure 34 A and B.

- a. A circular mark on the valve on the interface area with its seat,
- b. A radius edge on the seat instead of an expected sharp edge.

Figure 36 - Damage in the seat and valve

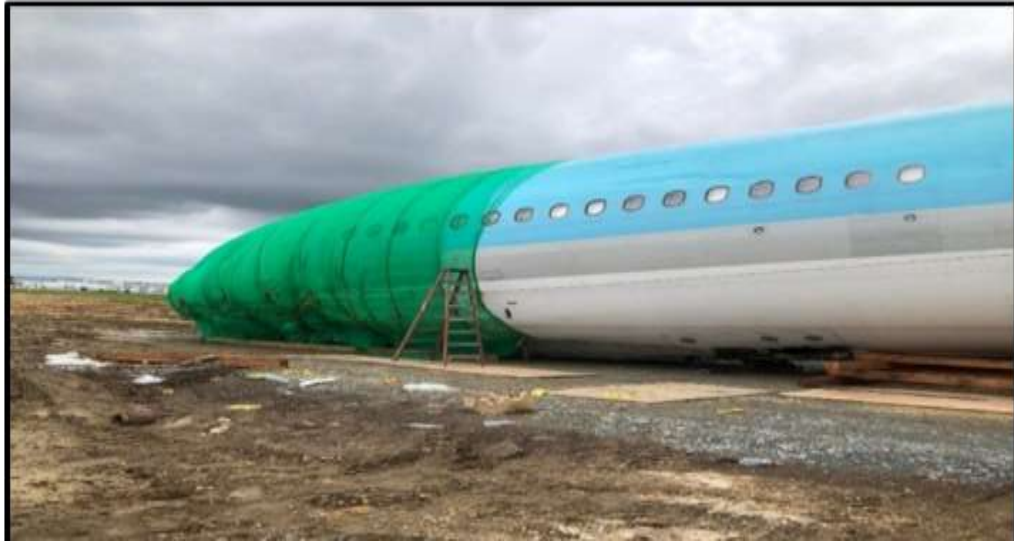
Figure 50 - The aircraft with collapsed NLG at the temporary relocation area.
