Republic of the Philippines  
CIVIL AVIATION AUTHORITY OF THE PHILIPPINES

# AIRCRAFT ACCIDENT INVESTIGATION AND INQUIRY BOARD

## FINAL REPORT

RP-C7284  
AVION TRANSPORT REGIONAL  
ATR 72-212A

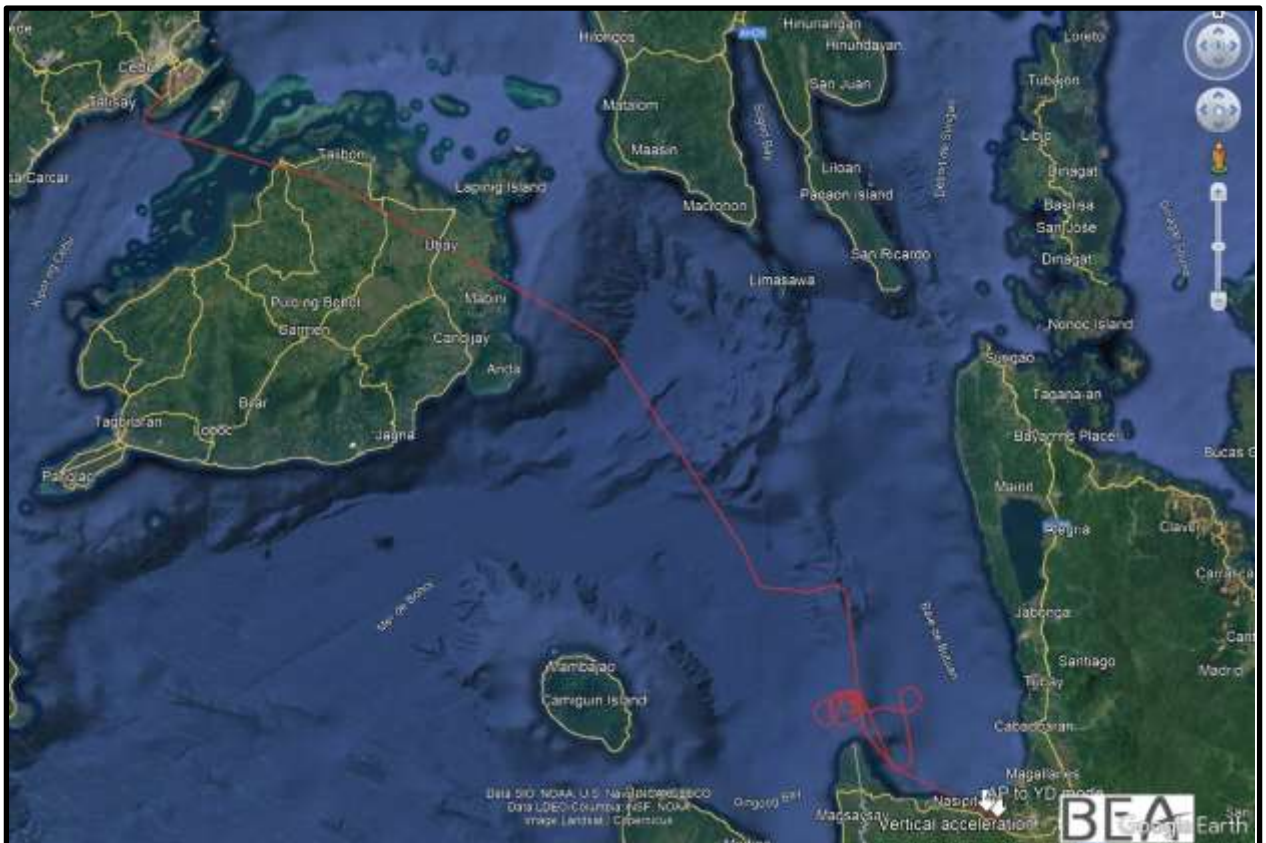
Figure 1 - Flight global trajectory.

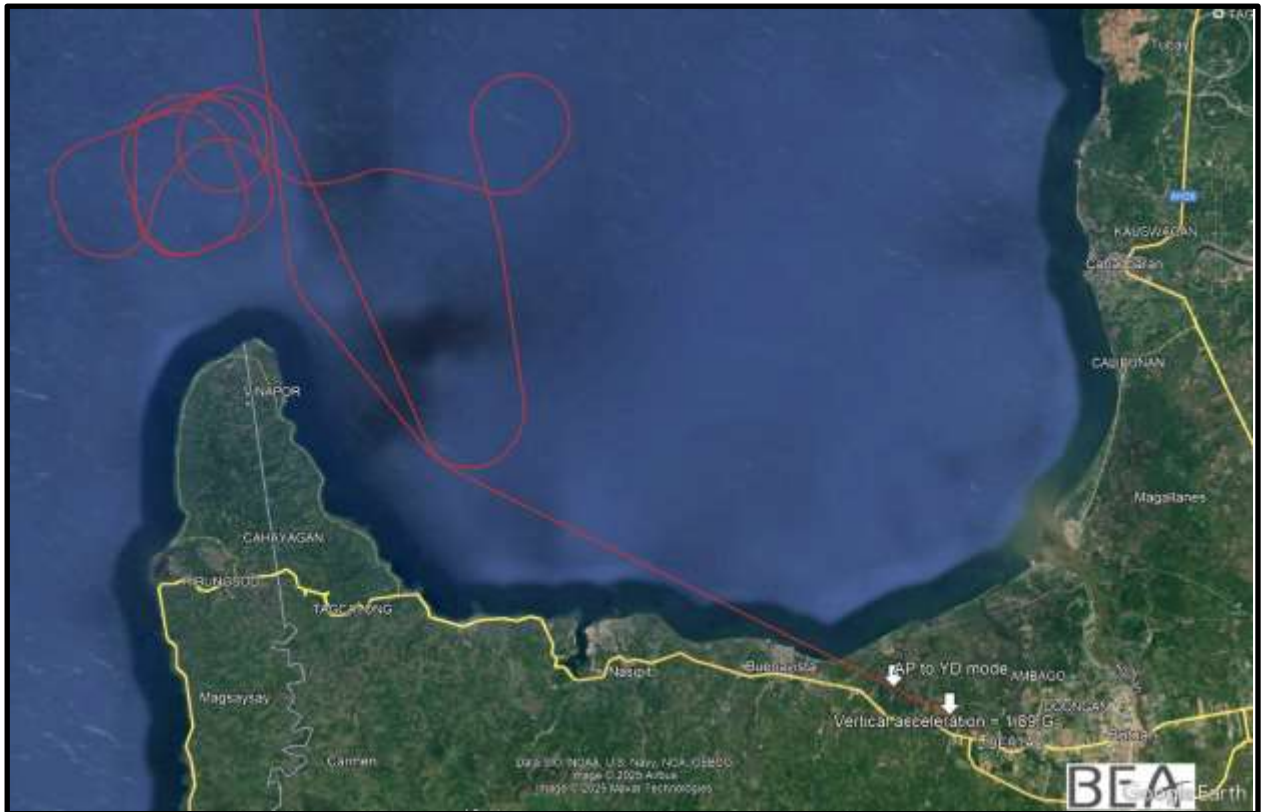
Figure 2 - End of the trajectory.

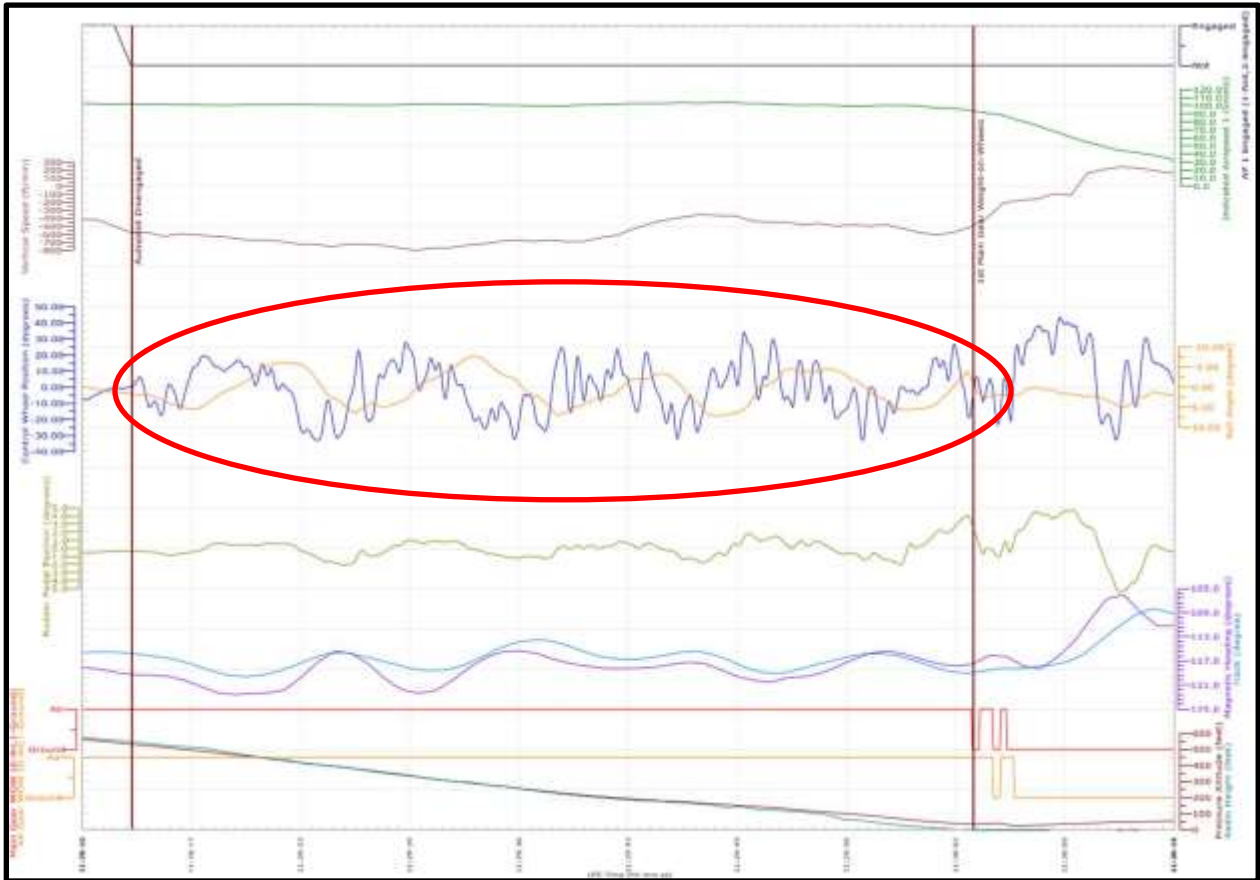
Over the next 50 seconds, prior to the aircraft touching down on the runway, it was observed that the aircraft oscillated around its longitudinal axis, where the roll angle varied between -8° (left wing down) and +7° (right wing down). There were corresponding cyclical inputs (See Figure 3) to the control wheel, ranging between 34.46° (left wing down) and -32.84° (right wing down). The magnetic heading in the same period was oscillating between 115.3° and 122.6°. The maximum descent rate recorded during this period did not exceed -800 feet/min.

Figure 3 – Cyclical inputs to the control wheel and oscillation of the roll angle after autopilot disengagement.

The cyclical nature of the control wheel inputs and the aircraft's corresponding roll behavior are consistent with pilot-induced oscillations (PIO), a condition where overcorrection or delayed responses can increase the magnitude of aircraft movement instead of stabilizing it. The combination of aerodynamic factors, crosswind correction, and pilot input likely contributed to the behavior observed. Such inputs can result in pitch or roll instability, which may lead to a firmer than normal landing or bounce. Despite the oscillations, the crew maintained a stabilized approach and proceeded with the landing.

- b. To reinforce flight crew training on manual handling techniques during final approach, particularly during nighttime and marginal weather conditions, emphasizing the avoidance of pilot-induced oscillations (PIO) and the importance of timely and appropriate control inputs.

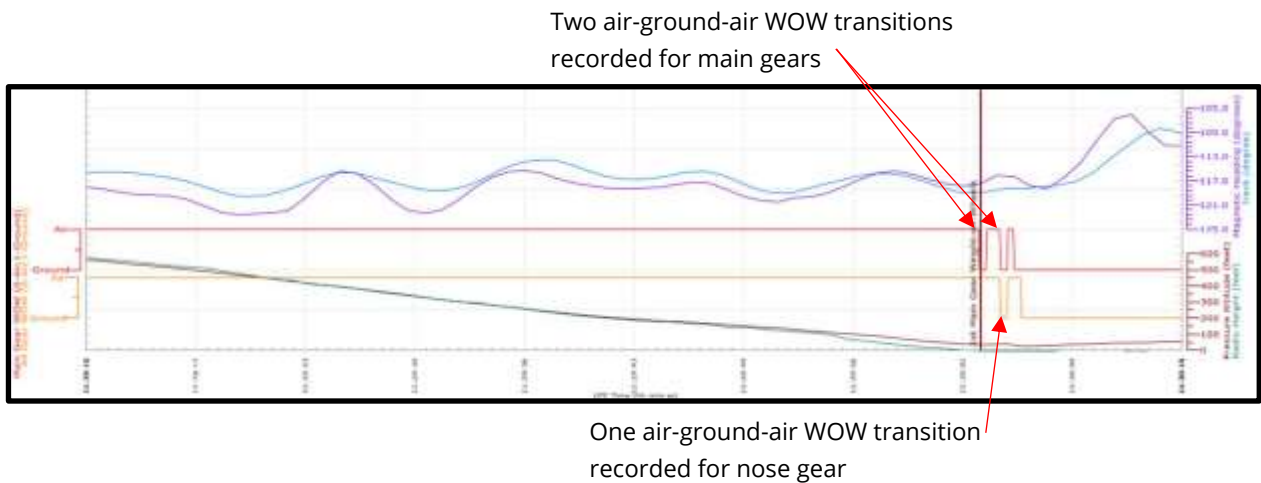
At 11:30:04 UTC, the first main gear weight-on-wheel (WOW) “ground” signal was recorded momentarily before it transitioned to “air” again. This is consistent with the aircraft experiencing a bounce on the initial touchdown and becoming airborne again. The aircraft heading during the initial touchdown was 117.5° (nose pointing right of the runway), and the recorded coordinates were +8.954581 (latitude) +125.471992 (longitude). The maximum vertical acceleration recorded during this initial bounce was +1.89 G. A second later, the second sequence of air-ground-air WOW signal transition was recorded for the main gear WOW, with a similar air-ground-air WOW signal transition recorded for the nose gear. The second touchdown was flat, where all three gears touched down simultaneously with a low pitch angle. The final “air” to “ground” WOW transition for the main gear was recorded at 11:30:06 UTC, and the same WOW transition for the nose gear was recorded within the second (see Figure 4).

Figure 4 – WOW transition of the main gears and the nose gear.

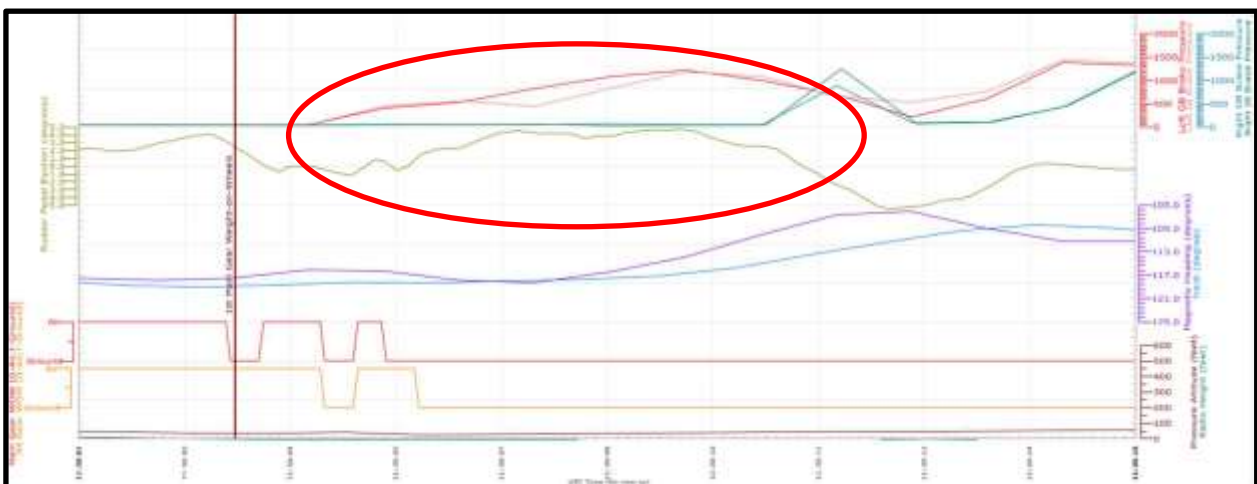
It was observed that almost immediately after the first bounce, the brake pressure for the left outboard and inboard wheels started to increase to approximately 1,200 PSI between 11:30:04 UTC to 11:30:10 UTC while the brake pressure for the right outboard and inboard wheels did not show any appreciable increase until after 11:30:10 UTC (see Figure 5). During this period, the rudder pedal input varied from +4.8 (left yaw command) to -5.5° (right yaw command). The aircraft heading after the final bounce was 116.3° and continued to increase to 118.3° before decreasing to a minimum value of 106.1° (see Figure 6).

Figure 5 – An Increase in the left brake pressure coincided with left rudder pedal inputs.

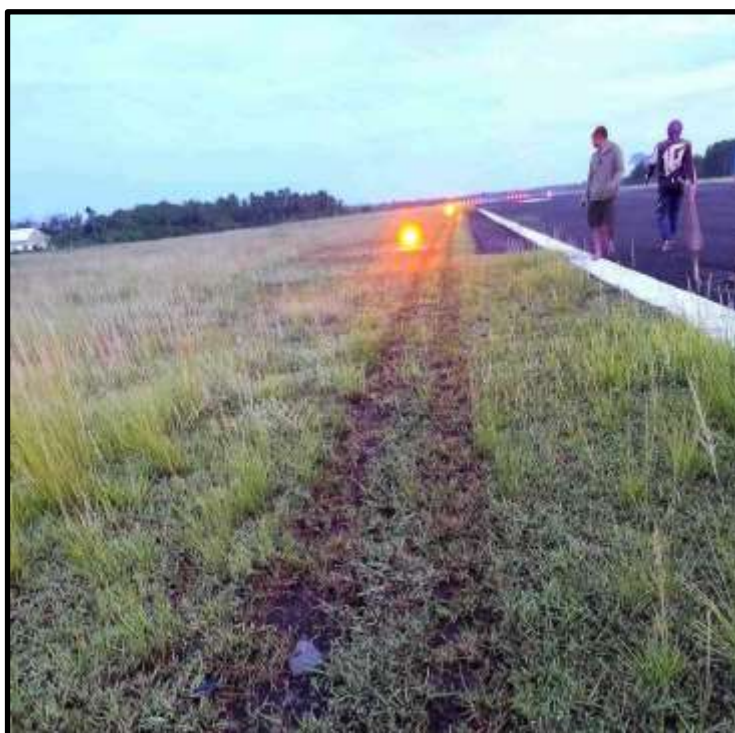
A post-incident runway inspection revealed tire marks indicating that the aircraft touched down at coordinates 8° 57' 18" N, 125° 28' 16" E, which is approximately 200.6 meters from the threshold of runway 12. The touchdown point was noted to be predominantly on the right side of the runway centerline, with the left main landing gear approximately 13 meters from the centerline and the right main landing gear approximately 17 meters from the centerline.

Further inspection revealed that the aircraft's right main landing gear exited the paved portion of the runway approximately 240 meters from its touchdown point and remained in the grassy area for about 158 meters before returning to the concrete surface of the runway. Additionally, the right main landing gear was approximately 24 meters from the runway centerline and around 1.8 meters from the runway edge line while off the paved surface. These physical observations serve as strong indications that a runway excursion had occurred (Figure 9).

Figure 9 – Photo taken the morning after the incident, showing tire path marks outside of the runway's paved surface.

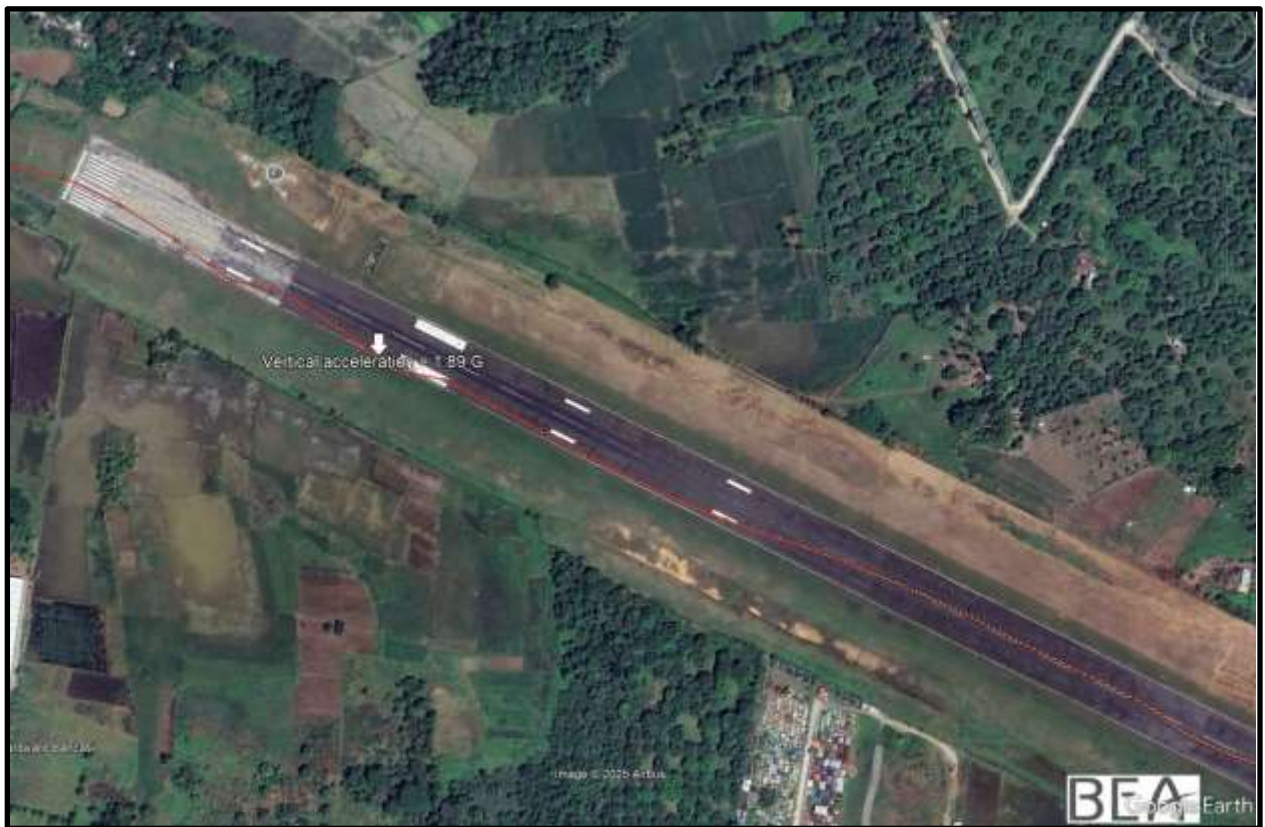
Figure 10 – Trajectory of the landing.

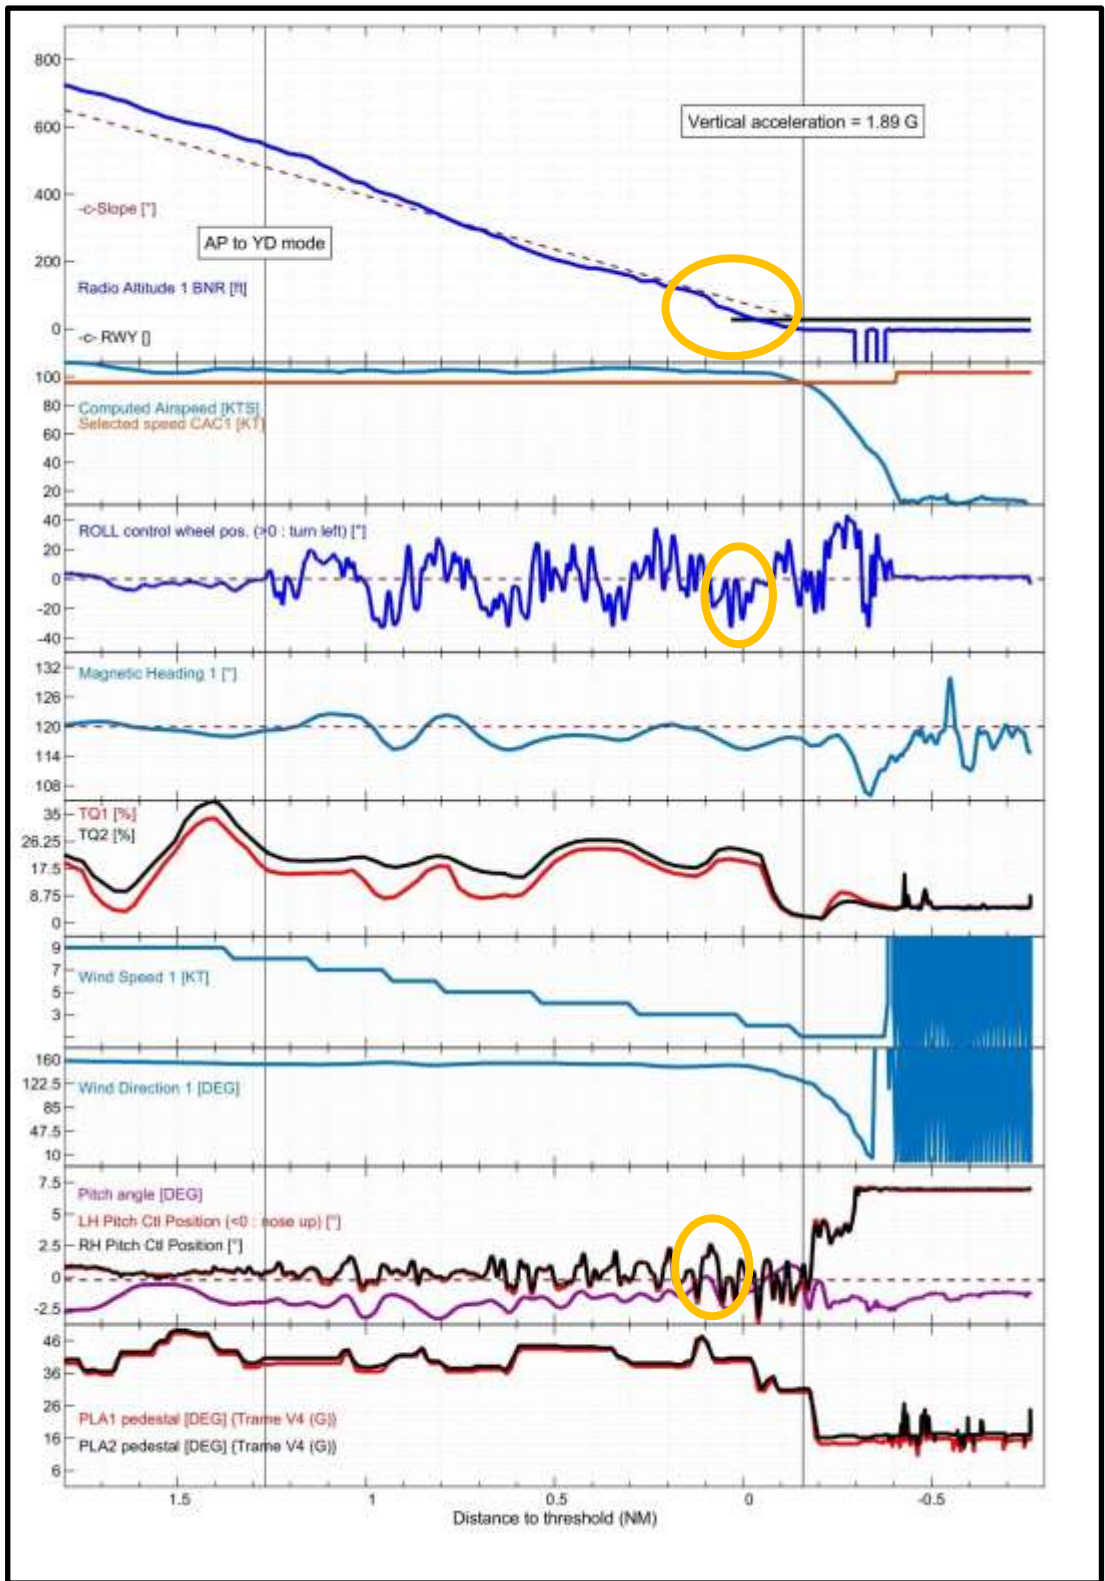
Figure 11 – Glide path.

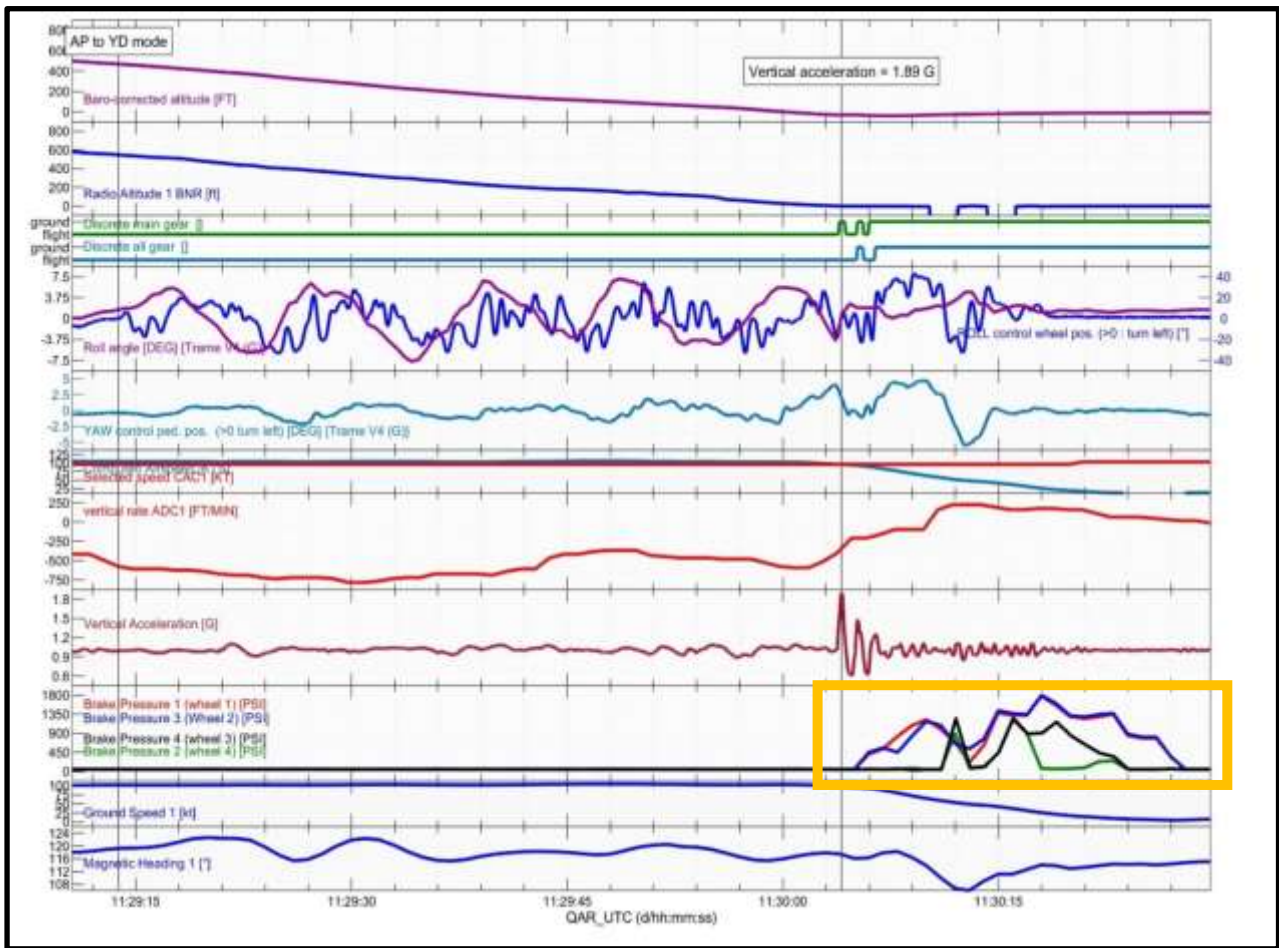
Following the touchdown, further analysis revealed that brake pressure for the left outboard and inboard wheels increased to approximately 1,200 PSI, while the right-side wheels showed no significant brake pressure. Additionally, rudder pedal input varied from  $+4.8^\circ$  (left yaw command) to  $-5.5^\circ$  (right yaw command), indicating active directional control inputs during the initial phase of the rollout. These inputs suggest that the flight crew was not only actively managing directional control but also fully aware of their position on the runway. As such, the flight crew's claim of having lost visibility immediately after touchdown appears inconsistent with the recorded data.

Figure 12 - Graph indicating the time that left actions on the wheel and the left braking actions occurred.

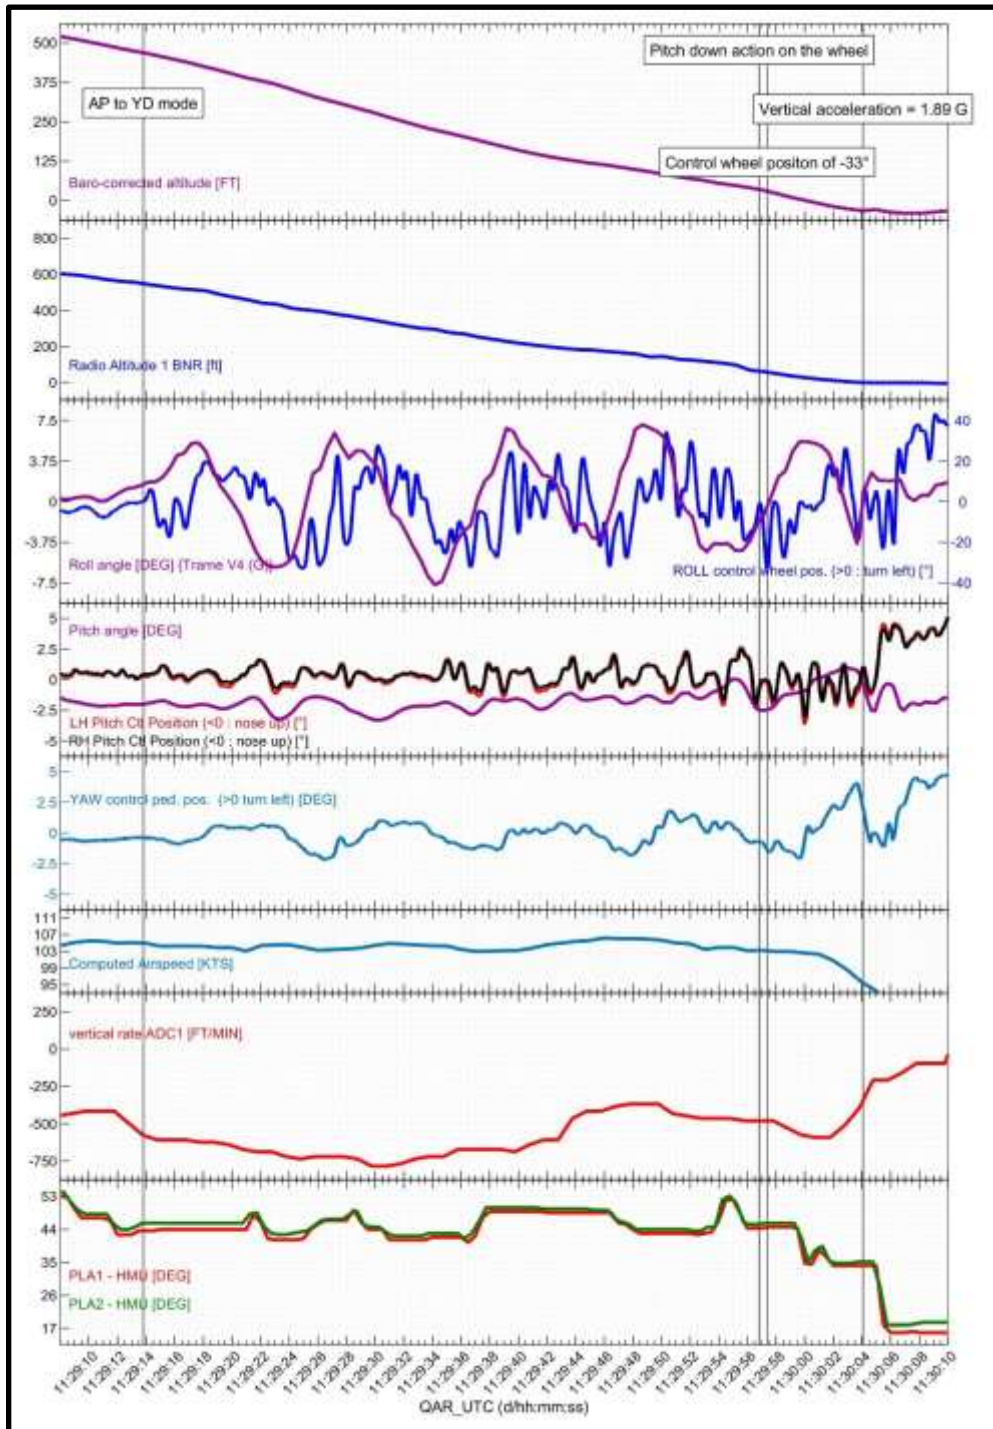
Figure 13 – Zoomed graph of relevant parameters.
