AIRCRAFT ACCIDENT INVESTIGATION AND INQUIRY BOARD

FINAL REPORT

RP-C4321
PIPER AIRCRAFT INC.
PA-23-250

TITLE: Serious Incident involving a PA-23-250 type of aircraft with Registry Number RP-C4321 sustained damage on both propellers following a runway overrun at runway 36, Jorge Abad Airport, Itbayat, Batanes Philippines, on August 28, 2025/1330H

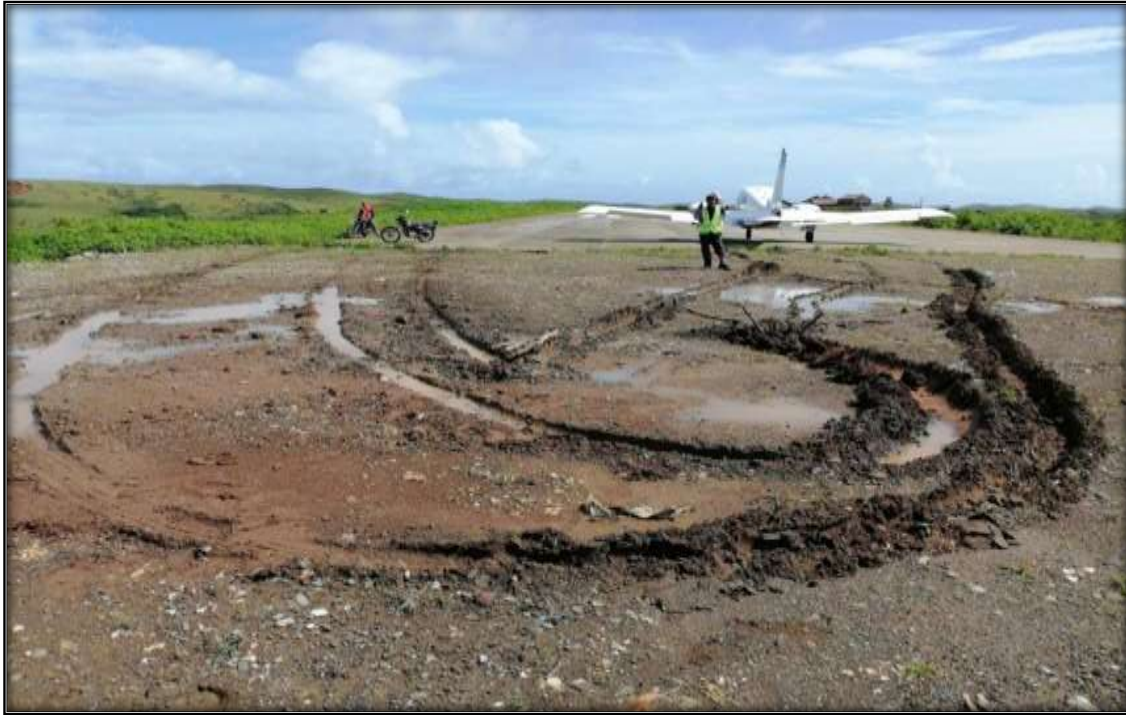
The pilot reported a loss of brakes while on a landing roll at RWY 36 of the RPLT. The aircraft made an overrun and came to a full stop 20 meters from the end of the runway with grid coordinates of 20° 43'38"N; 121°48'35"E. Airport personnel immediately responded to assist the aircraft occupants. The responders found the occupants with seat belts still fastened and the aircraft wheels partially embedded in mud. The pilot and passengers were assisted in disembarking the aircraft normally. The aircraft was

Figure 1 - RP-C4321 repositioned from the soft ground to the concrete pavement of the runway.

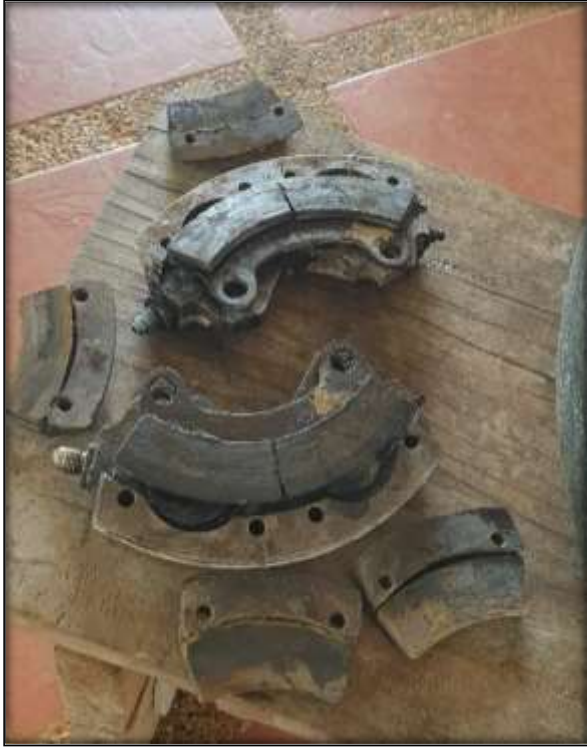
- a. Manual brake pressure check using pedal brakes. There was consistent pressure noted on both pedal brakes.
- b. Removed, disassembled, and inspected both L/H and R/H brake assemblies. It was found within serviceable limits, with no signs of brake fluid leaks.
- c. Performed brake fluid contamination and discoloration check. There were no contaminants found and no visible discoloration was noted.
- d. Inspected brake components. All inspected parts were found in good condition and within serviceable limits (Figures 2, 3, 4 and 5).

Figure 2 - Left brake pads.

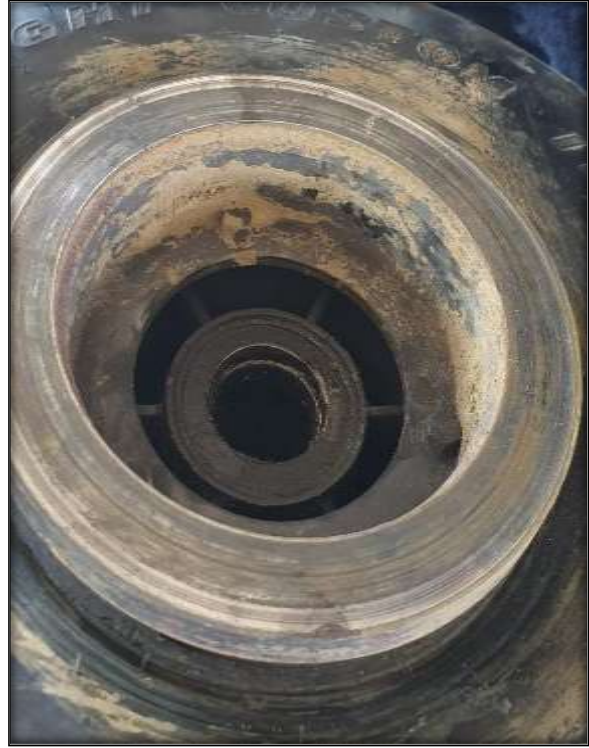
Figure 3 - RP-C 4321 left wheel brake disc.

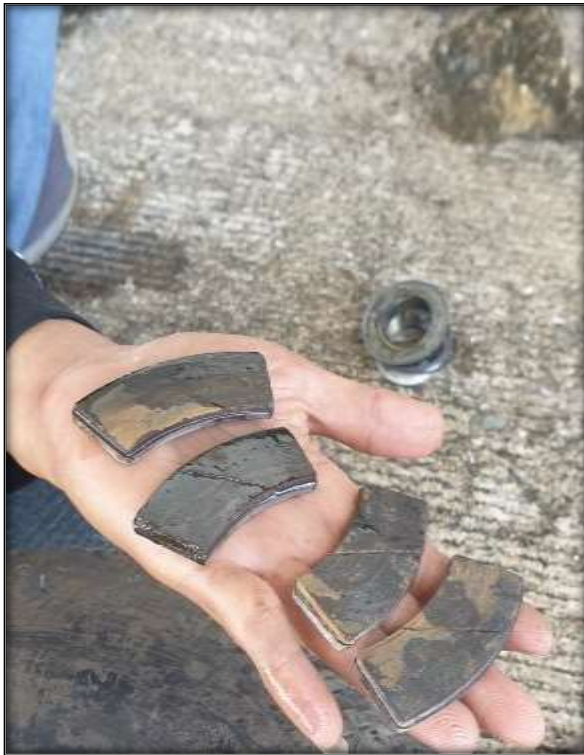
Figure 4 - Right brake pads.

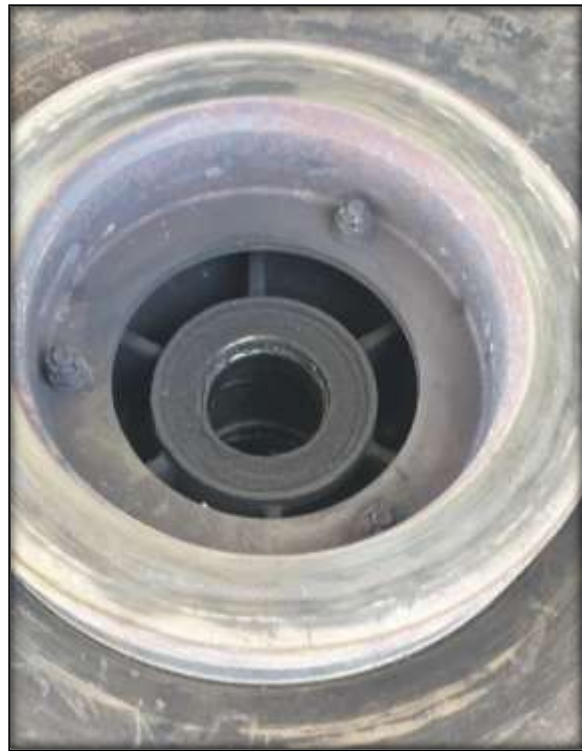
Figure 5 - RP-C 4321 right wheel brake disc.

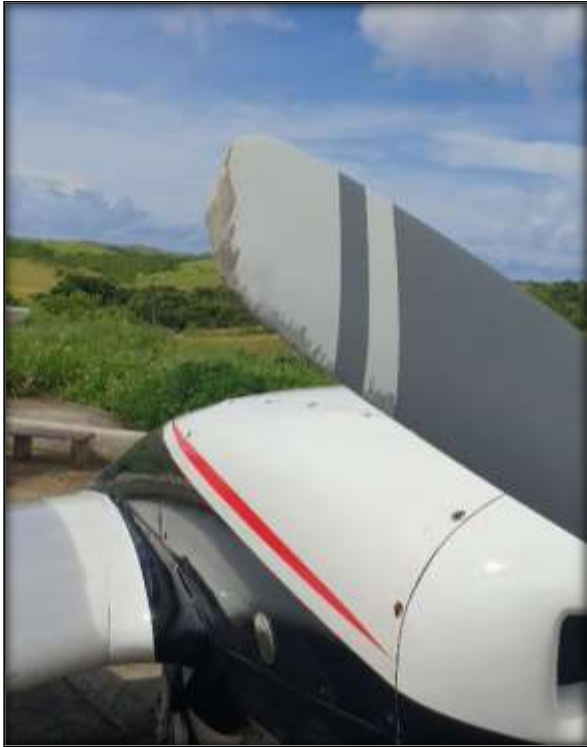
Figure 6 - RP-C 4321 Nicks at left propeller blade.

The aircraft made an overrun and came to a full stop 20 meters from the end of the runway 36 with grid coordinates of 20°.43'38"N; 121°.48'35"E. Both propellers sustained nicks due to contact with loose stones after the aircraft overrun the runway and aircraft wheels partially embedded in mud.

With the said inspection, both blades on L/H propeller assembly requires shop work/ inspection due to damage. Both blades on R/H propeller assembly is reparable (Figures 6, 7 and 8).

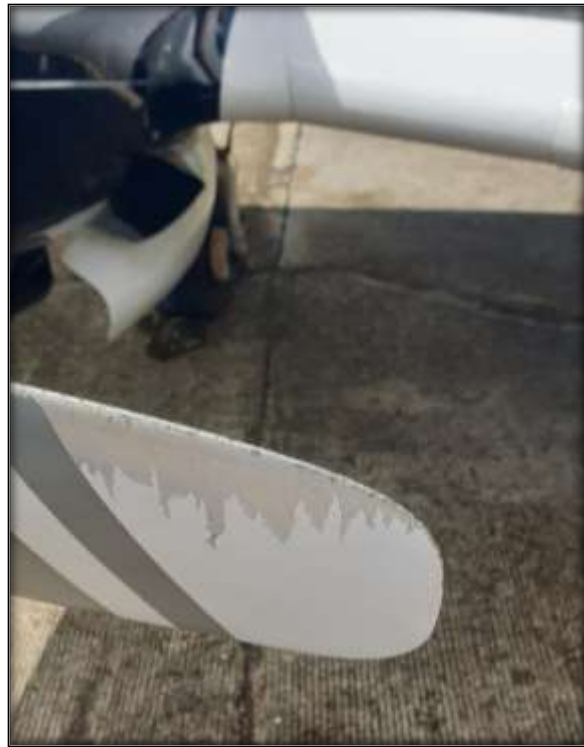
Figure 7 - RP-C 4321 other left propeller blade.

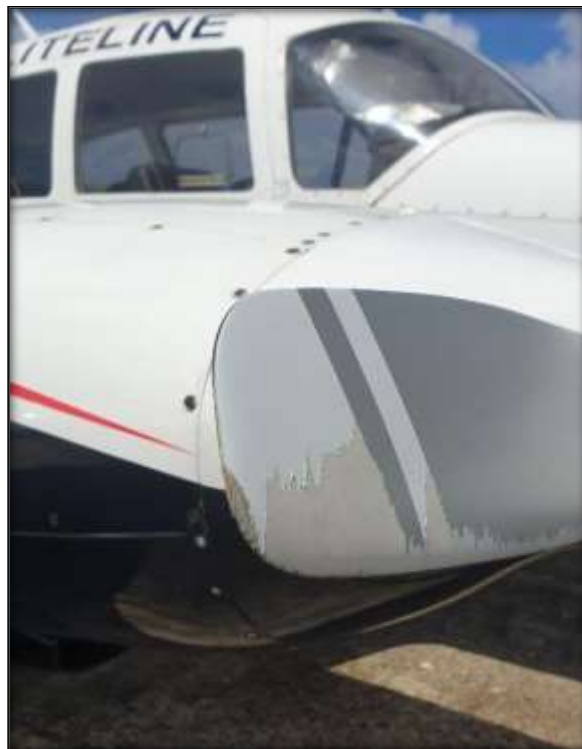
Figure 8 - RP-C4321 nicks at the right propeller blade.
