Republic of the Philippines
CIVIL AVIATION AUTHORITY OF THE PHILIPPINES

FINAL REPORT

RP-C1018 GIPPSAERO, GA8 AIRVAN

TITLE: A serious incident involving a Gippsaero/GA8 Airvan type of aircraft with Registry Number RP-C1018 owned and operated by WCC Aviation Company, Inc. that executed a forced landing due to an engine non-mechanical failure at a harvested cornfield area in Barangay District 1, Reina Mercedes, Isabela, Philippines 10Km away from Cauayan Community Airport, Philippines on August 31, 2025/1115H local time.

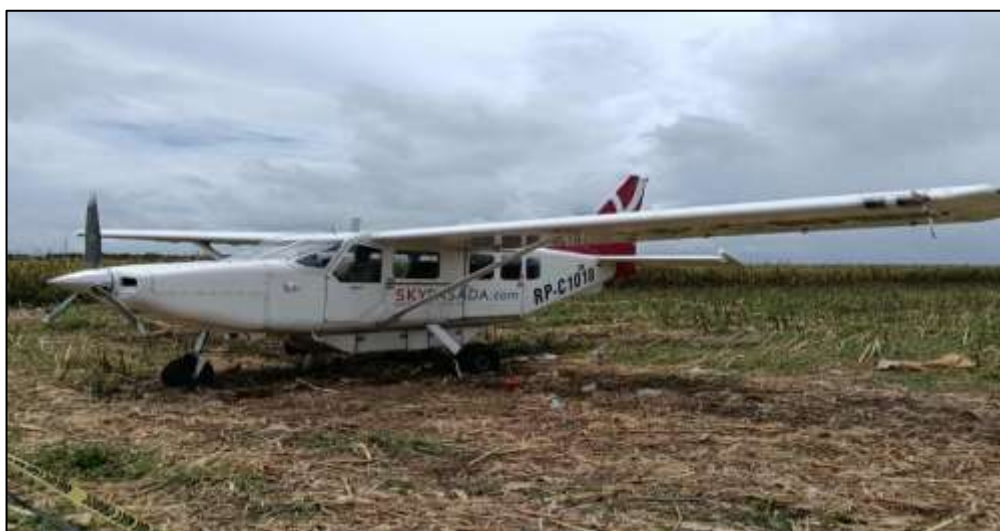
Figure 1 - RP-C1018 on its final position at the incident site.

The aircraft touched down on the field under control, coming to rest after a short ground roll. It sustained minor damage to the intake and exhaust manifolds. There was no post-impact fire. The surrounding terrain was level and unobstructed, and the aircraft remained upright and intact following the forced landing.

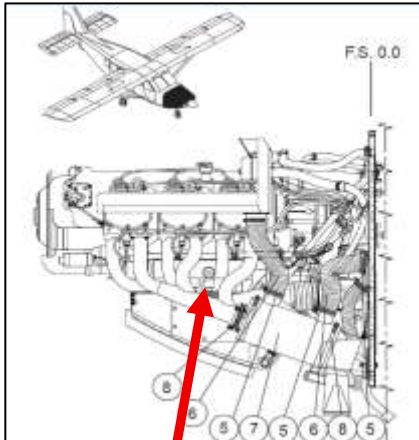
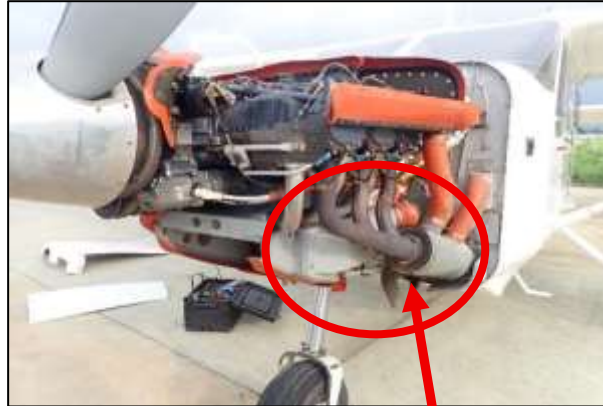
Figure 3 - The aircraft engine.

The on-site examination of aircraft RP-C1018 revealed that the airframe assembly sustained no structural damage as a result of the forced landing. The aircraft remained upright and intact at the occurrence site. Inspection of the engine compartment identified damage localized on the lower left section of the engine assembly (see Figure 3). Examination of the engine accessories showed that the Air Induction Intake System insulation, composed of composite material, was degraded and partially damaged (Figure 4a). Additionally, the left-hand (LH) exhaust muffler shroud system exhibited a detached muffler tube from its muffler shroud assembly (Figure 4b).

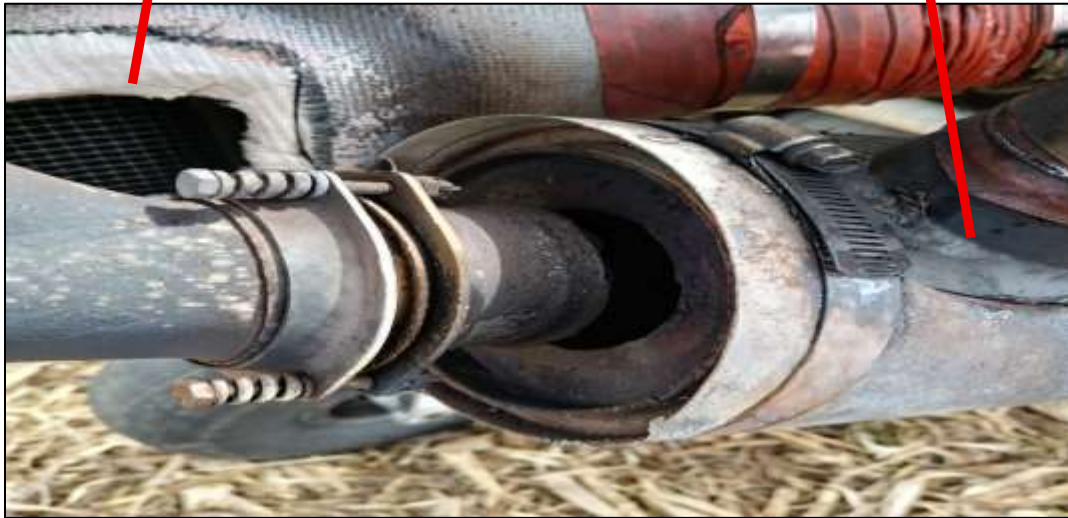
Figure 4 - The Exhaust Shroud Muffler System and Air Induction System assembly.

It was assessed that the rupture of the LH exhaust muffler tube resulted in the release of hot exhaust gases into the engine bay, which subsequently damaged the adjacent air induction intake insulation. The degradation of these components likely altered the air-to-fuel ratio and compromised normal combustion, leading to progressive engine roughness and eventual engine stoppage in flight. A ruptured exhaust muffler typically produces abnormal acoustic signatures such as hissing or tapping sounds, accompanied by noticeable loss of engine performance, reduced fuel efficiency, and presence of exhaust fumes in the cabin. The escaping high-temperature gases can also cause thermal damage to nearby insulation, wiring, or other engine accessories, increasing the risk of component failure or fire.

Similarly, a damaged air induction manifold insulation can result in air leakage, affecting the air-to-fuel mixture and causing rough idling, misfiring, loss of power, and poor engine performance. If uncorrected, such a condition may result in engine overheating or, in severe cases, flameout. Evidence suggests that the damage to the exhaust and intake systems developed progressively over time and may have been overlooked during periodic or specific maintenance inspections, as these components are maintained on an "on-condition" basis. During the occurrence flight, the degraded Air Induction Intake System may have been contaminated by exhaust gases escaping from the ruptured muffler tube, causing irregular combustion and engine misfiring that culminated in a complete power loss.

- a. Engine power loss due to thermal and mechanical deterioration of the Air Induction System insulation and ruptured LH Exhaust Muffler Shroud, resulting in contamination of the intake airflow and eventual loss of engine power in flight (material failure).

- 5.1.1 The operator should conduct immediate visual inspections on all GA8 Airvan aircraft in its fleet to ensure that the engine Air Induction Intake and the LH Exhaust Muffler Shroud System do not exhibit damage similar to that identified in the ongoing investigation.

- 5.1.3** The operator should develop and implement a reliability-based maintenance program for on-condition engine accessories, including the Air Induction Intake and LH Exhaust Muffler Shroud System.

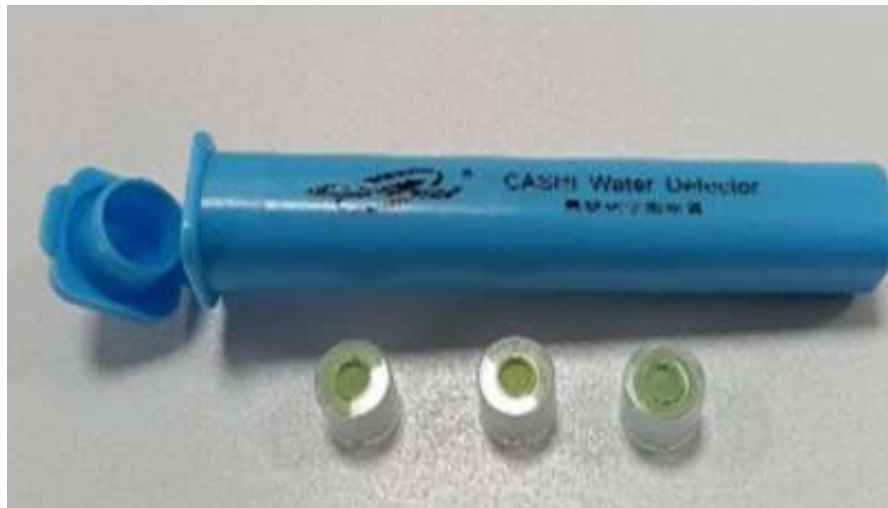
Figure 5a - CASRI water detection capsules.

Fuel samples were collected from both main fuel tanks and the fuel line leading to the Fuel Control Unit (FCU) to evaluate the possibility of fuel contamination as a causal factor. Testing was performed using a CASRI Water Detector, a specialized device widely accepted in the aviation industry for detecting the presence of free water in aviation gasoline (AVGAS). The CASRI test employs water detection capsules, where non-contaminated fuel produces a yellowish-green color, while water-contaminated fuel results in a dark green color change (see Figure 5a).

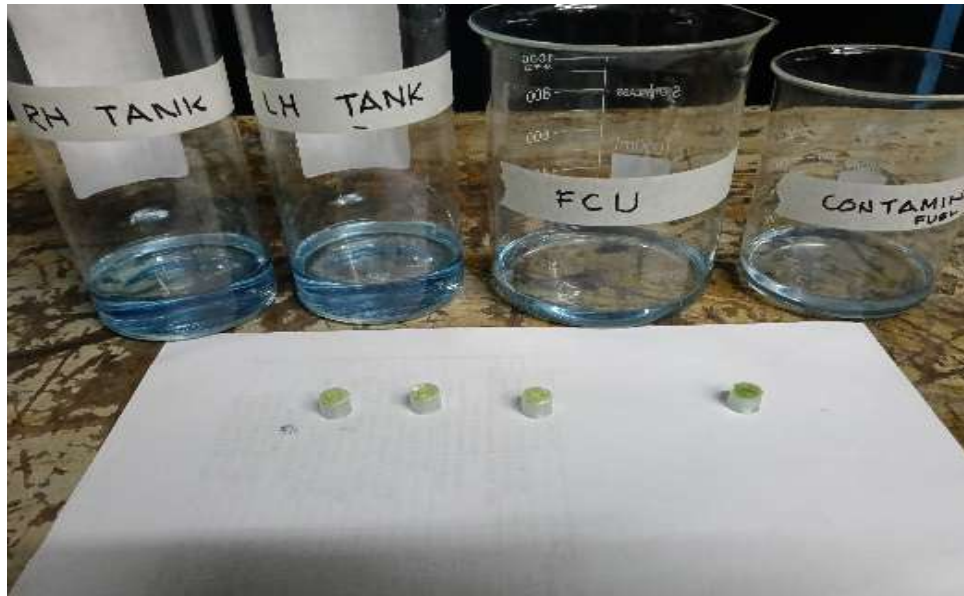
Figure 5b - Fuel in clear container.

Fuel samples were placed in transparent containers (Figure 5b) and tested sequentially, including a control sample deliberately contaminated with water for comparison. The test results indicated no presence of free water or particulate contamination in the fuel samples obtained from both the fuel tanks and the FCU supply line. The fuel quality was therefore assessed to be within acceptable limits, eliminating fuel contamination as a contributing factor to the engine malfunction (Figure 5).

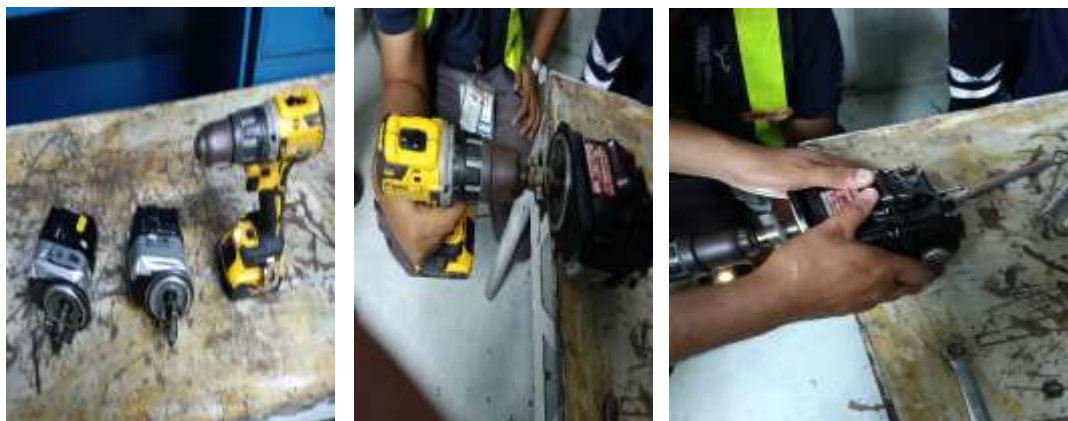
Figure 6 - Magneto Check.

Both left and right magnetos were removed and bench-tested using an impulse coupling/electrical drill setup to verify power generation capability. The

magnetos produced consistent electrical output during the test, indicating normal operational performance (see Figure 6). Based on the test results, the ignition system, including both magnetos, was assessed to be serviceable. The engine malfunction was therefore not attributed to a failure of the ignition system.

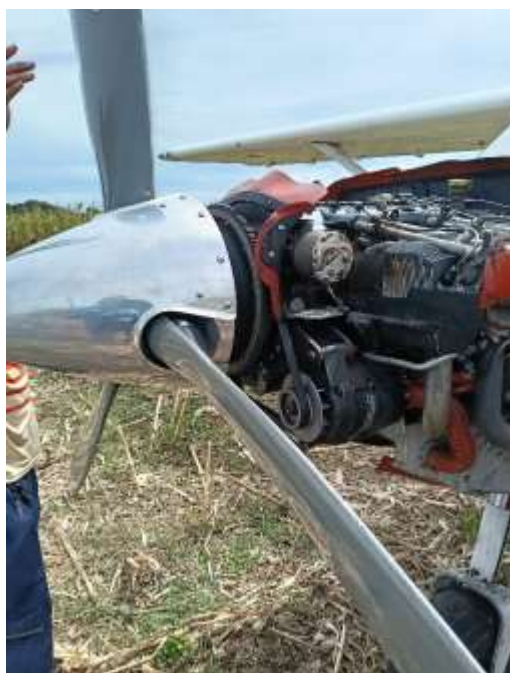
Figure 7 - Compression check.

During the on-site investigation, a manual rotation of the propeller was conducted to verify the presence of compression in each cylinder and to assess the engine's internal mechanical continuity. The engine demonstrated normal compression resistance in all cylinders, indicating no evidence of internal seizure, valve malfunction, or piston damage. This finding supports that, prior to the in-flight engine stoppage, the engine's mechanical integrity and compression performance were within normal operational limits. Based on these results, it was concluded that the engine failure was not caused by a loss of compression or any internal mechanical defect related to the piston-cylinder assembly.

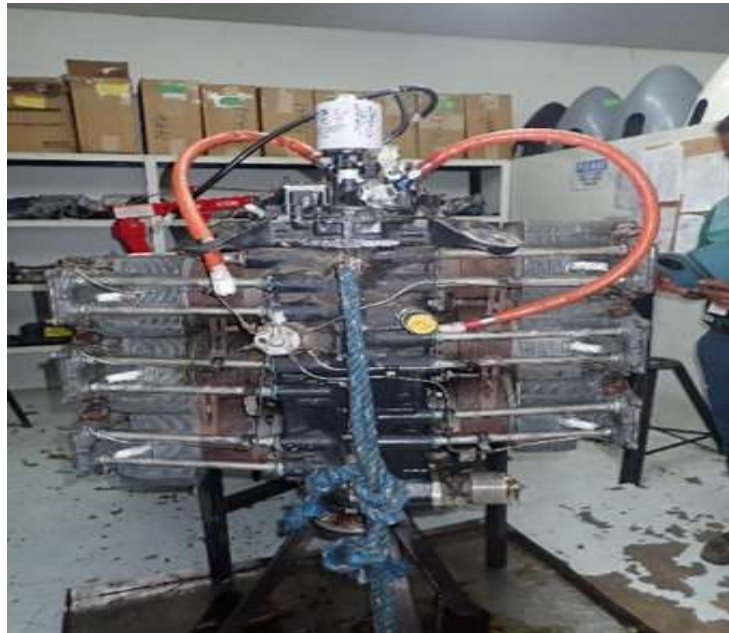
Figure 8 - The engine prepared for ignition/sparkplug inspection.

A total of twelve (12) spark plugs were removed from the engine for examination. The inspection results revealed that four (4) spark plugs were clean and serviceable, while eight (8) spark plugs exhibited heavy carbon deposits on the electrodes and insulator areas. The presence of carbon fouling indicates incomplete combustion, which can lead to reduced ignition efficiency, engine misfiring, and loss of power output during flight. These conditions may have contributed to the progressive degradation of engine performance prior to the in-flight power loss. The fouling was assessed as likely progressive in nature, possibly resulting from rich fuel mixture operation, inadequate combustion temperature, or prolonged low-power settings during previous flights, and may not have been fully detected during routine maintenance checks.
