### **FINAL REPORT**

**RP-C7653**  
**TEXTRON AVIATION INC., CESSNA, C-172M**

**TITLE:** Incident involving a Textron Aviation Inc., Cessna, C-172M type of aircraft with registry number RP-C7653 owned and operated by Leading Edge International Aviation Academy Inc. that had a Runway Excursion at Lingayen Community Airport, Lingayen, Pangasinan, Philippines on March 02, 2019 at about 1515H (local) 0715 UTC.

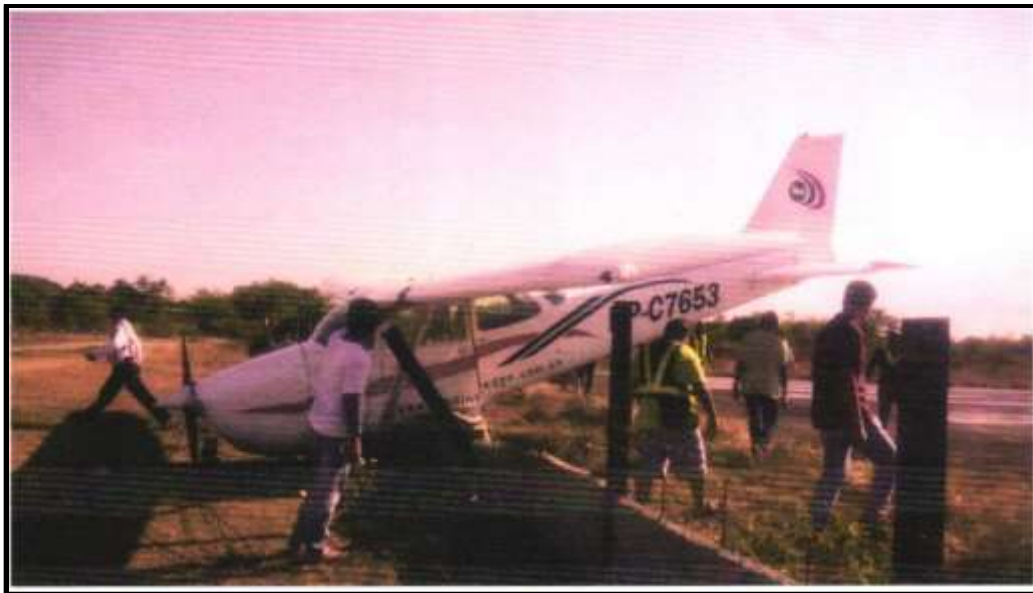
The aircraft with the SP in the control touched down 600 meters after the threshold of Runway 08. The FI took over to stop the aircraft but to no avail as it continued its path and came in contact with the airport concrete perimeter fence. Witnesses on the ground stated that the aircraft landed after passing the security outpost which was located mid-field and tried to stop, leaving tires marks on the runway but later hit the fence.

Figure 1: RP-C7653 on its final resting point.

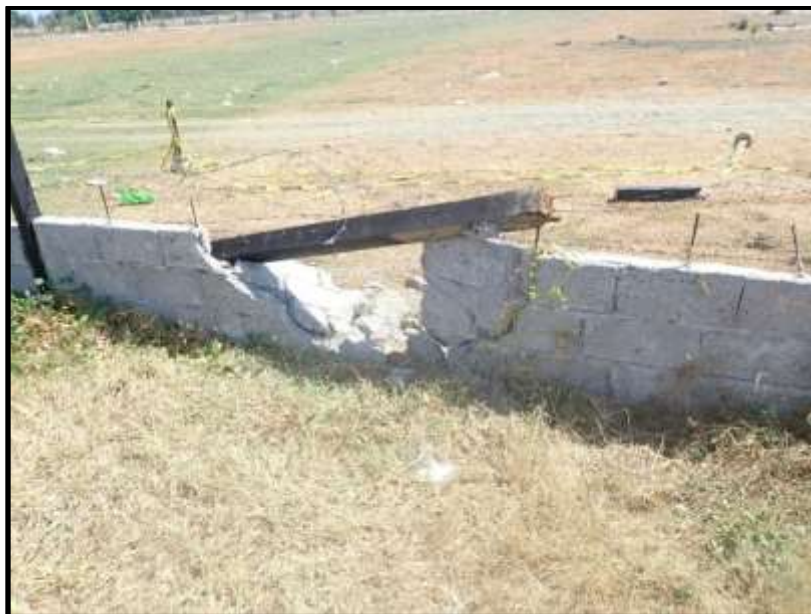
The aircraft touched down mid runway and overshoots the runway. It came to a halt about 350 meters away from the threshold end of runway 08 and settled upright with fuselage heading 165 degrees at coordinates 16.0211.13N, 120.1449E. The runway has visible tire track marks running to about 150 meters going to the left from the centerline before the threshold end of runway 08.

Figure 2. The aircraft collided with the airport perimeter fence.

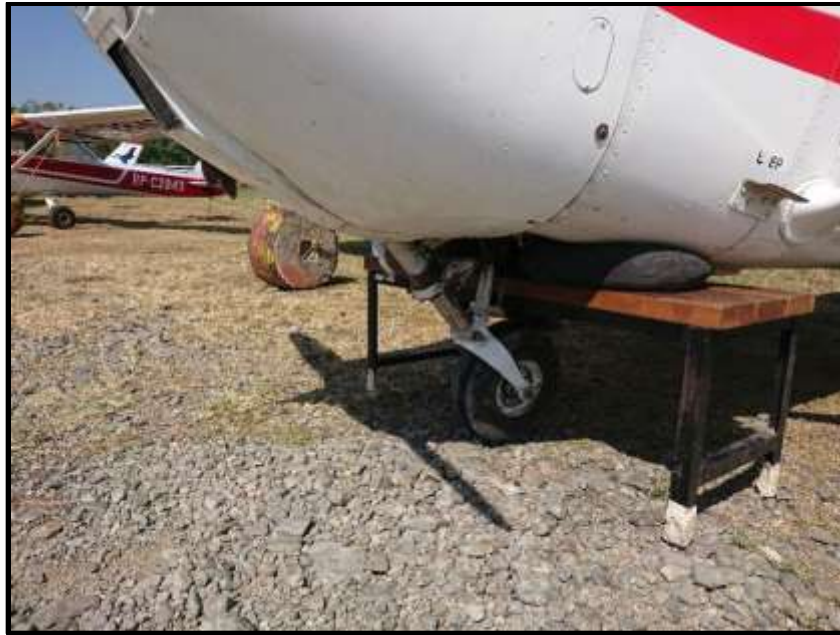
1.3.1 The aircraft substantial damage on its nose landing gear assembly.

1.3.4 Nose Landing Gear Steering rod.

Figure 3. The aircraft nose landing gear assembly was damage upon impact with the fence.
