# AIRCRAFT ACCIDENT INVESTIGATION AND INQUIRY BOARD

## FINAL REPORT

### RP-C7730 TEXTRON AVIATION/C172

**TITLE:** A serious incident involving a C172 type of aircraft with Registry Number RP-C7730 operated by Leading Edge International Aviation Academy Inc., that involved in a runway side excursion event at Runway 01, San Fernando Airport, Poro Point Freeport Zone, San Fernando City, La Union, Philippines after landing on September 12, 2025/1001H local time.

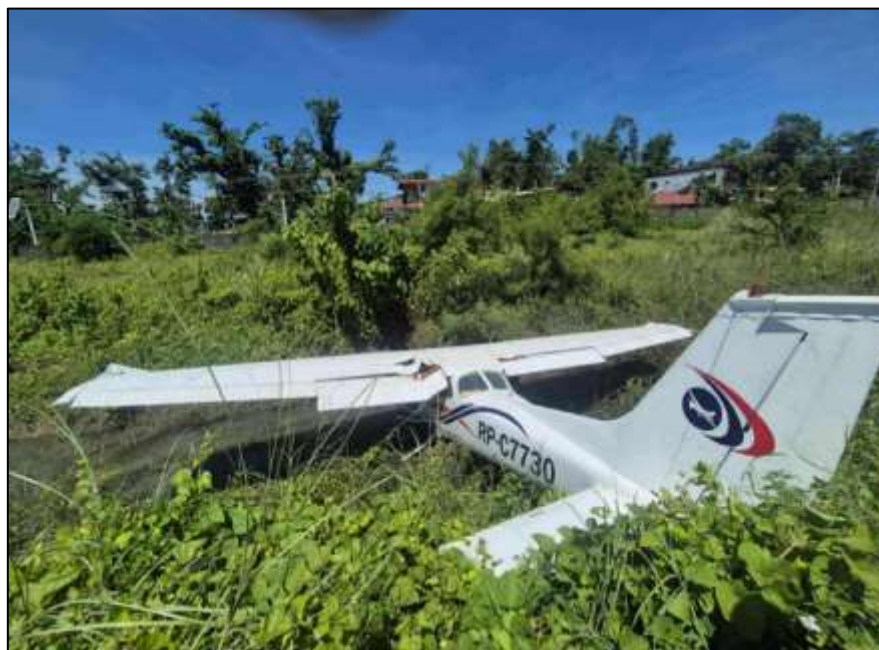
The aircraft sustained damage to both wingtips, the propeller, nose landing gear, and forward fuselage. The pilot of another company aircraft, RP-C7530, positioned on the south taxiway, reported the occurrence to RPUS Tower. The duty air traffic controller activated airport rescue and firefighting services, which responded promptly and secured the accident site. Airport operations were suspended until 1409H, after which normal flight activity resumed.

Figure 1 - RP-C7730 at its final position.

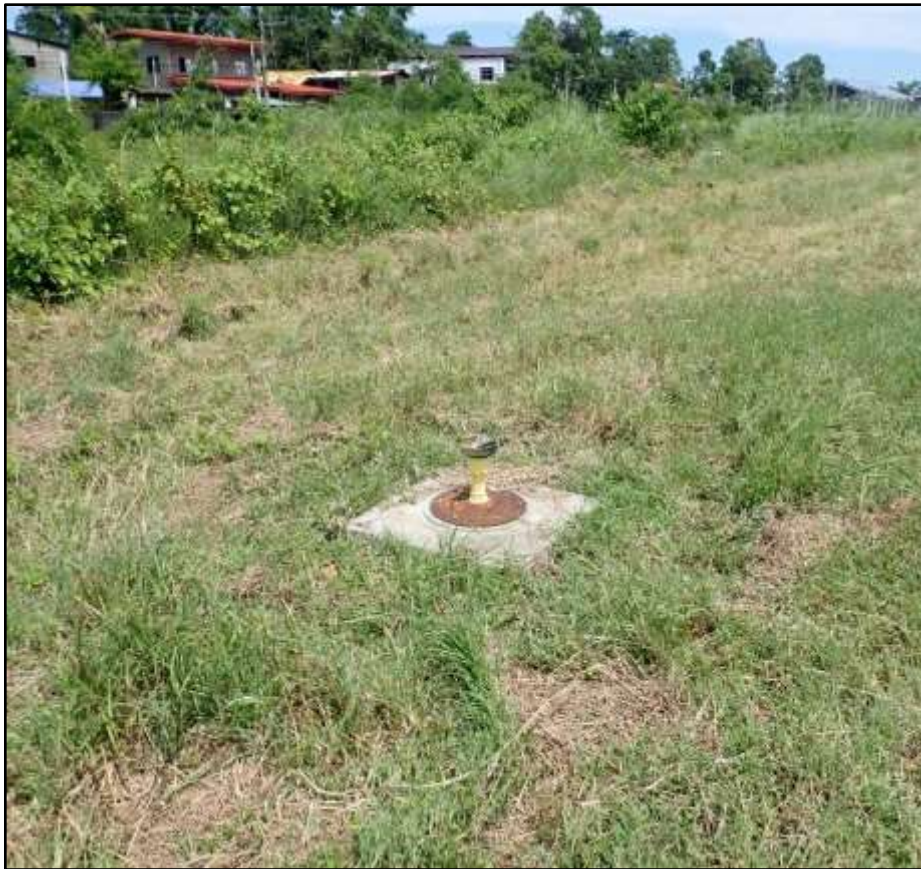
The aircraft collided with one (1) runway edge light passing runway to-go marker #3.

Figure 2 - runway side light.

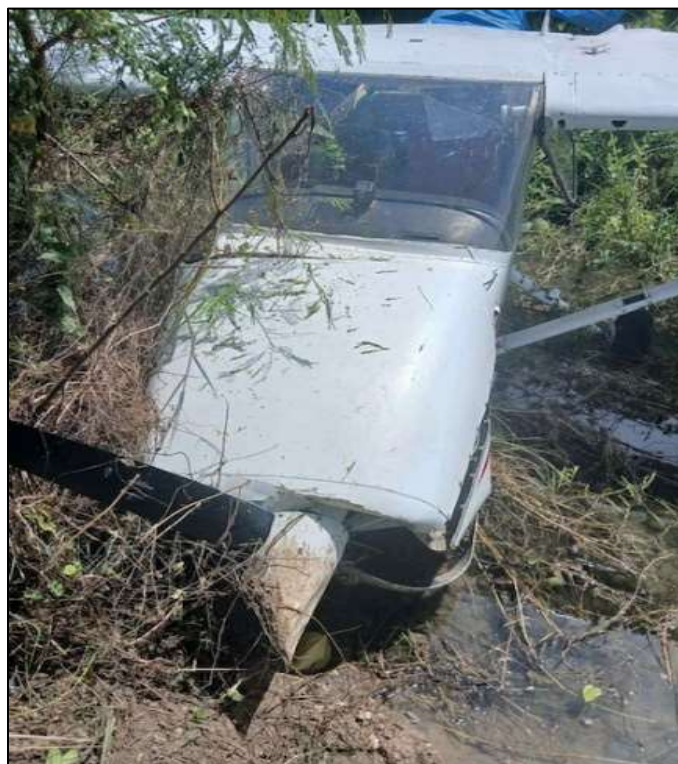
The aircraft came to rest in a nose-low attitude, sustaining impact damage to both wingtips, the propeller (Figure 3), and the nose landing gear. The FI immediately shut down the engine, and all occupants exited the aircraft with minor injuries. The aircraft settled at coordinates 16°35'43.47"N, 120°18'10.28"E, with its final heading-oriented west. All occupants were transported to the hospital for medical evaluation. No post-impact fire occurred.

Figure 3 - RP-C7730 impact damage on the propeller.

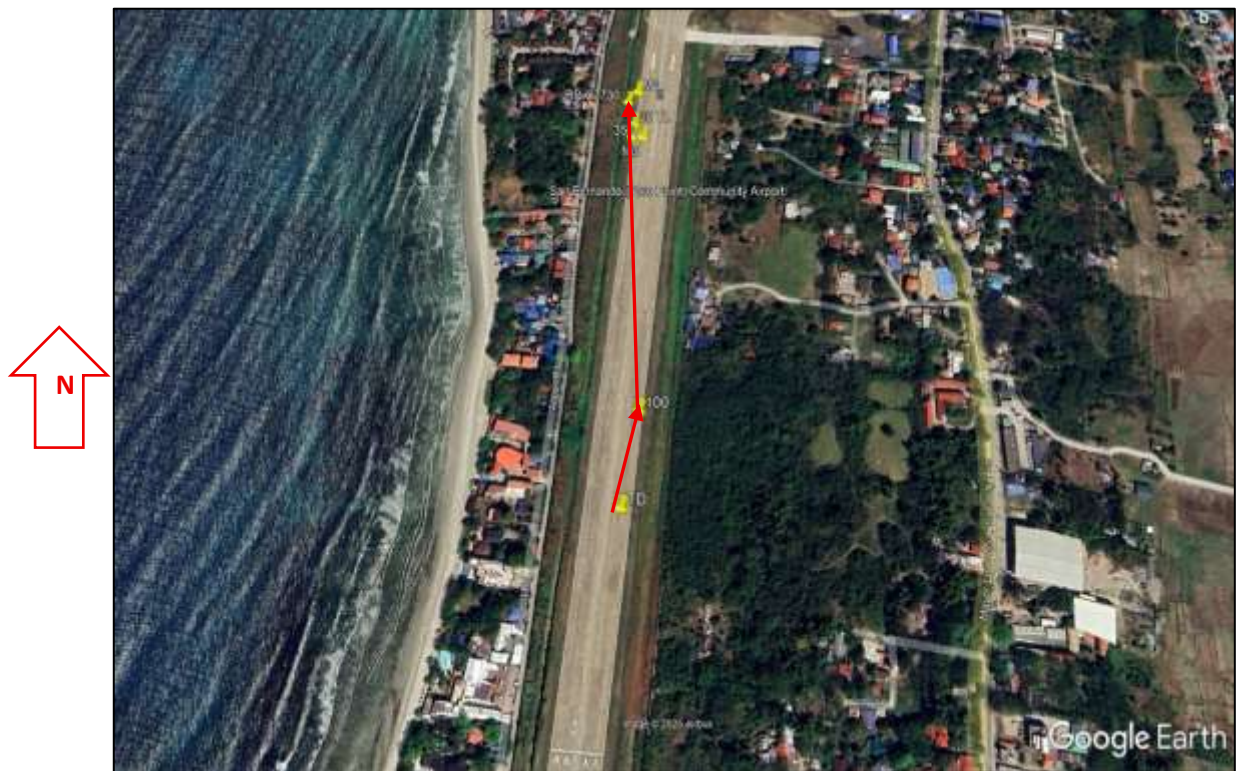
Upon landing at RPUS, the aircraft touched down approximately 200 meters beyond the displaced threshold of Runway 01, slightly right of the centerline. It

subsequently began to drift further to the right. The PPT attempted to correct the deviation but applied excessive control input, causing the aircraft to veer left. The aircraft then departed the paved surface, struck a runway edge light, and entered the adjacent storm canal (Figure 6).

Figure 6 – The aircraft touch down (TD) zone and path going out of the runway.

- g. There were no records of engine discrepancy noted on the engine logbook.
- h. The aircraft touched down approximately 200 meters beyond the displaced threshold of Runway 01, right of the centerline, at an excessive airspeed and above normal glide profile.
- i. The aircraft departed the runway, struck a runway edge light, and entered the adjacent storm canal.
