FINAL REPORT

RP-C5911
DE HAVILLAND AIRCRAFT OF CANADA LIMITED
DHC-8-402

OPERATOR: AIR PHILIPPINES CORPORATION, DBA PAL EXPRESS

DATE OF OCCURRENCE: DECEMBER 27, 2024

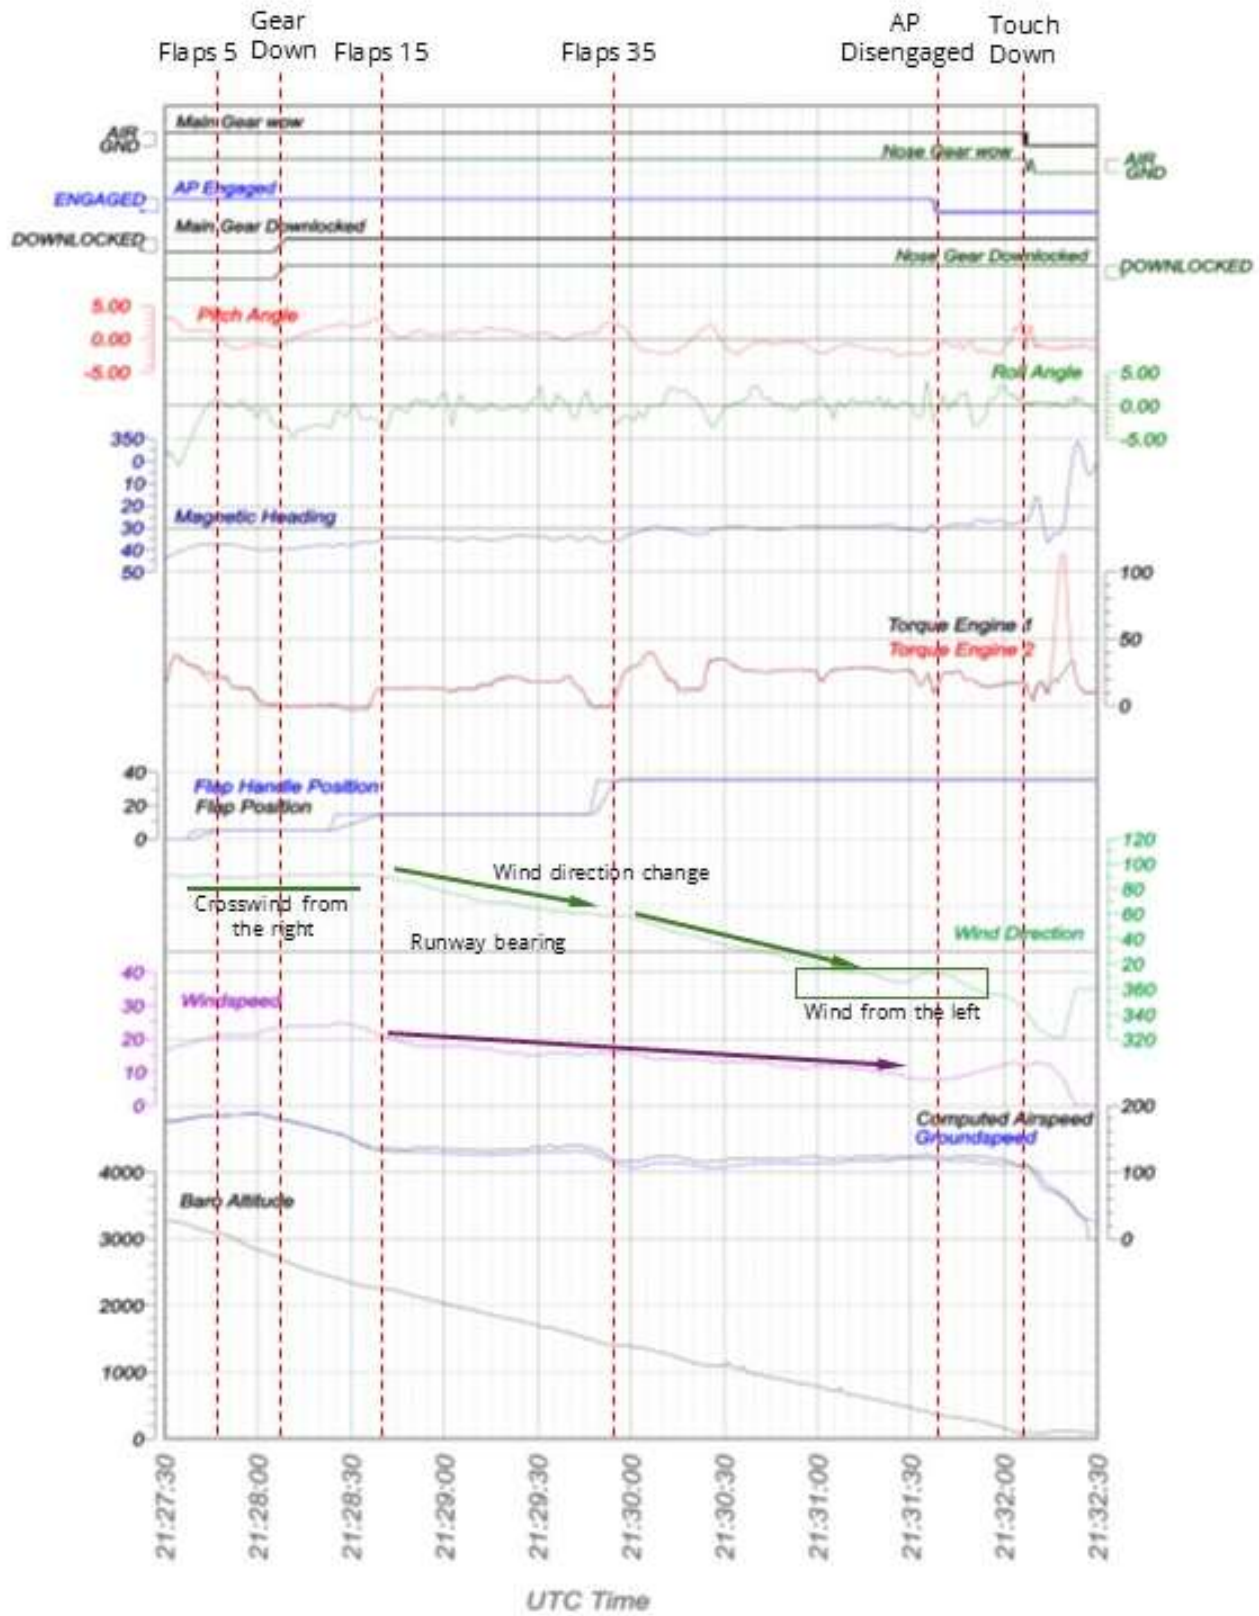
Figure 5 – FDR data during the approach.

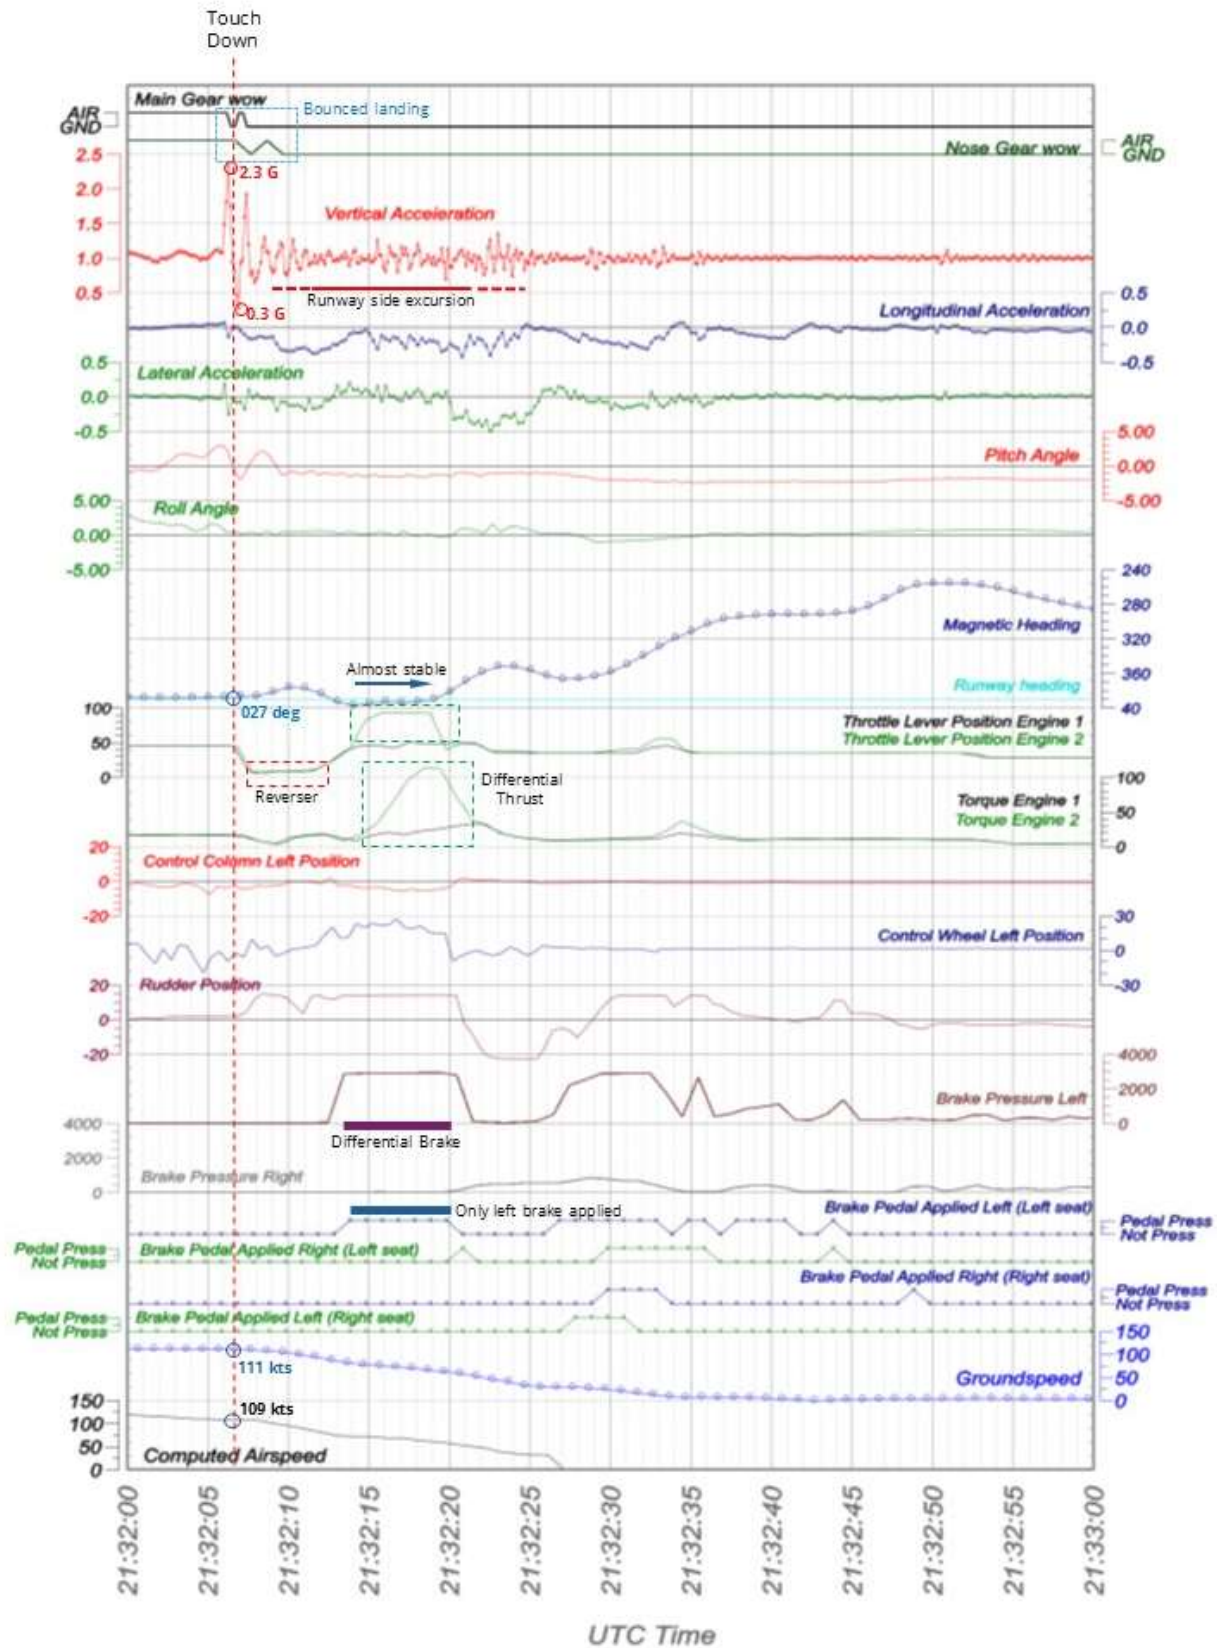
No rudder, engine, or brake system malfunctions were identified in the recorded data.

Figure 6 – FDR data during the landing.

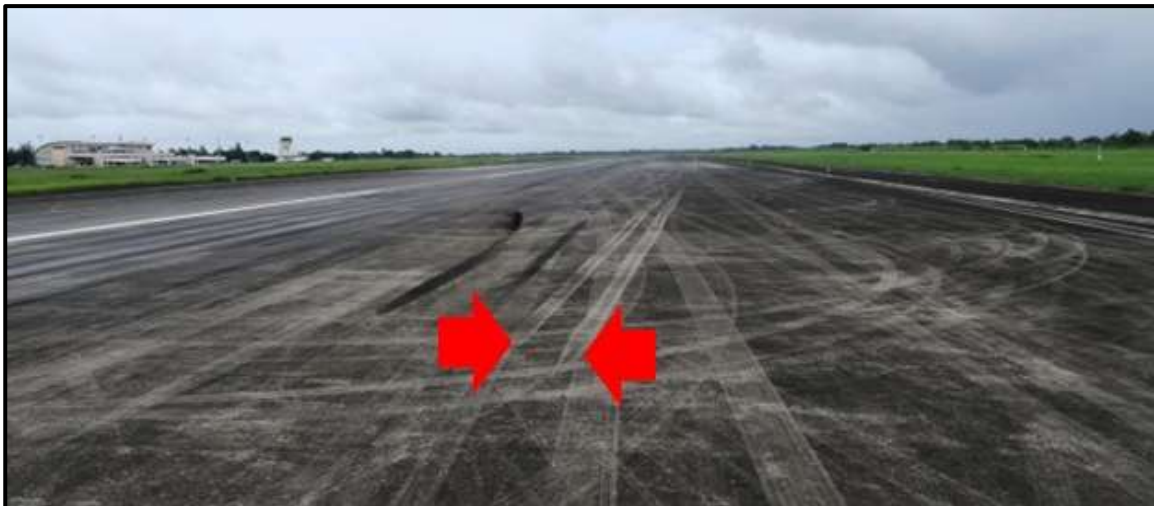
The marks showed that all the aircraft's tires were off the paved surface for approximately 147.84 meters before returning toward the runway centerline. The right MLG tires remained outside the runway edgeline for approximately 729.39 meters and reached a maximum lateral distance of approximately 36.31 meters from the runway centerline.

Figure 6 – Tire marks from the aircraft's MLG at the touchdown point.

Although the pilot reported that the aircraft remained within the runway centerline during touchdown, tire marks on the runway indicated that all landing gears touched down on the right-hand side of the centerline. This observation suggests a possible visibility limitation during actual touchdown due to prevailing weather conditions.

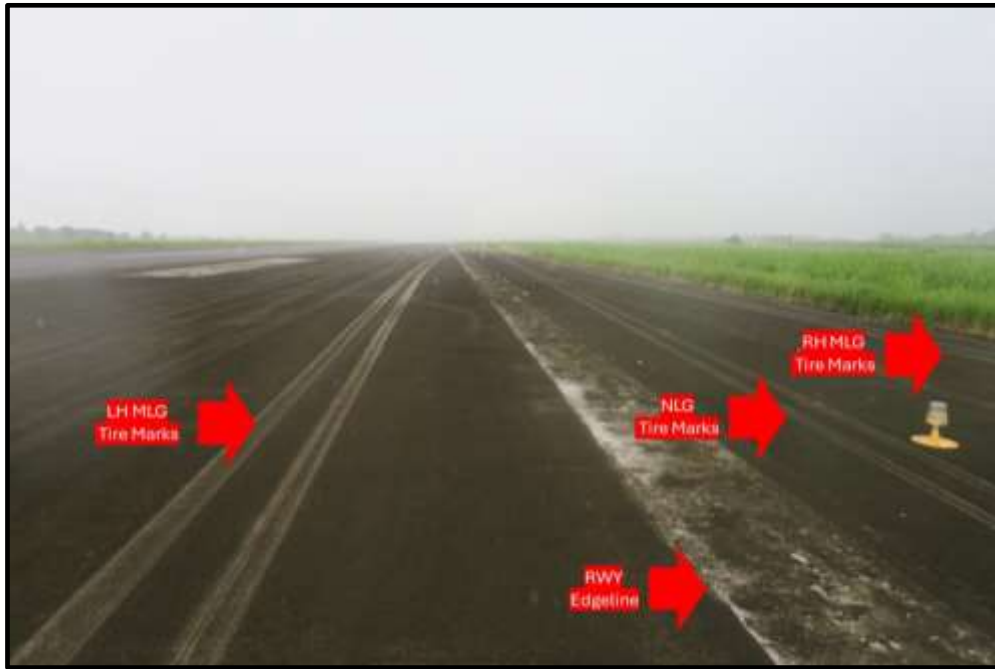
Figure 7 – Aircraft tire marks abeam the runway edgeline.

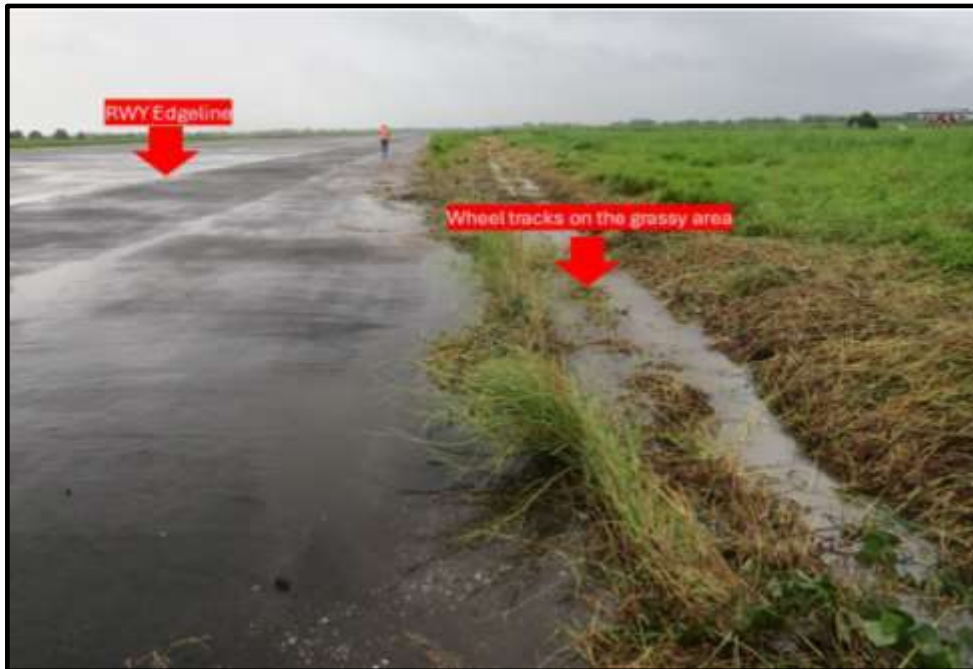
Figure 8 – Aircraft tire marks on the grassy area beside the runway.

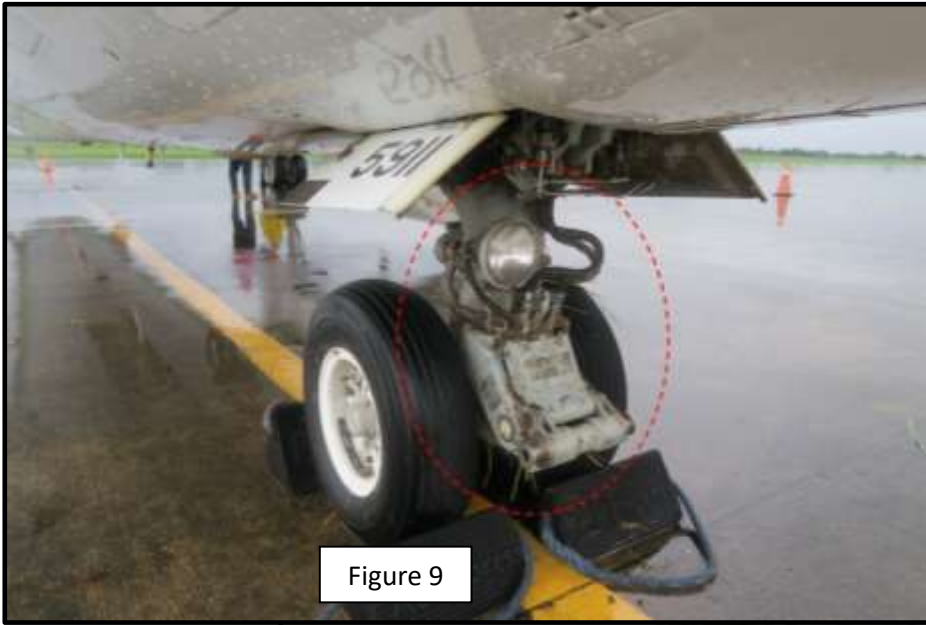
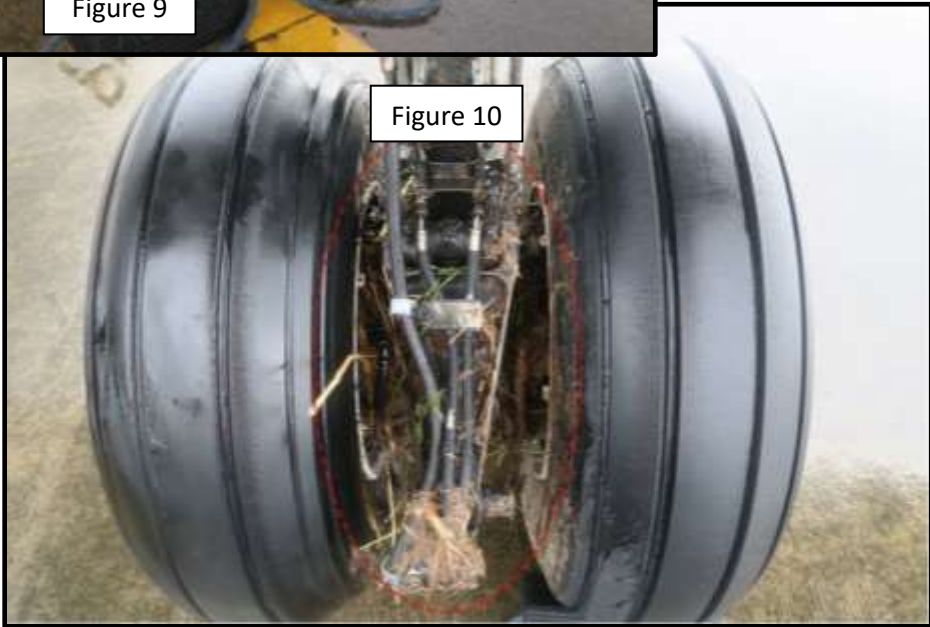
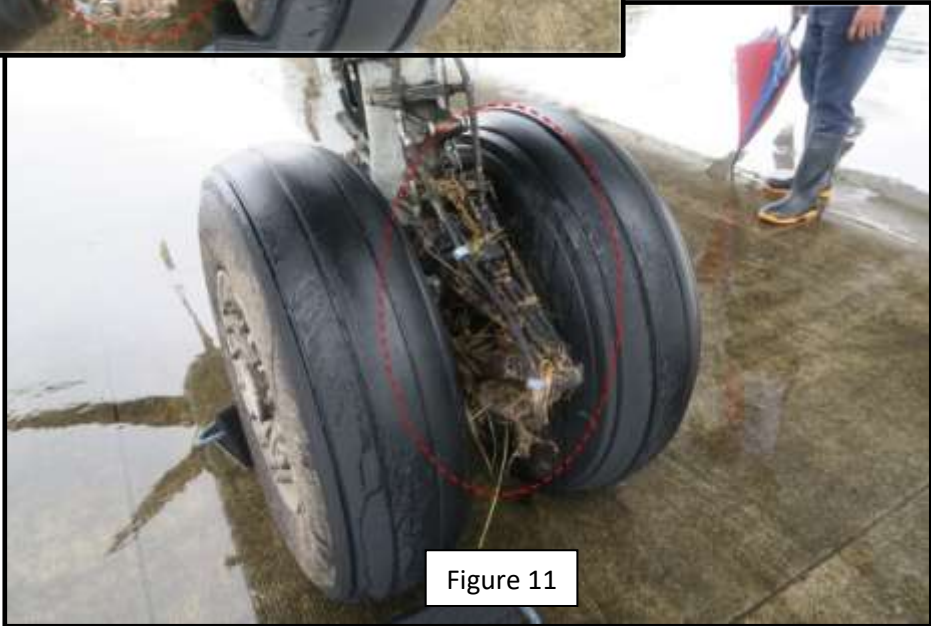
Figure 9-11 – Aircraft landing gears with traces of mud and grass.
