# AIRCRAFT ACCIDENT INVESTIGATION AND INQUIRY BOARD

## FINAL REPORT

### RP-C8262 PIPER AIRCRAFT CORPORATION/PA-31

***PLACE OF OCCURRENCE: PALANAN COMMUNITY AIRPORT,  
PALANAN, ISABELA, PHILIPPINES***

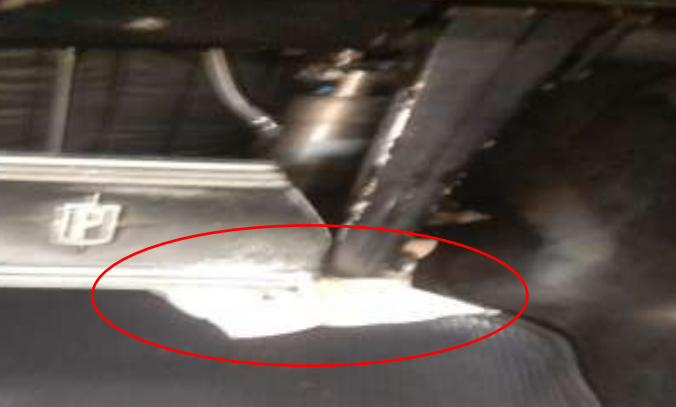
Figure 5- Right rudder/brake pedal forward hydraulic master piston.

The investigation revealed that there was no external damage to the aircraft. Unfortunately, the aircraft's right rudder/brake pedal forward hydraulic piston (brake master) had a leak from its gasket/seal. This resulted in a leak of hydraulic fluid on the right-side wheel brake system, causing the right main landing gear brake to malfunction (Figure 5). As part of its maintenance program, the company should conduct a thorough inspection of the aircraft's right rudder/brake pedal forward hydraulic master piston. Since this is the first time this kind of event has manifested itself, the pilot and maintenance crew may have overlooked the signs that the pedal component is deteriorating.

The company sent two (2) mechanics to Palanan Community Airport to address the event's brake component issue. What the mechanics did was clean the aircraft's right hand brake pedal forward hydraulic piston. One of the mechanics placed a rag under the pedal to check for leaks after testing the component several times and finding it operable (Figure 6). The AMO included the affected part in the 50- and 100-hour inspection package, as specified in the manufacturer's aircraft service manual, during
