Republic of the Philippines
CIVIL AVIATION AUTHORITY OF THE PHILIPPINES

FINAL REPORT

HL7525 AIRBUS A330-322

DATE OF OCCURRENCE: OCTOBER 23, 2022

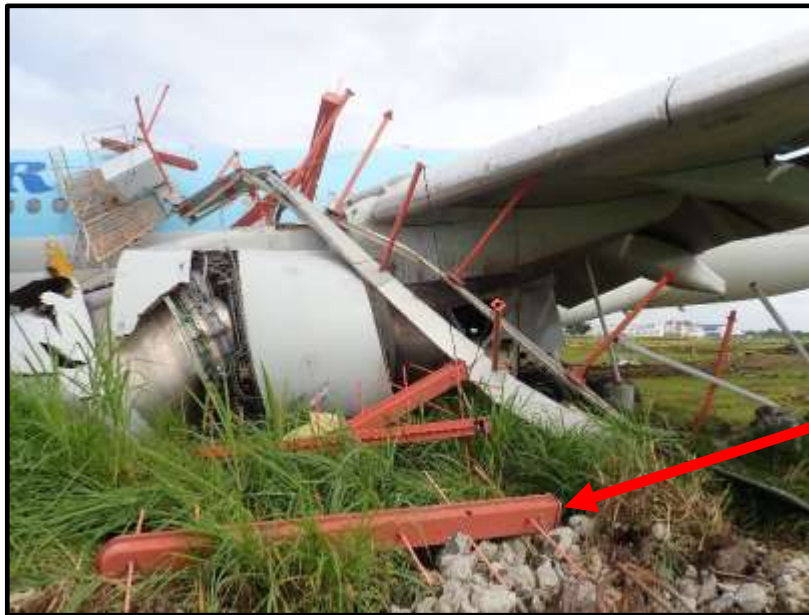
1.4.2 One (1) ILS Localizer Antenna (Figure 3).

Figure 3 - RPVM RWY 22 Localizer antenna.

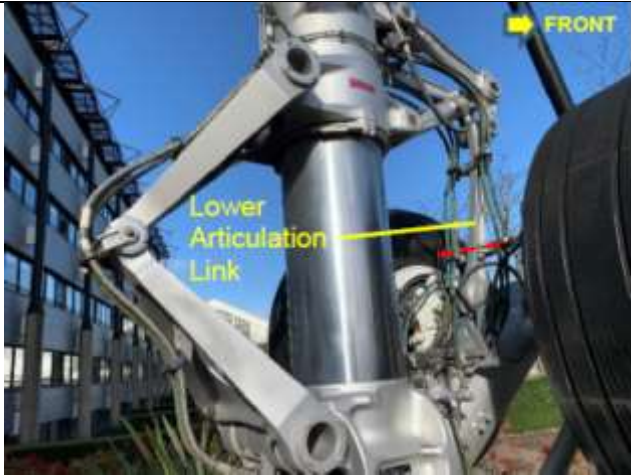
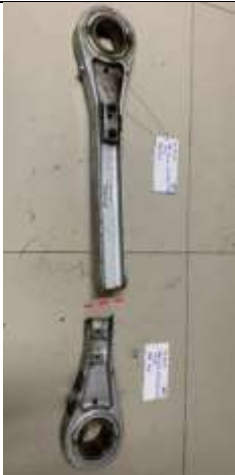
IMAGE No.	PART LOCATION	IMAGE OF REMOVED PART
1

The site investigation further shows that the RH MLG lower articulation link was broken. Moreover, as a consequential event of the step impact, the rupture of the RH MLG led to tearing off the 2M electrical harness. All the sensors (L/G position, brake temp, tire pressure, etc.) and tachometers (wheelspeeds) of the MLG are powered through two electrical routes: 1M and 2M. For LGCIUs, 1M supplies sensors are dedicated to LGCIU1, and 2M supplies sensors are dedicated to LGCIU2. The loss of the 2M electrical route resulted in losing half of the proximity sensors of the RH MLG (i.e., tachometers, bogie trail proximity sensors, pitch-trimmer proximity sensors, and tire pressure indication system (TPIS) sensors).

After the rear wheels of the RH MLG hit the step, the bogie beam had a sharp derotation that resulted in the LAL being ruptured. This subsequently allowed the bogie beam to continue its derotation freely and made contact with the lower torque link (front wheels not being stopped by the ground due to the aircraft trajectory). The sequence of events was shown in figure 19.

The laboratory investigation found significant evidence that the RH LAL was fractured in a manner consistent with ductile overload, with no specific crack initiation site or other fracture morphologies observed. This suggests that there was no prior defect present in the part and the fracture was purely a result of a tensile overload.

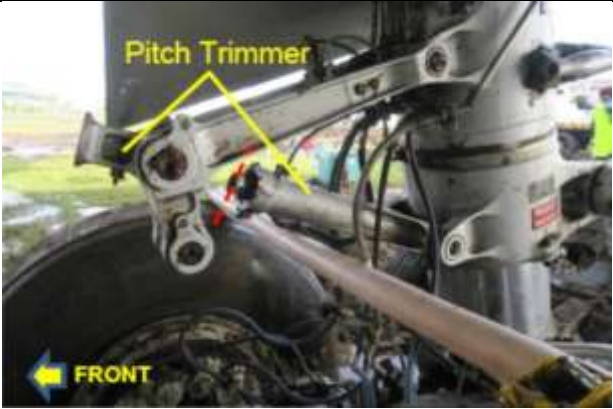
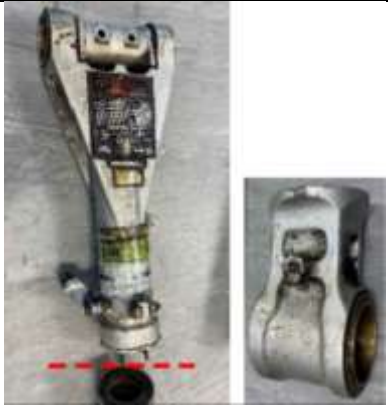
2

With the RH MLG Bogie Pitch Trimmer Rod End disconnected due to the lower articulation link fracture, it was possible for contact to occur between the BPT cylinder and the pitch trimmer proximity sensor brackets as the release of energy swung it upwards. This matched damage was seen on the RH MLG proximity sensor 31GA2 harness that was completely torn out and disconnected. The proximity sensor 31GA1 harness was also partially torn out.

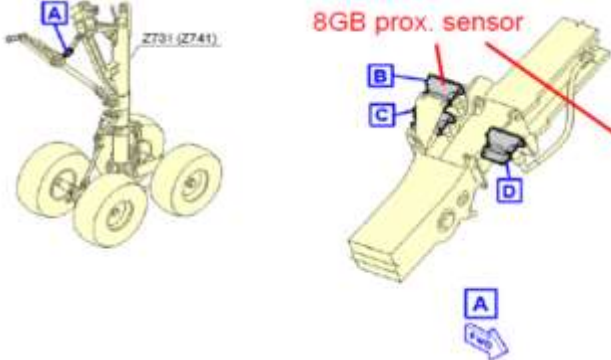
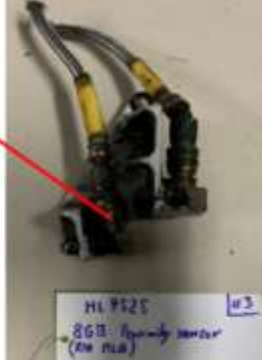
IMAGE No.	DESCRIPTION	LOCATION	P/N
7	Proximity Sensor 8GB (downlock) with its connector and 15cm of harness	R/H MLG lock link (side stay assembly)	C13502-08

Additionally, 8GB sensor was sent to the BEA to give details of the fault transmitted through ACARS. This part was sent to Safran Landing System in Gloucester, UK, then to the manufacturer Crane Aerospace in Lynnwood, USA, and finally back to Gloucester.

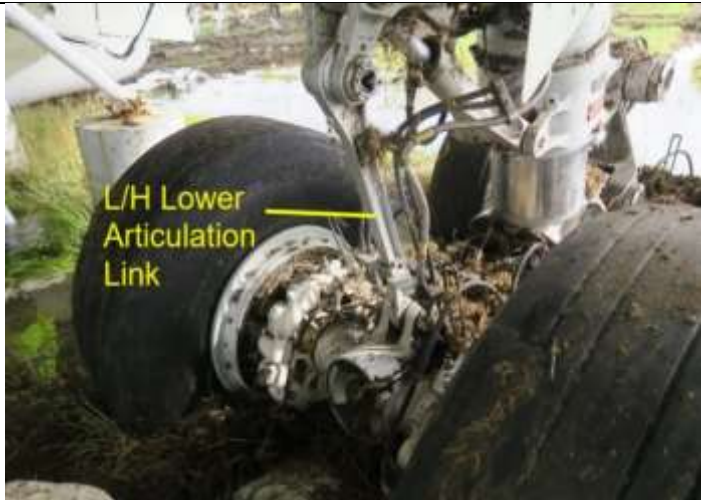
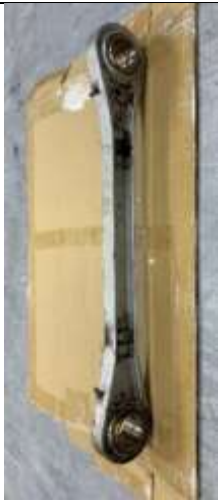
IMAGE No.	DESCRIPTION	LOCATION	P/N
8	L/H MLG Lower Articulation Link	Front side of the bogie	201589208

On the other hand, there was no fracture of the LH MLG LAL. Physical measurements of key dimensions were performed and found to be within drawing tolerance. A 3D scan was also performed, with the resulting model compared with a nominal model. This showed that the two models concurred with each other, demonstrating that no permanent deformation had occurred.

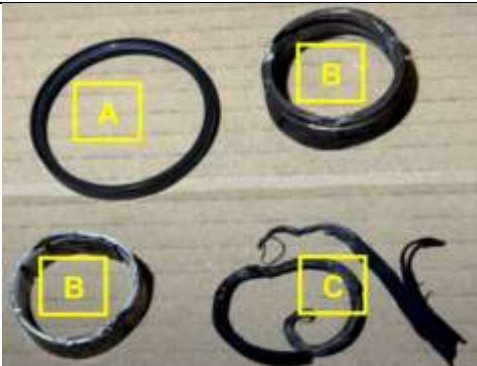
During on-site observation of RWY22 threshold, some parts were found on the ground. They were collected and sent to the BEA for identification. These parts were sent to Safran Landing System in Gloucester, UK.

IMAGE No.	DESCRIPTION	IMAGE OF PART
9	<ul style="list-style-type: none"> 1 seal - A 2 pieces of electrical connectors - B 2 pieces of rubber - C

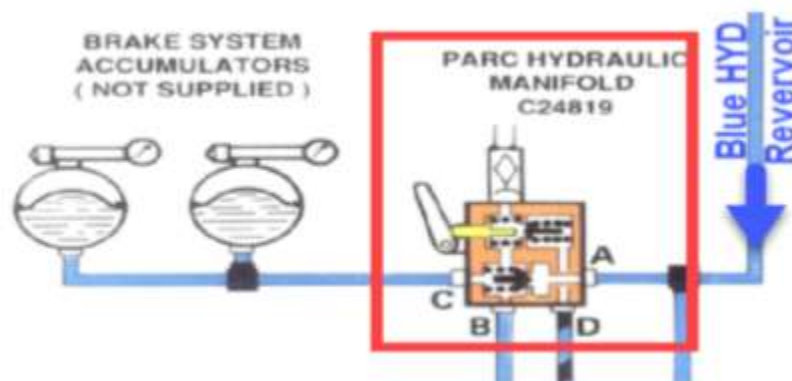
Figure 34 A - The Park Hydraulic Manifold Schematic

All these components were tested as per CMM and all were found No Fault Found (NFF) except the Park Hydraulic Manifold, where an internal leakage was found on the Pressure Release Valve (PRV) as shown in figure 34 A and B.

The PRV function is to protect the system from any overpressure in the Alternate Braking System and is normally closed during operation. According to the manufacturer, this valve is not supposed to be regularly operated, the cracking pressure is normally reached only after an over-pressure on the blue Hydraulic circuit and during manual decompression operations for maintenance. In qualification, 1000 operations of the valve are required and completed. The consequences of a sole internal leakage of the PRV are a pressure decrease in the Accumulators after a long aircraft parking (without any hydraulic power). This can be detected by the flight crew who, as per A330/A340 flight crew operating manual Standard Operating Procedures (SOPs), will check the accumulator pressure during the Preliminary Cockpit Preparation: (Figure 37)

Following this event, Airbus has launched a study to enhance the A330 reverser logic in order to keep thrust reversers (most important benefit in terms of landing performance) in the conditions of this event. With regard to the “dormant” failure on the alternate braking system, Airbus is investigating improvements of the maintenance documentation in order to better detect such an internal leakage (Reference: Airbus Contribution Report dated February 16, 2024).

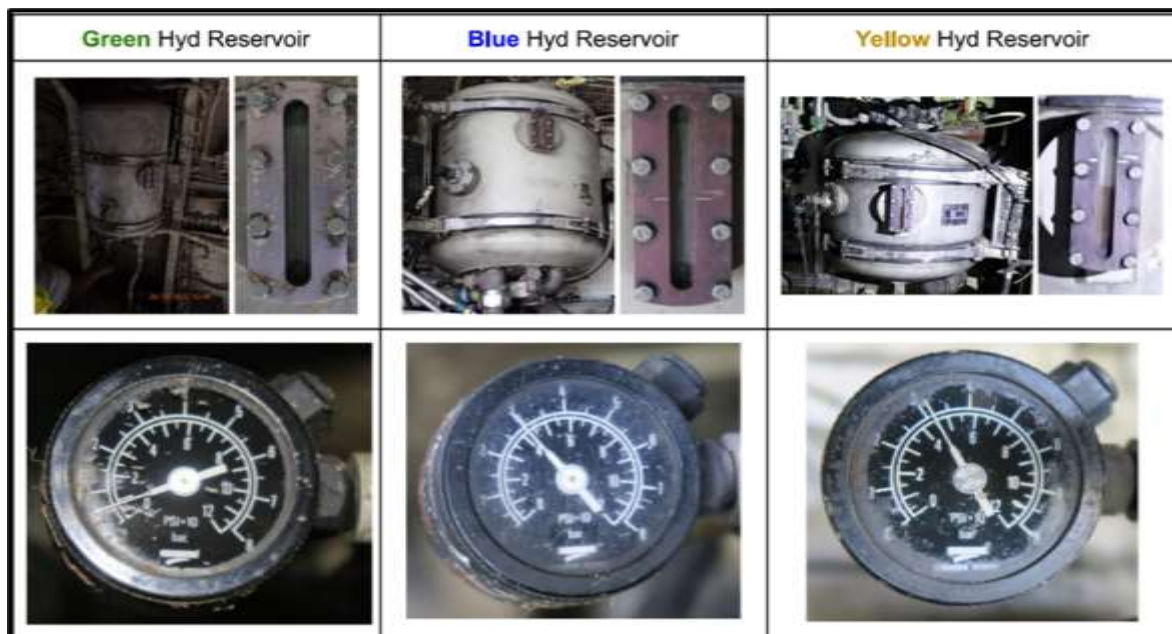
Figure 38 - The hydraulic reservoir and their specific accumulator

The Green reservoir was found empty. It is assumed that the Green hydraulic fluid leak happened due to the damages to the NLG supply green hydraulic system pipes after the NLG collapsed. Air Pressure in the Green reservoir was found at zero (0). The Yellow reservoir was found closed to normal level. Air Pressure in the Yellow reservoir was found nominal about three (3) bars. The A330 hydraulic reservoir and respective gauges are shown (Figure 38).

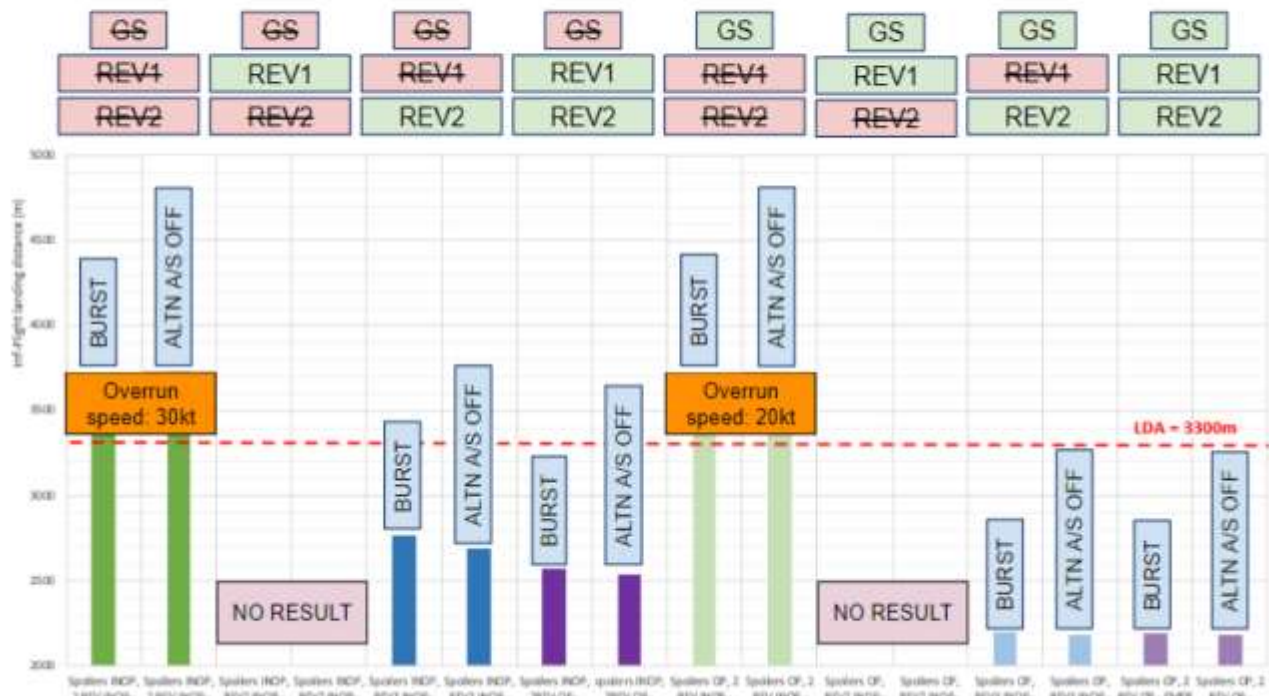
Figure 39 - The result.

It has to be noted also that in these computations, the pilot inputs (i.e. brake and rudder pedal applications) are optimized in order to keep the aircraft trajectory on the RWY axis. In case of alternate braking without antiskid (as tire bursts are not guaranteed in such a situation), the performance tool computed two (2) scenarios: a landing distance with normal tires (called "ALTN A/S OFF" and a landing distance with all tire bursts. All the combinations of deceleration means recovery (i.e. with GS and/or REV available) have been computed.

The conclusions are the following:

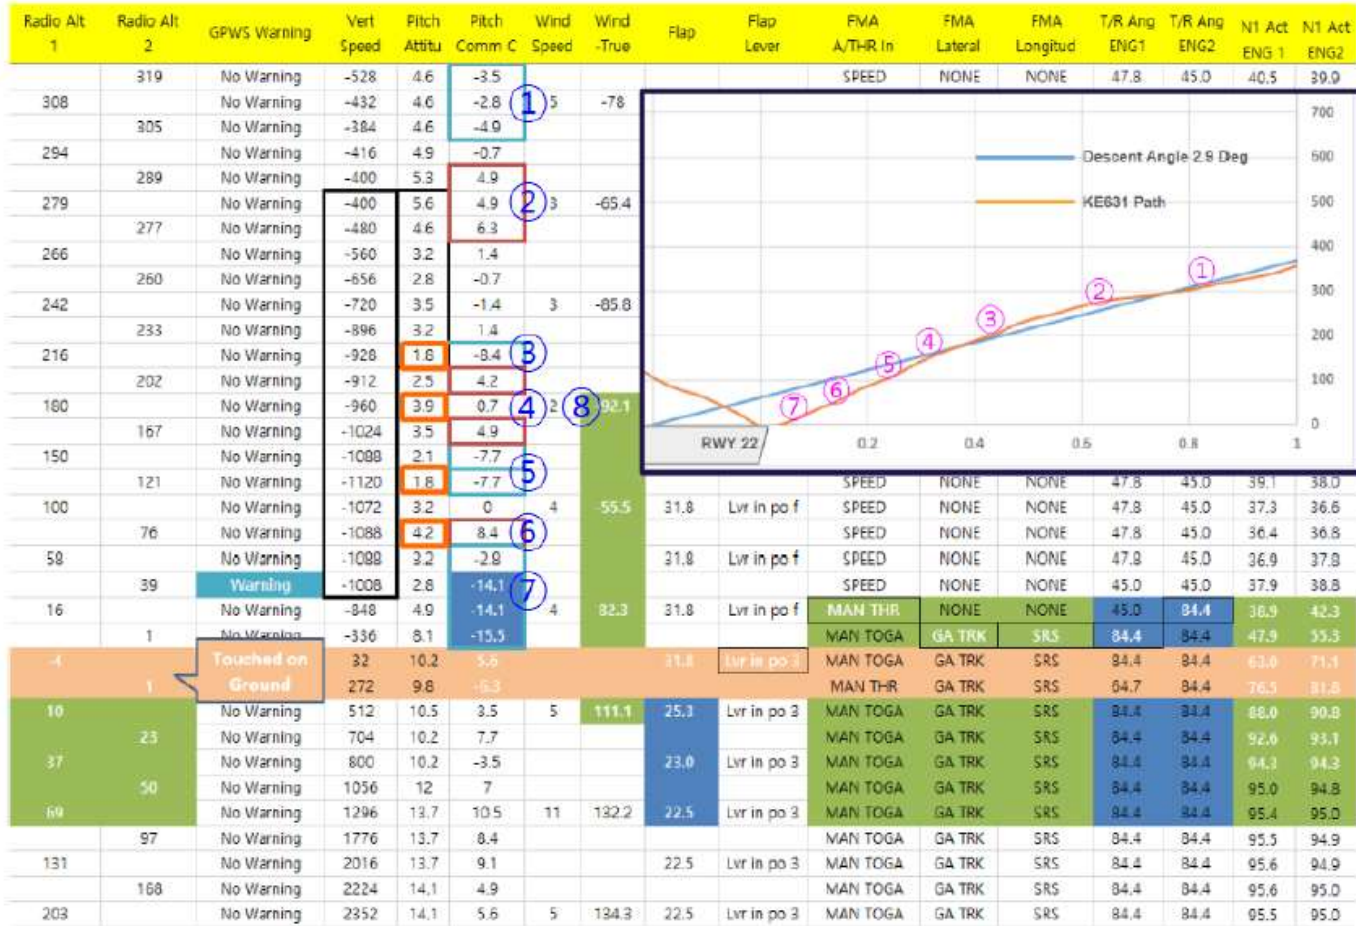
Figure 40 - DFDR Analysis

8. From RA 180 ft to the ground contact, the wind direction changed from a right crosswind to a side tail wind by approximately 180 degrees. During this period, the captain made at least three (3) attempts to reduce the descent rate, yet the aircraft's descent rate remained unchanged due to uncontrollable factors. Additionally, this timing coincided with the captain's statement regarding sensing strong downdrafts, and it aligns with the analysis indicating the presence of Vertical Wind Factor (Multiple downdrafts).

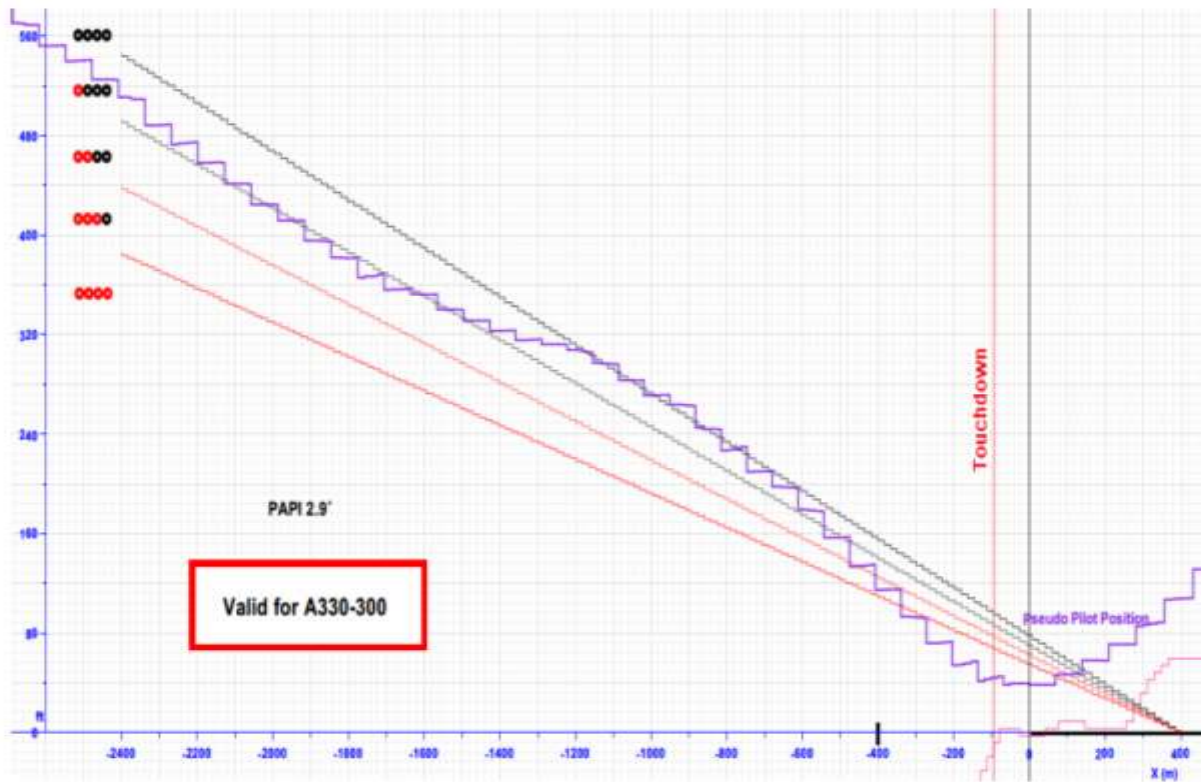
Figure 41 - The vertical flight path.

As mentioned, between 14:26:06 UTC (300 ft RA) and 14:26:22 UTC (70 ft RA), there was high-pitch sidestick activity and high roll sidestick activity. The calibrated airspeed (CAS) remained stable around speed target (Vapp) and the aircraft passed durably below the 3° flight path at 150 ft RA. In these regards, the aircraft vertical flight path versus the PAPI profile (2.9°) during the last 400 ft AGL was reconstructed as shown (Figure 41).

According to this reconstruction, the PAPI indications were the following:

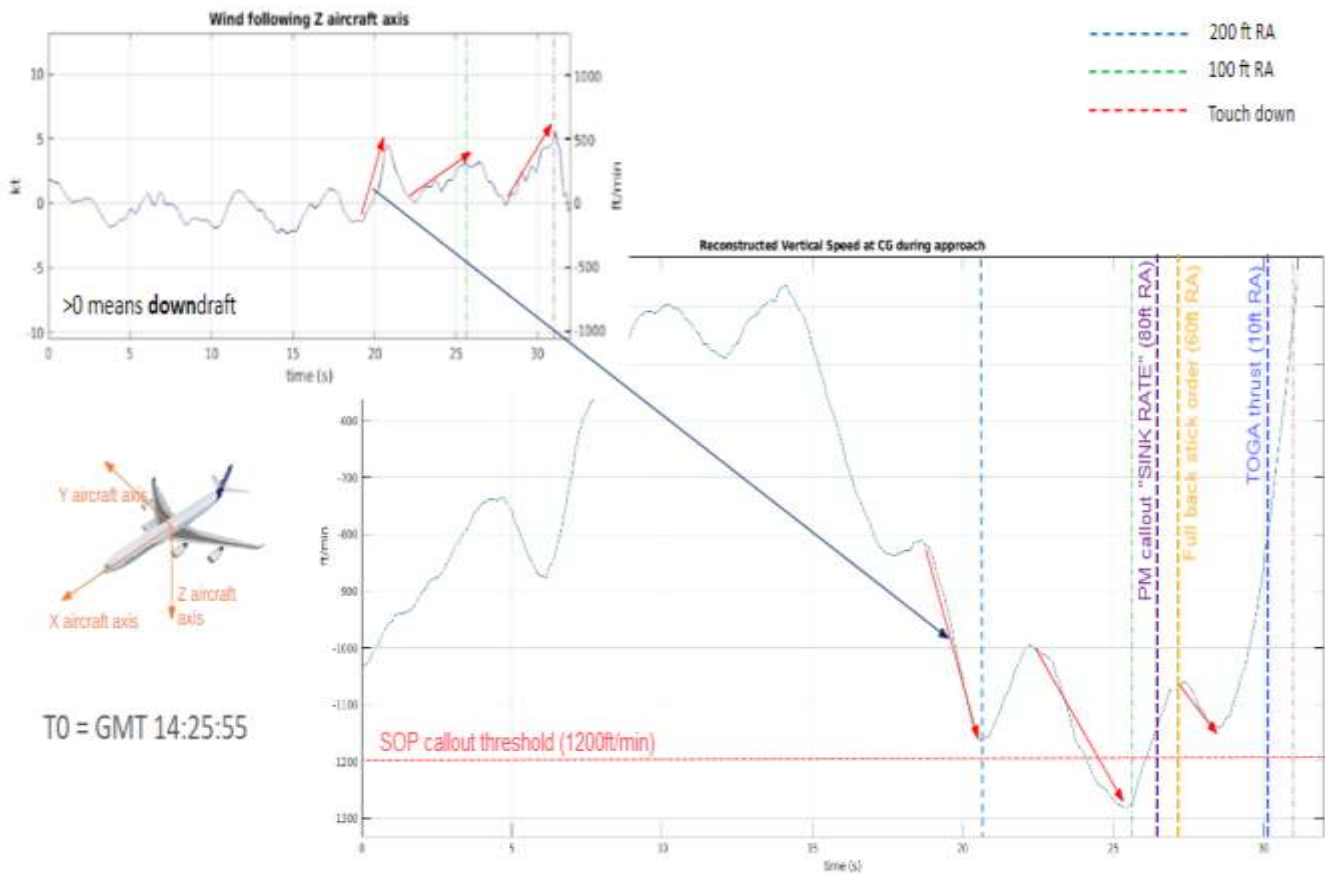
Figure 43 - Vertical Speed re-computation

This vertical speed re-computation shows that the two first downdrafts increased the Vz from 800ft/min to almost 1300ft/min reached at 100 ft RA. The PM callout occurred about 2sec after the Vz increased above 1200ft/min.

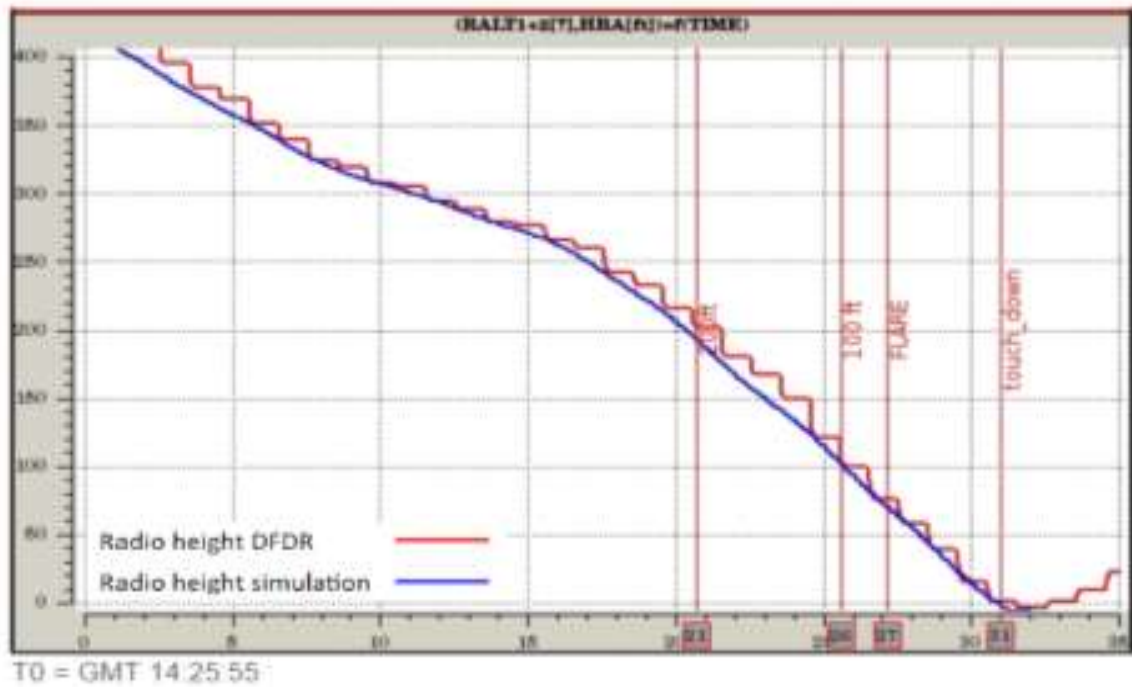
Figure 44 - Sidestick input

This shows that this simulation matches pretty well the event validating the settings of the computation.

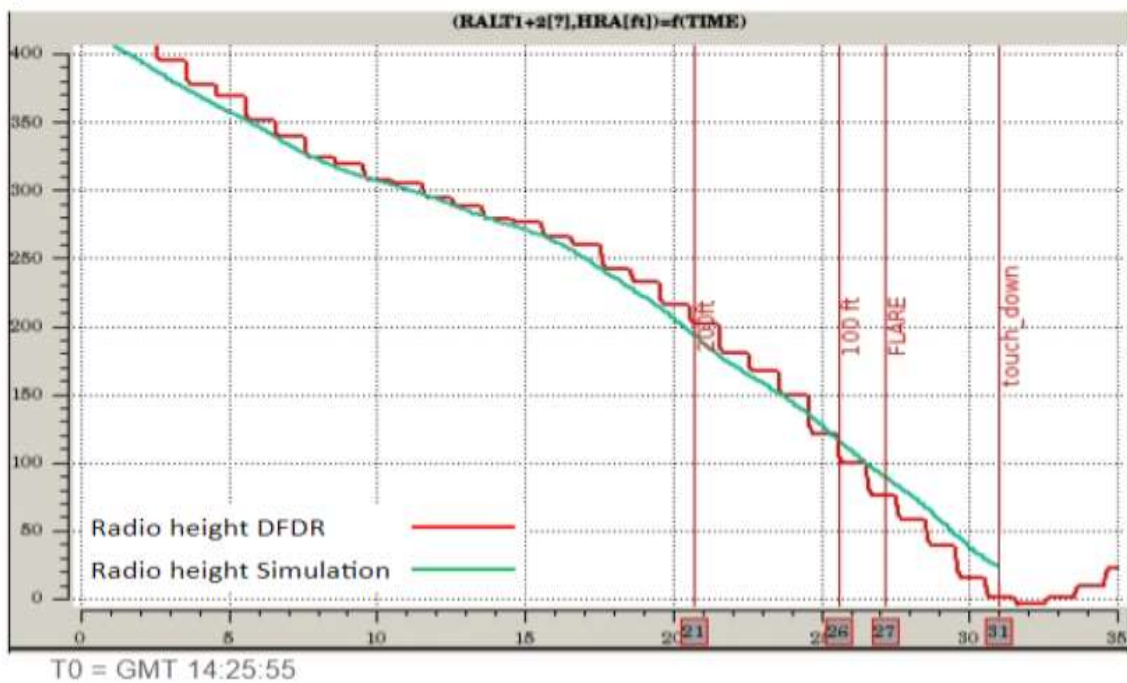
Figure 45 - Sidestick input with no wind.

This simulation shows that the wind was a contributing factor that led the aircraft flying below the correct fly path in the last 100 ft RA (25 ft RA at event touchdown).

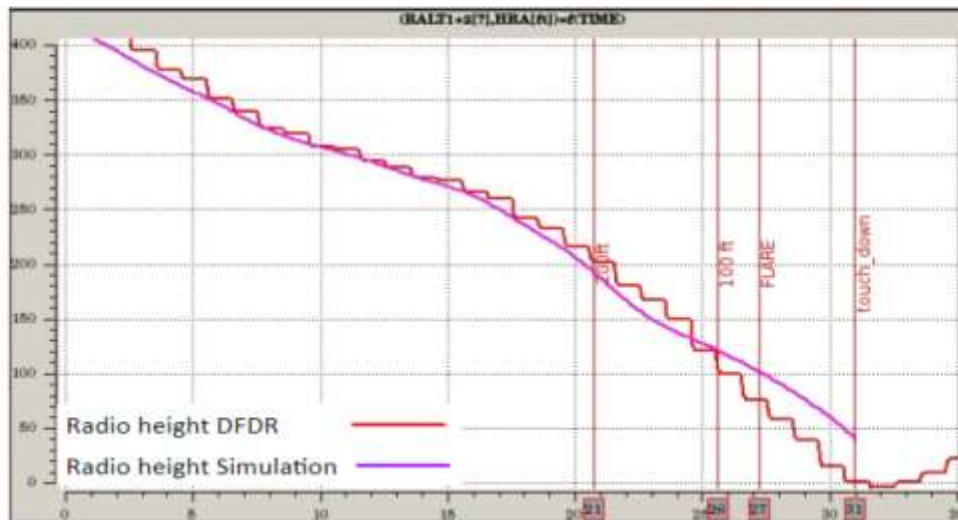
Figure 46 - Sidestick with wind.

The simulation shows that the pilot sidestick input was also a contributing factor with a higher impact on the trajectory than the wind: 40ft RA (iso 25ft RA) at event touchdown. The following simulations were done to assess when the G/A should have been performed to avoid the touch with the ground:

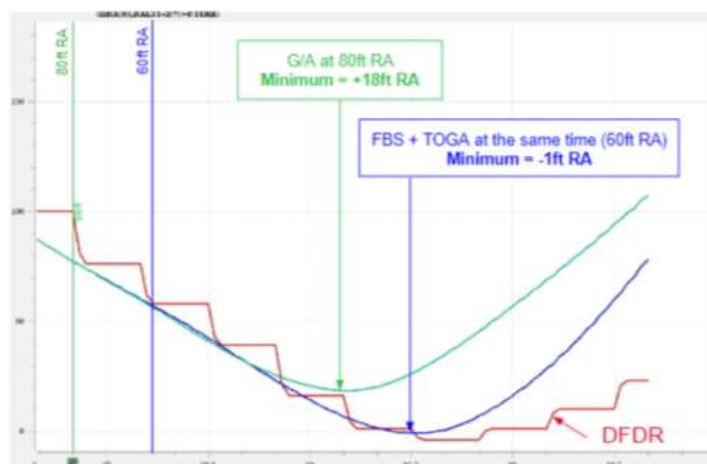
Figure 47 - Graph 1.

- A simulation with TOGA thrust applied at the time of the Full Back Stick (FBS) input (i.e. 60ft RA) as requested by the Go-Around Standard Operating Procedure (vs event where TOGA was applied about 3sec after the FBS order).
- A simulation with a G/A initiated at 80ft RA (i.e. ~1sec before the actual initiation).

As a conclusion, the Handling Qualities analysis shows that:

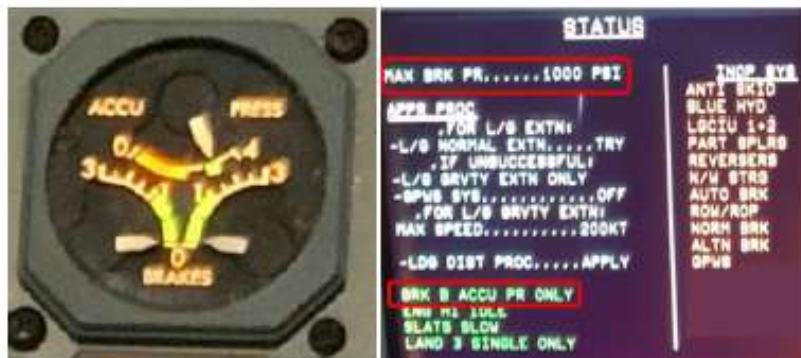
- However this procedure clearly mentioned that the braking was only available on ACCU press (“BRK B ACCU PR ONLY” displayed in the STATUS) and the information of the Brake ACCU pressure is provided on the triple indicator located on the main instrument panel (F/O side), cf. below snapshots of the triple indicator and the STATUS page of the HYD B RSVR LO LVL ECAM procedure taken during the replay of the KAL event in the simulator.
