Republic of the Philippines
CIVIL AVIATION AUTHORITY OF THE PHILIPPINES

FINAL REPORT

RP-C1018 GIPPSAERO, GA8 AIRVAN

TITLE: A serious incident involving a Gippsaero/GA8 Airvan type of aircraft with Registry Number RP-C1018 owned and operated by WCC Aviation Company, Inc. that executed a forced landing due to an engine non-mechanical failure at a harvested cornfield area in Barangay District 1, Reina Mercedes, Isabela, Philippines 10Km away from Cauayan Community Airport, Philippines on August 31, 2025/1115H local time.

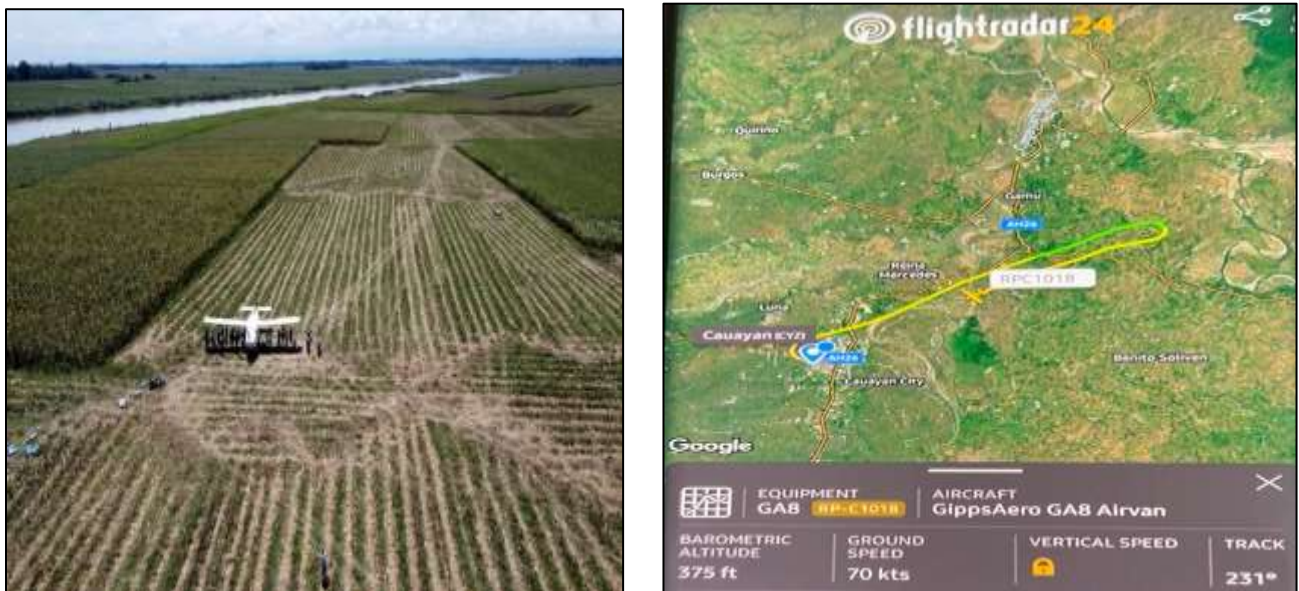
Figure 2 - RP-C1018 impact field and flight path as per Flightradar24.

The aircraft touched down on the field under control, coming to rest after a short ground roll. It sustained minor damage to the intake and exhaust manifolds. There was no post-impact fire. The surrounding terrain was level and unobstructed, and the aircraft remained upright and intact following the forced landing.
