# AIRCRAFT ACCIDENT INVESTIGATION AND INQUIRY BOARD

## FINAL REPORT

### RP-C7730 TEXTRON AVIATION/C172

**TITLE:** A serious incident involving a C172 type of aircraft with Registry Number RP-C7730 operated by Leading Edge International Aviation Academy Inc., that involved in a runway side excursion event at Runway 01, San Fernando Airport, Poro Point Freeport Zone, San Fernando City, La Union, Philippines after landing on September 12, 2025/1001H local time.

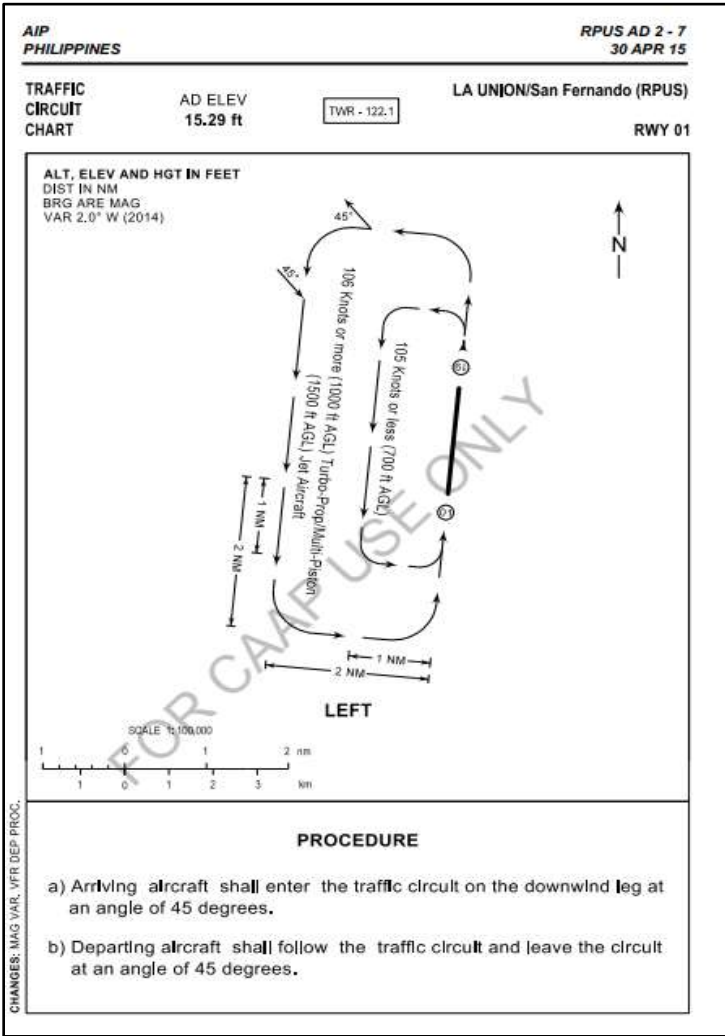
At San Fernando Community Airport, the Runway 01 traffic pattern is situated on the water side and is flown as a left-hand pattern, as published in the CAAP Aeronautical Information Publication (AIP). The training flight, arriving from the south, was cleared to land on Runway 01 (Figure 5).

Figure 5 - RPUS Runway 01 flight pattern procedure.

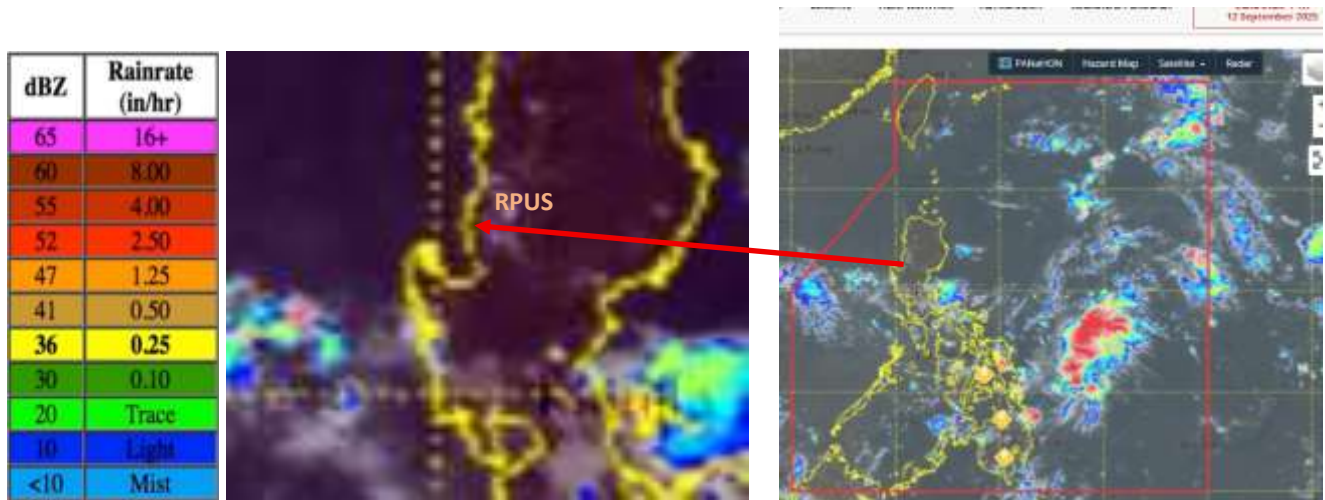
Additional meteorological data from the Philippine Atmospheric, Geophysical and Astronomical Services Administration (PAGASA), sourced from the Subic Radar Facility, depicted a broader weather pattern affecting the region, showing a weather formation situated to the southeast of RPUS on the day of the event (Figure 7).

Figure 7 - PAGASA RADAR weather image.
