FINAL REPORT

RP-C5911
DE HAVILLAND AIRCRAFT OF CANADA LIMITED
DHC-8-402

OPERATOR: AIR PHILIPPINES CORPORATION, DBA PAL EXPRESS

DATE OF OCCURRENCE: DECEMBER 27, 2024

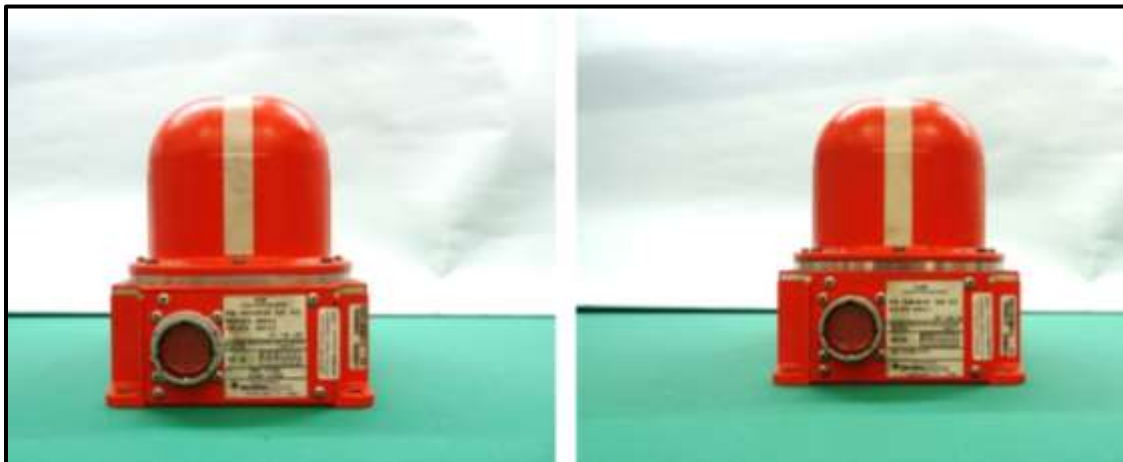
Figures 1 and 2 – RP-C5911’s DFDR and CVR.

The aircraft is equipped with a Digital Flight Data Recorder (DFDR) and a Cockpit Voice Recorder (CVR) as required by the Philippine Civil Aviation Regulations (PCAR).

The recorded parameters and data were intact, allowing for an accurate reconstruction of the incident dynamics. The data were analyzed and validated with the assistance of the Japan Transport Safety Board (JTSB) using the appropriate interpretation tools.

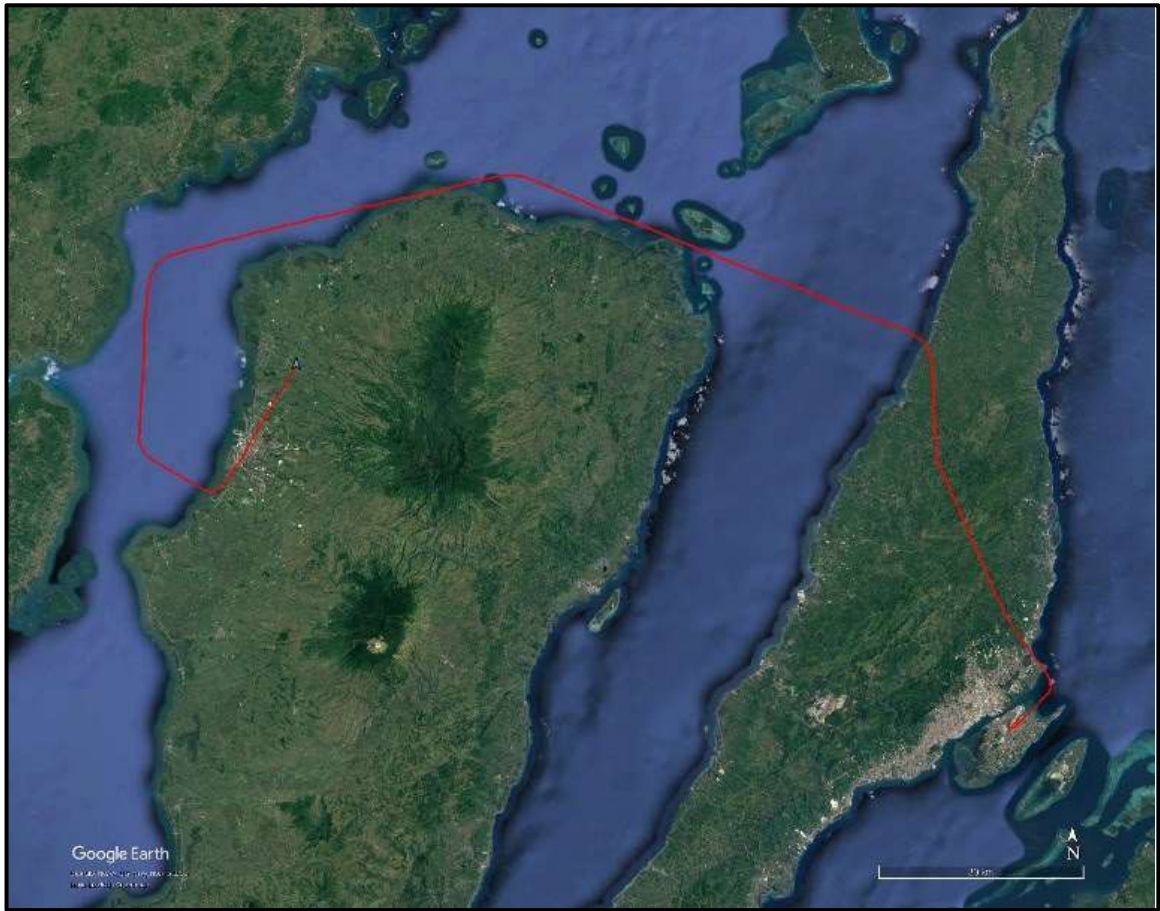
Figure 3 – Flight route based on FDR.

The aircraft came to a complete stop at 21:33:03 UTC with a heading of 289°, a pitch angle of 1.93°, and a roll angle of 0.35°.

No rudder, engine, or brake system malfunctions were identified in the recorded data.
